Building Pathology Report

Seaforth, Ontario

Prepared By Dr. Christopher Cooper

Revision Date: July 30, 2018

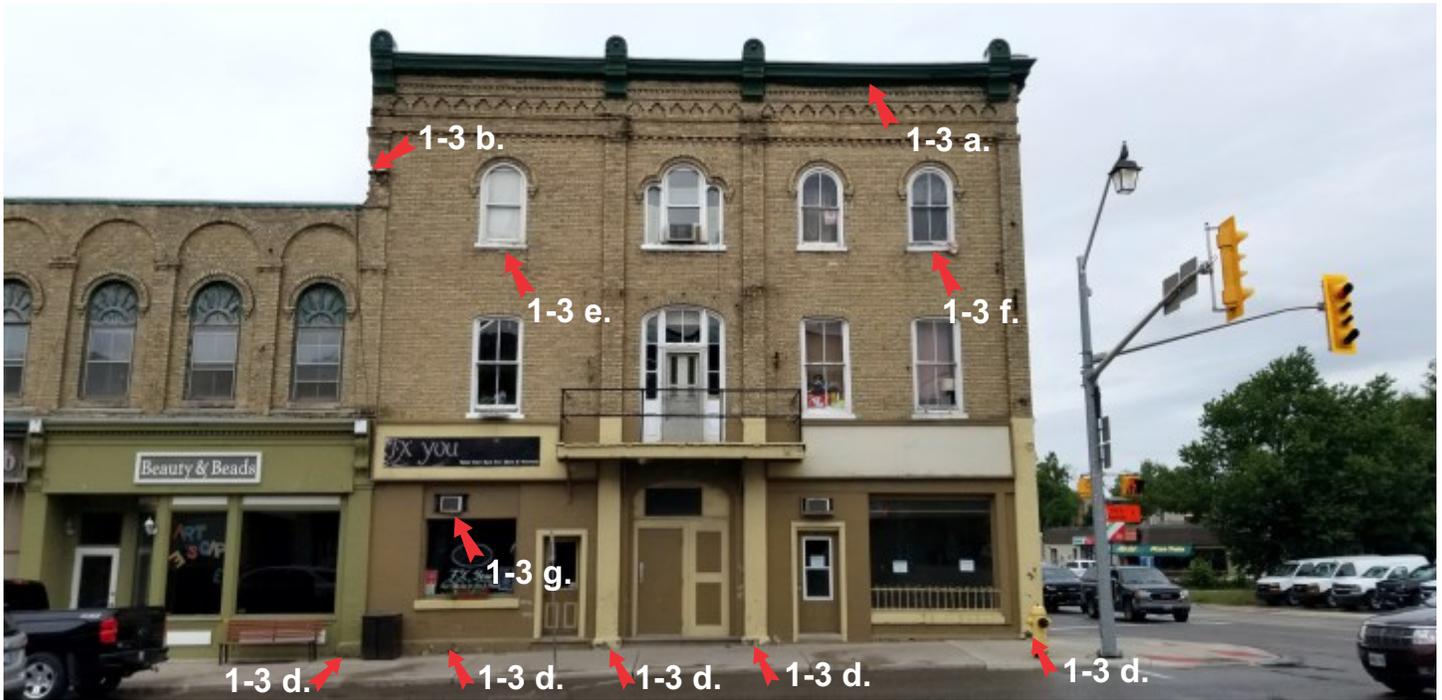
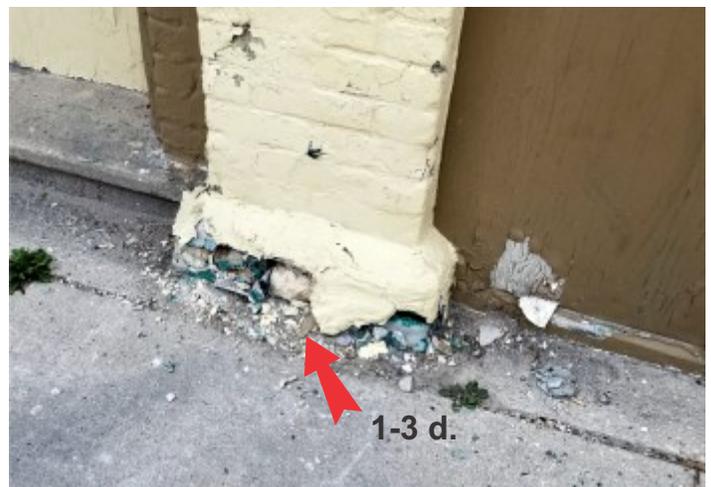
1-3 a. The flashing located at the upper roof parapet wall and above the fascia board shows some areas of deterioration and may have not been caulked properly. I have noted that the flashing at the junction of this building and the building to the south may not have been caulked or let into the masonry properly and may be allowing water to find its way between the flashing and the masonry units, which will inevitably cause problem with damp and spalling of masonry units.

1-3 b. The main above-grade masonry exterior cladding is in fair condition with several areas of deterioration due to miss-managed roof water, however, cement has been used to fill voids in the original all lime-based mortar which is very damaging. Water and soluble salts which destroy lime mortar must be kept in check therefore keeping these joints properly pointed is very important to the health of the exterior brick cladding. Repointing of the brick works should be done utilizing only lime-based mortar devoid of any cement. Any spalled (broken-off) brick or washed out mortar should first be investigated as to the reason why they have spalled or washed out i.e. broken or cracked caulking around windows, Portland cement, landscape material too close to masonry, bad eavestroughs and downspouts or flashing, generally spalled masonry, and washed out mortar are a symptom of a moisture problem and should be repaired (water issues) as a priority.

1-3 c. Ancillary side walls were traditionally pargeted with a suction bond of lime mortar. Concrete pargetting will hold copious amounts of moisture between the soft brick and the concrete parget itself causing massive spalling issues destroying the underlining brick during freeze and thaw cycles. Cementitious materials should be removed wholesale and the entire wall pargeted with an all lime suction bond to allow the transmission of moisture to the exterior.

1-3 d. All the main structural masonry support pilasters have deterioration at its base where it comes in contact with the sidewalk. This problem is due to freeze and thaw cycles and soluble salts (winter road salt) destroying the masonry units. Water and soluble salts which destroy lime mortar must be kept in check therefore keeping these joints properly pointed is very important to the health of the exterior brick cladding.

1-3 e. A significant bulge in the masonry below the sill noted, is a clear indicator of water finding its way between the wythes of the brick below. An investigation of the brick mortar and caulking will need to be made to see where the water is entering the brick wythes. This area may need to be rebuilt if the mortar has failed.

1-3 f. The building has timber sub-sills under the majority of the existing windows. There are signs of deterioration and loss of the paint surface. These sub-sills should be scraped, and any areas of rot repaired with a two-part epoxy system and repainted. Sills and sub-sills should never be caulked on the bottom as this can create issues with the passage of moisture which can rot out the sill and the sub-sill.

1-3 i. These cast-iron brackets are lovely and very character defining. However, one bracket is missing to the north allowing no support for the balcony above. These brackets should be inspected thoroughly to see if they are anchored securely and not corroded.

1-3 jk. Much of the decking and the sub-structure is fraught with cuboidal wet rot and is very unsafe. The balcony needs to be replaced wholesale and should not have access to it by human occupants until these issues are remediated.

Repointing of the brick works should be done utilizing only lime-based mortar devoid of any cement. And, a regular yearly maintenance routine will need to be employed to keep the mortar in check and repair as necessary.

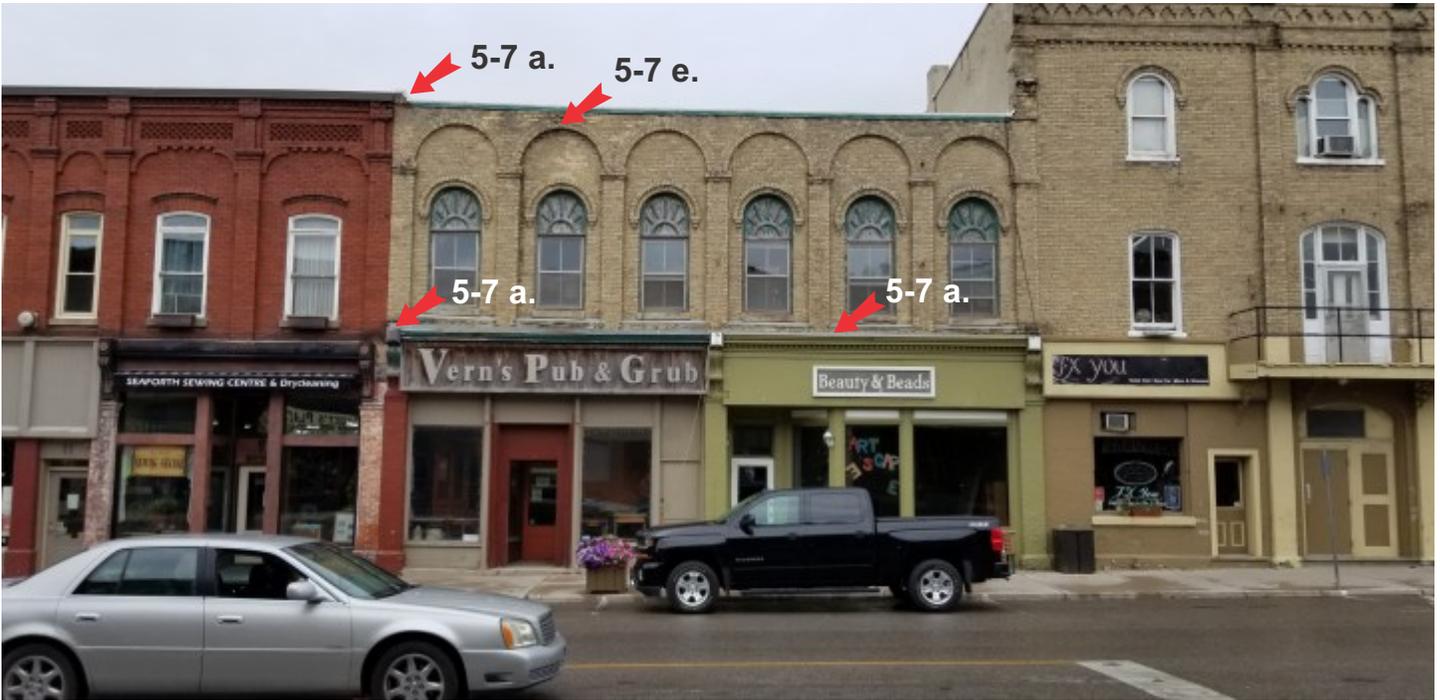
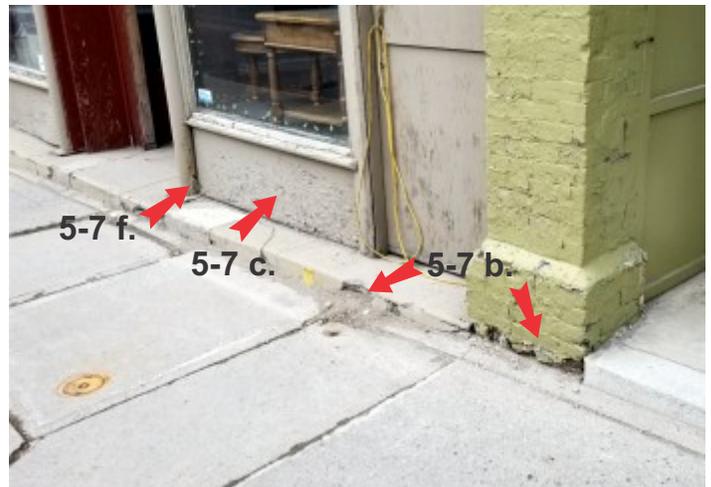
5-7 a. The flashing located at the upper roof parapet wall and above the fascia board and console bracket flashing shows some areas of deterioration and may have not been caulked properly. I have noted that the flashing at the junction of this building and the building to the south may not have been caulked or let into the masonry properly and may be allowing water to find its way between the flashing and the masonry units, which will inevitably cause problem with damp and spalling of masonry units.

5-7 b. All the main structural masonry support pilaster plinth has deterioration at its base where it comes in contact with the sidewalk. This problem is due to freeze and thaw cycles and soluble salts (winter road salt) destroying the masonry units. Water and soluble salts which destroy lime mortar must be kept in check therefore keeping these joints properly pointed is very important to the health of the exterior brick cladding. Repointing of the brick works should be done utilizing only lime-based mortar devoid of any cement. And, a regular yearly maintenance routine will need to be employed to keep the mortar in check and repair as necessary.

5-7 d. The exterior brick work has many areas over windows with pronounced pyramidal cracks. Many of these types of cracks may have appeared in the first decade after original construction due in part to excessive shrinkage of wooden window frames and lintels. However, it can also indicate a problem with rot and the masonry has shifted.

5-7 e. The main above-grade masonry exterior cladding is in fair condition with several areas of deterioration due to miss-managed roof water, however, cement has been used to fill voids in the original all lime-based mortar which is very damaging. Water and soluble salts which destroy lime mortar must be kept in check therefore keeping these joints properly pointed is

very important to the health of the exterior brick cladding. Repointing of the brick works should be done utilizing only lime-based mortar devoid of any cement. Any spalled (broken-off) brick or washed out mortar should first be investigated to the reason why they have spalled or washed out i.e. broken or cracked caulking around windows, Portland cement, landscape material too close to masonry, bad eavestroughs and downspouts or flashing, generally spalled masonry, and washed out mortar are a symptom of a moisture problem and should be repaired (water issues) as a priority.

5-7 f. This building employs cast-iron columns to support the main beam which in-turn supports the upper levels. Some signs of corrosion have been noted. These columns should be inspected more closely to see if they still have structural integrity at their bases. Rust should be wire-brushed and the whole of the column kept well painted.

5-7 g. The main timber beam supporting the upper levels is exposed and shows signs of deterioration. This should have a paint film applied to protect it from the elements. Any rot areas should be repaired with a two-part epoxy or replaced wholesale.

5-7 h. The joint between this building and the adjacent building should be kept well pointed with lime mortar to not allow water to penetrate, which could create a spall condition.

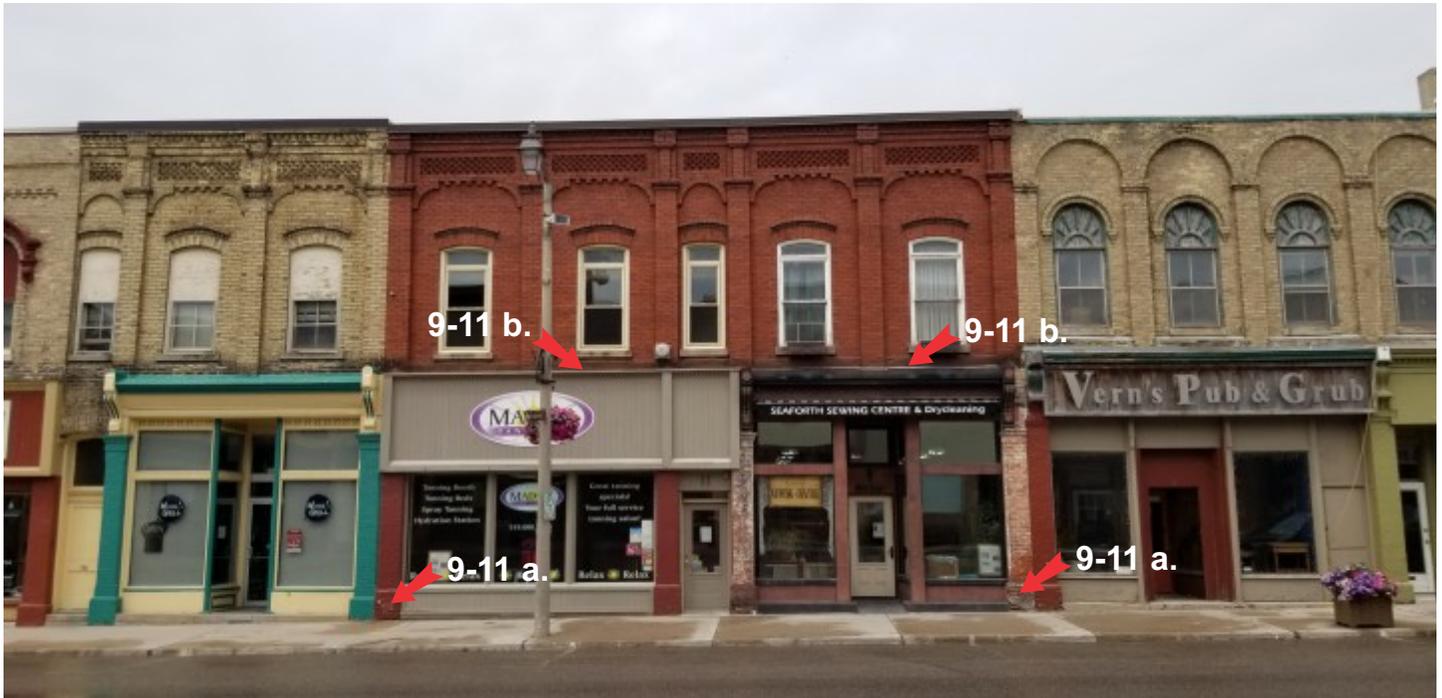
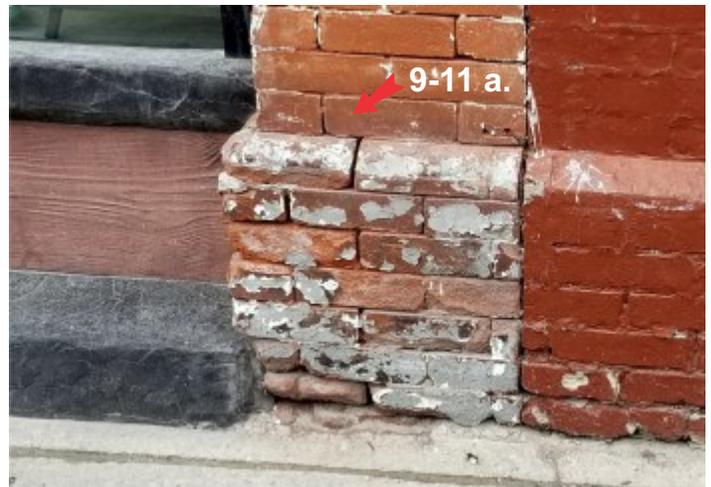
9-11 a. All the main structural masonry support pilaster plinth has deterioration at its base where it comes in contact with the sidewalk. This problem is due to freeze and thaw cycles and soluble salts (winter road salt) destroying the masonry units. Water and soluble salts which destroy lime mortar must be kept in check therefore keeping these joints properly pointed is very important to the health of the exterior brick cladding. Repointing of the brick works should be done utilizing only lime-based mortar devoid of any cement. And, a regular yearly maintenance routine will need to be employed to keep the mortar in check and repair as necessary.

9-11 b. The flashing located at the upper roof parapet wall appears to be in excellent condition. However, the fascia board and console bracket flashing shows some areas of deterioration and may have not been caulked properly or let into the brick work and may be allowing water to find its way between the flashing and the masonry units, which will inevitably cause a problem with damp and spalling of masonry units.

9-11 c. The main above-grade masonry exterior cladding is in very good condition! However, there are several areas of deterioration due to (former) mismanaged roof water. Water and soluble salts which

destroy lime mortar must be kept in check therefore keeping these joints properly pointed is very important to the health of the exterior brick cladding. Repointing of the brick works should be done utilizing only lime-based mortar devoid of any cement. Any spalled (broken-off) brick or washed out mortar should first be investigated to the reason why they have spalled or washed out i.e. broken or cracked caulking around windows, Portland cement, landscape material too close to masonry, bad eavestroughs and downspouts or flashing, generally spalled masonry, and washed out mortar are a symptom of a moisture problem and should be repaired (water issues) as a priority.

9-11 d. All areas of painted timber (i.e. console brackets and original window trim) should be scraped and repainted.

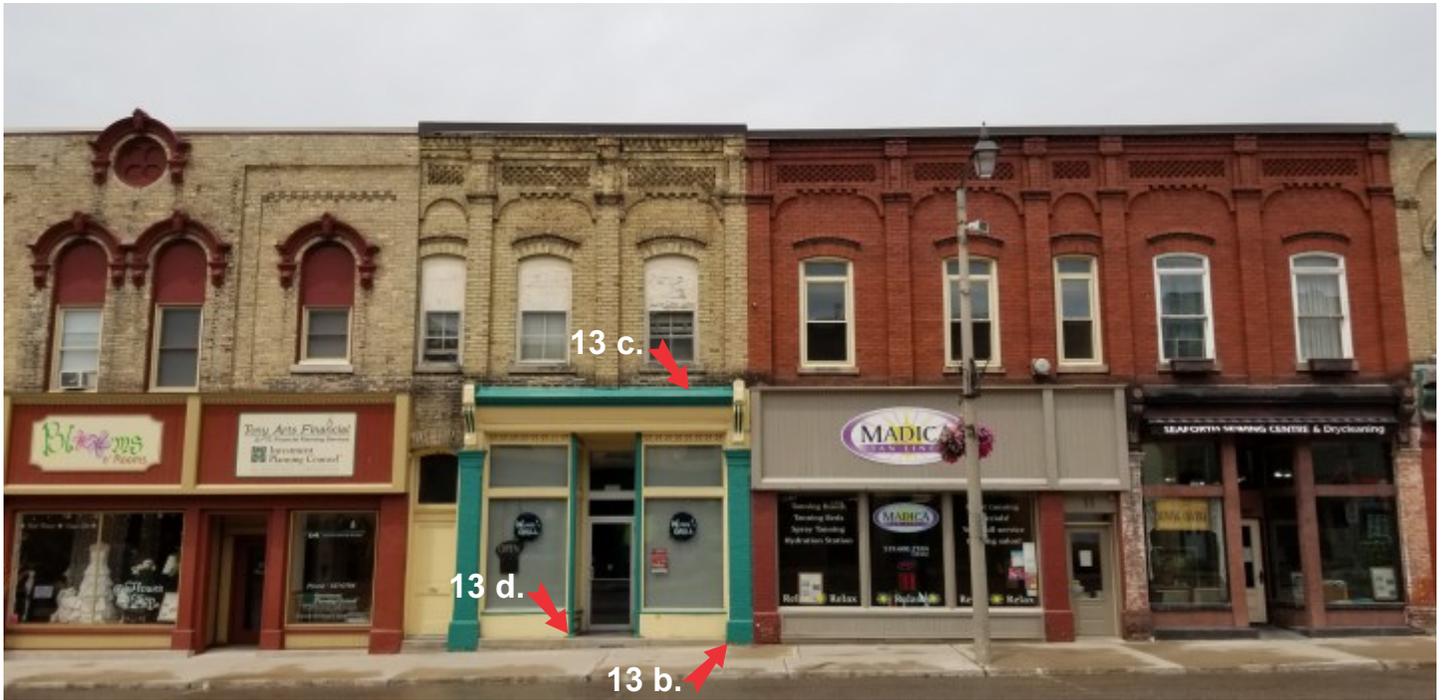
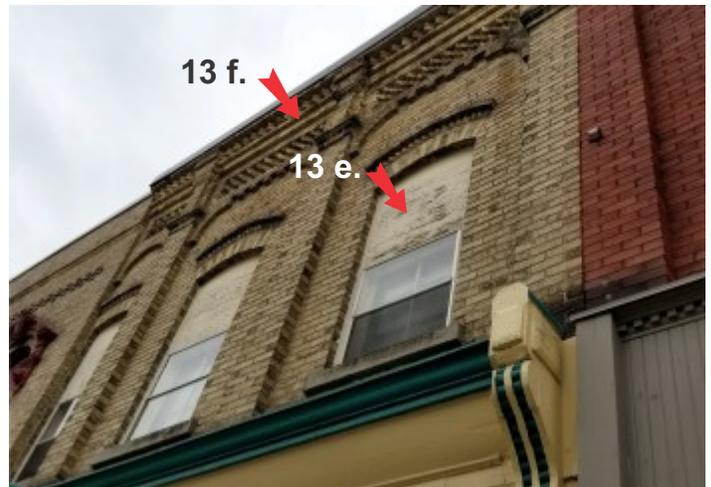
13 a. All areas of painted timber (i.e. console brackets and original window trim) should be scraped and repainted. If there are any areas of cuboidal wet rot, those areas that are simple flat sections of timber should be replaced wholesale with like material. Any areas with remarkable architectural moulding and detail should have any areas of cuboidal wet rot repaired with a two-part epoxy system.

13 b. All the main structural masonry support pilaster plinth has deterioration at its base where it comes in contact with the sidewalk. This problem is due to freeze and thaw cycles and soluble salts (winter road salt) destroying the masonry units. Water and soluble salts which destroy lime mortar must be kept in check therefore keeping these joints properly pointed is very important to the health of the exterior brick cladding. Repointing of the brick works should be done utilizing only lime-based mortar devoid of any cement. And, a regular yearly maintenance routine will need to be employed to keep the mortar in check and repair as necessary.

13 c. The flashing located at the upper roof parapet wall appears to be in excellent condition. However, the fascia board and console bracket flashing shows some areas of deterioration and may have not been caulked properly or let into the brick work and may be allowing water to find its way between the flashing and the masonry units, which will inevitably cause problem with damp and spalling of masonry units.

13 d. This building employs cast-iron columns to support the main beam which in turn supports the upper levels. Some signs of corrosion have been noted. These columns should be inspected more closely to

see if they still have structural integrity at their bases. Rust should be wire-brushed and the whole of the column kept well painted.

13 f. The main above-grade masonry exterior cladding is in very good condition! However, there are several areas of deterioration due to (former) mismanaged roof water. Water and soluble salts which destroy lime mortar must be kept in check therefore keeping these joints properly pointed is very important to the health of the exterior brick cladding. Repointing of the brick works should be done utilizing only lime-based mortar devoid of any cement. Any spalled (broken-off) brick or washed out mortar should first be investigated to the reason why they have spalled or washed out i.e. broken or cracked caulking around windows, Portland cement, landscape material too close to masonry, bad eavestroughs and downspouts or flashing, generally spalled masonry, and washed out mortar are symptoms of a moisture problem and should be repaired (water issues) as a priority.

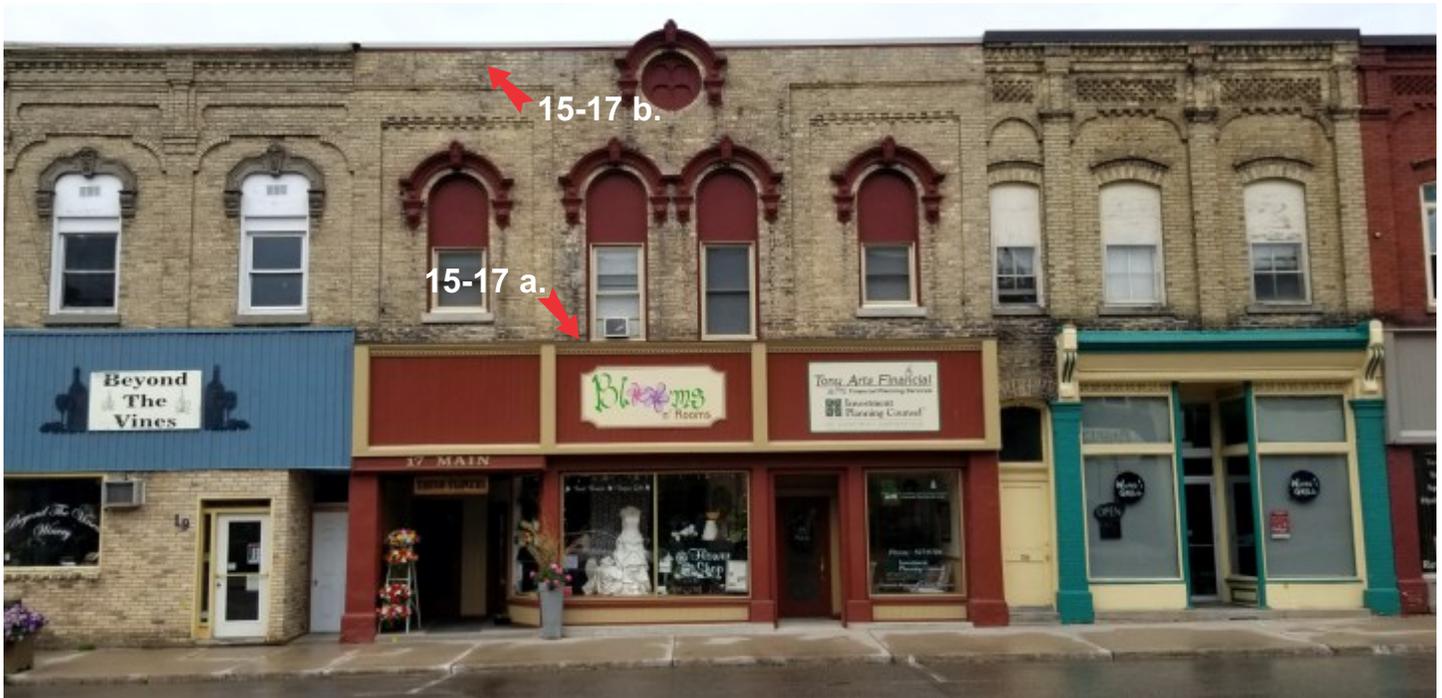
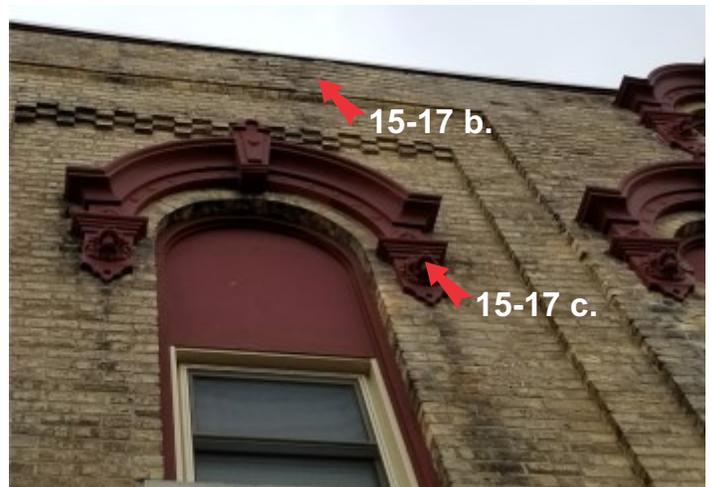
15-17 a. The flashing located at the upper roof parapet wall appears to be in good condition. However, the fascia board flashing shows some areas of deterioration and may have not been caulked properly or let into the brick work and may be allowing water to find its way between the flashing and the masonry units, which will inevitably cause problem with damp and spalling of masonry units.

15-17 b. The main above-grade masonry exterior cladding is in fair condition! However, there are several areas of deterioration due to miss-managed roof water, possibly in the past. Water and soluble salts which destroy lime mortar must be kept in check therefore keeping these joints properly pointed is very important to the health of the exterior brick cladding. Repointing of the brick works should be done utilizing only lime-based mortar devoid of any cement. Any spalled (broken-off) brick or washed out mortar should first be investigated to the reason why they have spalled or washed out i.e. broken or cracked caulking around windows, Portland cement, landscape material too close to masonry, bad eavestroughs and

downspouts or flashing, generally spalled masonry, and washed out mortar are a symptom of a moisture problem and should be repaired (water issues) as a priority. There is a considerable bulge in the wall which could indicate freeze and thaw damage which should be addressed to reset the affected areas.

15-17 c. This building has beautiful and very character defining cast iron hood mouldings and label-stops. As these are very heavy a periodical inspection should be made that they are affixed to the building properly e.g., metal fasteners let into the surrounding brick works are not corroded or missing.

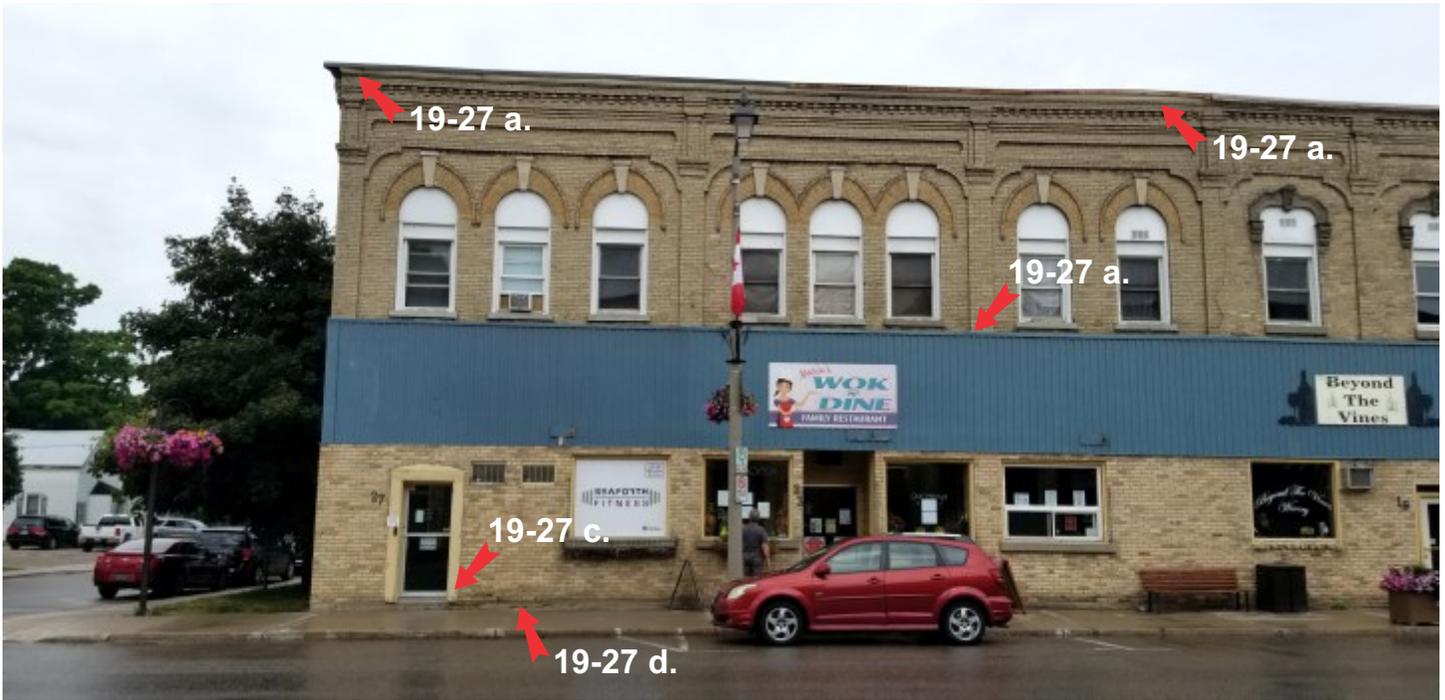
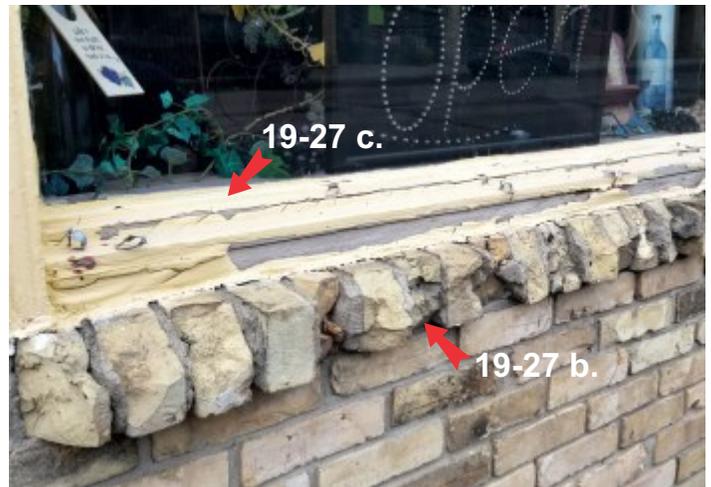
19-27 a. The flashing located at the upper roof parapet wall appears to be in very poor condition and needs to be replaced wholesale. The fascia board flashing shows some areas of deterioration and may have not been caulked properly or let into the brick work and may be allowing water to find its way between the flashing and the masonry units, which will inevitably cause problem with damp and spalling of masonry units.

19-27 b. The original brick sub-sill is in very poor condition. It has gone through many freeze and thaw cycles which has destroyed the sub-sill. This sill should be replaced wholesale.

19-27 c. All areas of painted timber should be scraped and repainted. If there are any areas of cuboidal wet rot, those areas that are simple flat sections of timber should be replaced wholesale with like material. Any areas with remarkable architectural moulding and detail should have any areas of cuboidal wet rot repaired with a two-part epoxy system.

has deterioration at its base where it comes in contact with the sidewalk. This problem is due to freeze and thaw cycles and soluble salts (winter road salt) destroying the masonry units. Water and soluble salts which destroy lime mortar must be kept in check therefore keeping these joints properly pointed is very important to the health of the exterior brick cladding. Repointing of the brick works should be done utilizing only lime-based mortar devoid of any cement. And, a regular yearly maintenance routine will need to be employed to keep the mortar in check and repair as necessary.

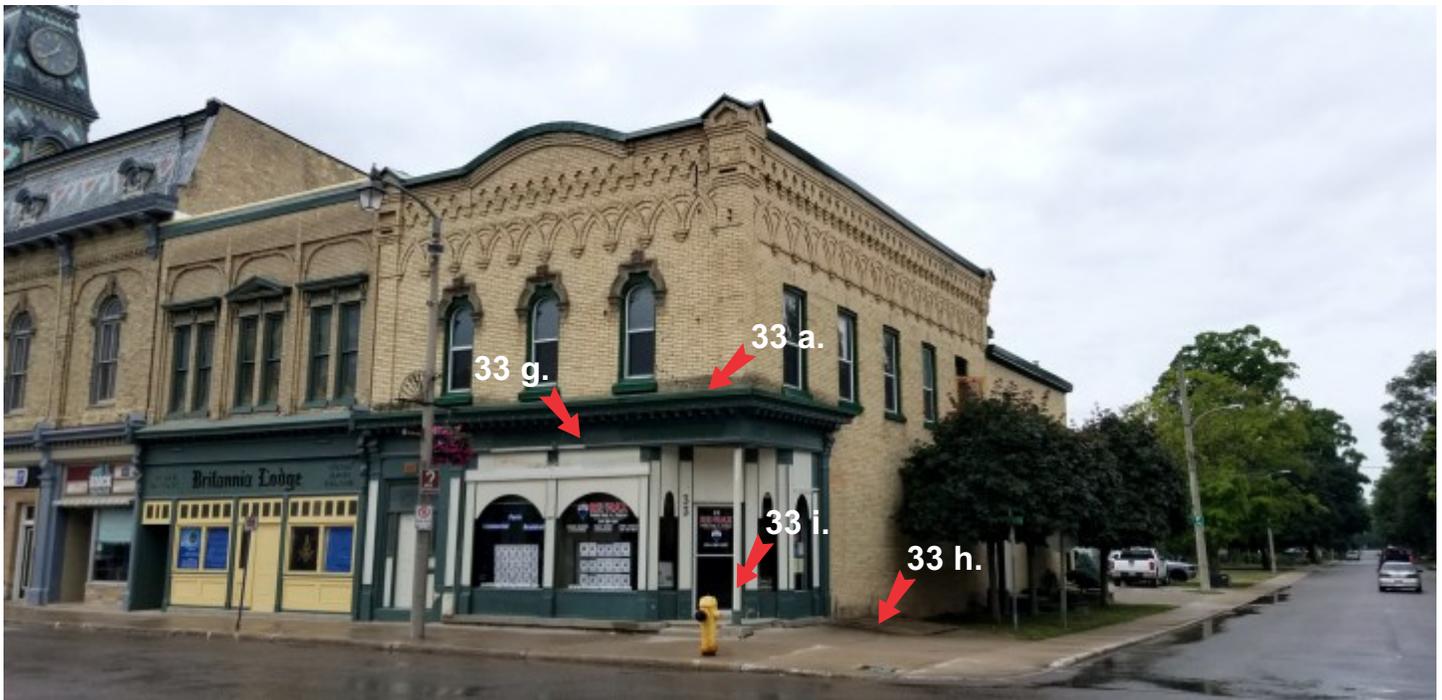
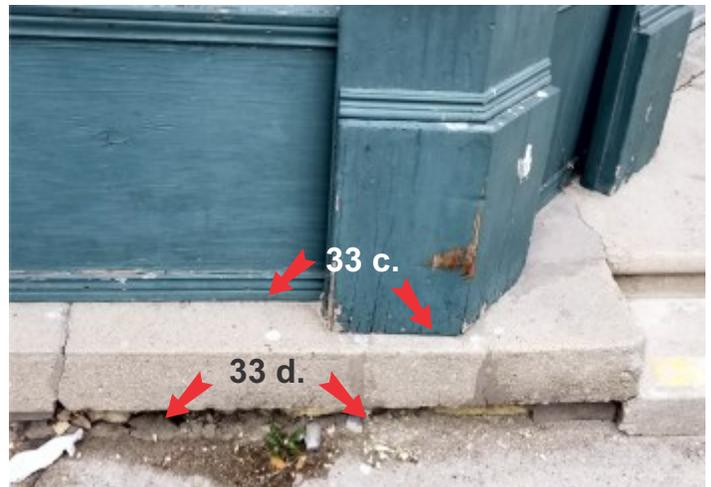
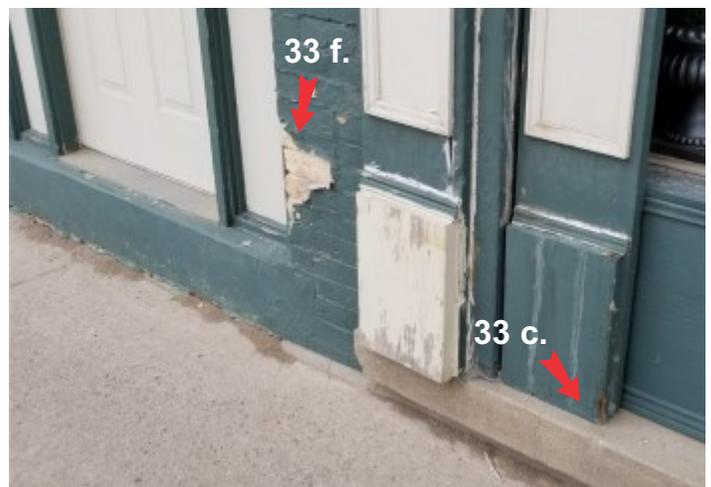
33 a. The flashing located at the upper roof parapet wall appears to be in excellent condition. However, the projecting fascia/frieze board shows some areas of deterioration and may have not been caulked properly or let into the brick work and may be allowing water to find its way between the flashing and the masonry units, which will inevitably cause problem with damp and spalling of masonry units.

33 b. The exterior brick work has a few areas with pronounced pyramidal cracks. Many of these types of cracks may have appeared in the first decade after original construction due in part to excessive shrinkage of wooden window frames and lintels. However, it can also indicate a problem with rot and the masonry has shifted.

33 c. This building has wooden elements in direct contact with masonry and concrete. Timber elements and masonry with the potential of sustained damp (e.g., sidewalks and in the instance a concrete or masonry plinth allowing ponding) will prematurely rot the timber. All timber should be terminated at least 1" above ground surface masonry.

33 d. Lower sections of brick work has deterioration at its base where it comes in contact with the sidewalk. This problem is due to freeze and thaw cycles and soluble salts (winter road salt) destroying the masonry units. Water and soluble salts which destroy lime mortar must be kept in check therefore keeping these joints properly pointed is very important to the health of the exterior brick cladding. Repointing of the brick works should be done utilizing only lime-based mortar devoid of any cement. And, a regular yearly maintenance routine will need to be employed to keep the mortar in check and repair as necessary.

33 f. I noted some area of brick which is painted, these areas should be touched up periodically.

33 i. This building employs a cast-iron columns to support the main beam which in-turn supports the upper levels. Some signs of corrosion have been noted. These columns should be inspected closer to see if they still have structural integrity at their bases. Rust should be wire-brushed and the whole of the column kept well painted.

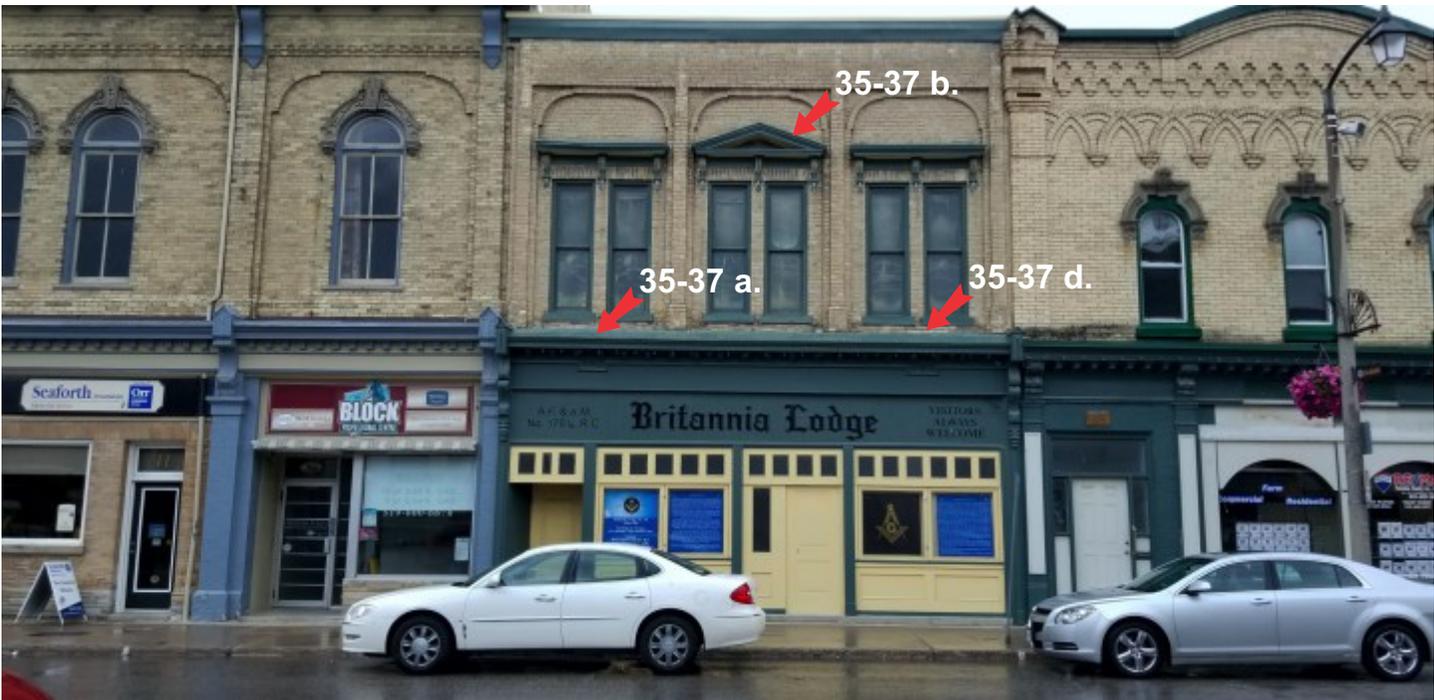
35-37 a. The flashing located at the upper roof parapet wall appears to be in excellent condition. However, the projecting fascia/frieze board may have not been caulked properly or let into the brick work and may be allowing water to find its way between the flashing and the masonry units, which will inevitably cause problem with damp and spalling of masonry units.

35-37 d. The main above-grade masonry exterior cladding is in fair condition! However, there are several areas of deterioration due to miss-managed roof water, possibly in the past. Water and soluble salts which destroy lime mortar must be kept in check therefore keeping these joints properly pointed is very important to the health of the exterior brick cladding. Repointing of the brick works should be done utilizing only lime-based mortar devoid of any cement.

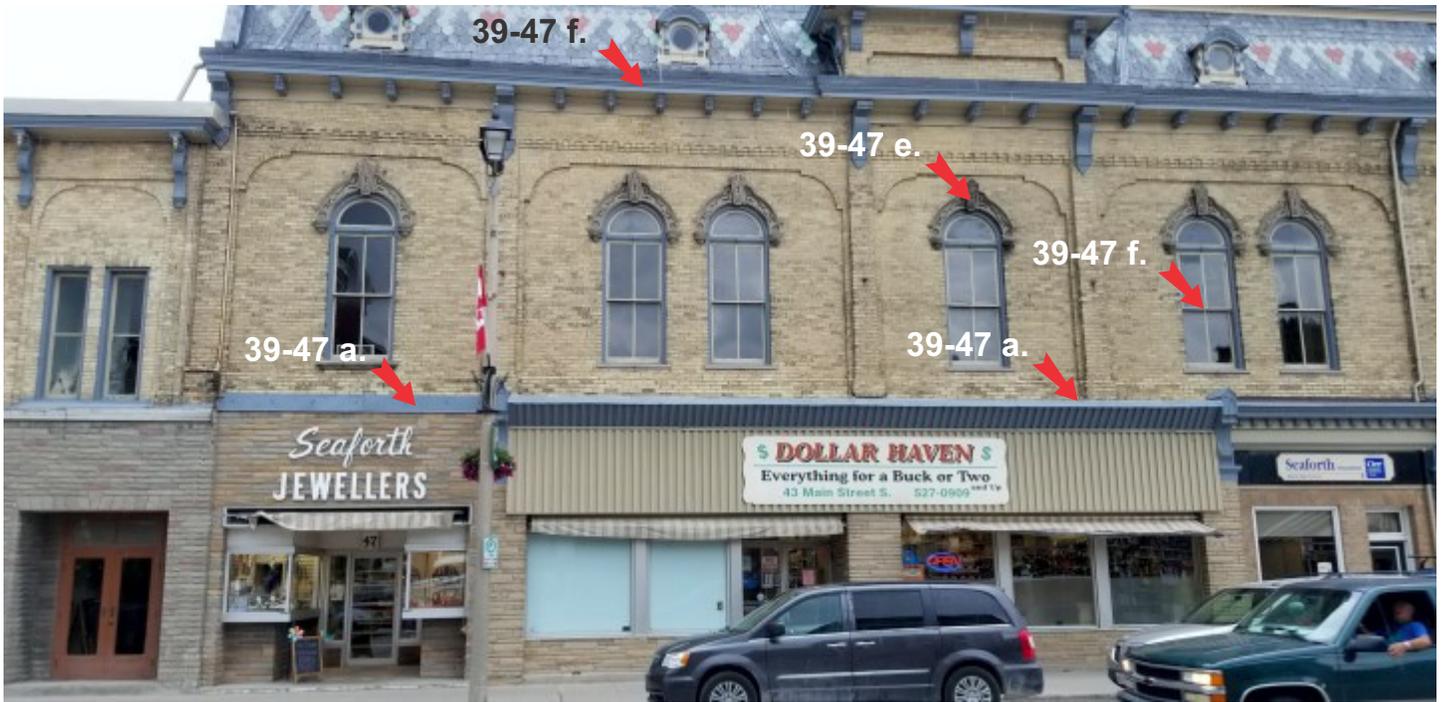
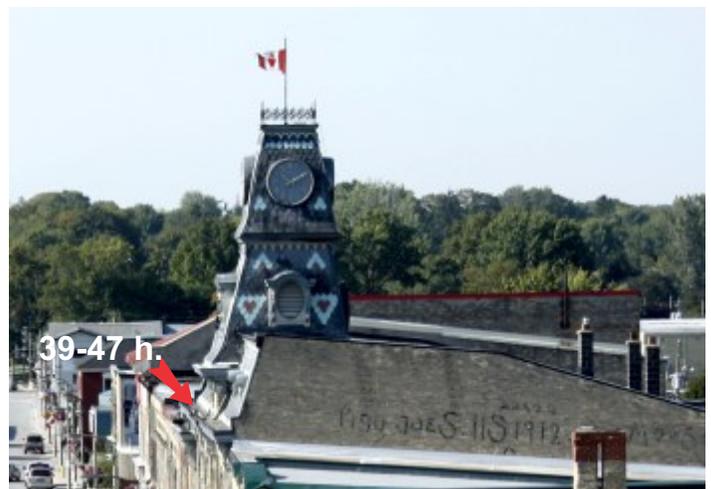
39-47 a. The flashing located at the upper roof parapet wall appears to be in fair condition, however, should be inspected for corrosion and or leaks on a regular basis. The fascia board and console bracket shows some areas of deterioration and may have not been caulked properly or let into the brick work and may be allowing water to find its way between the flashing and the masonry units, which will inevitably cause problem with damp and spalling of masonry units.

39-47 h. In the accompanying image (2012) some ponding was detected on the projecting architrave / pediment. This area should be inspected for proper drainage and the integrity of the roofing material. A leak could cause a rot condition and failure.

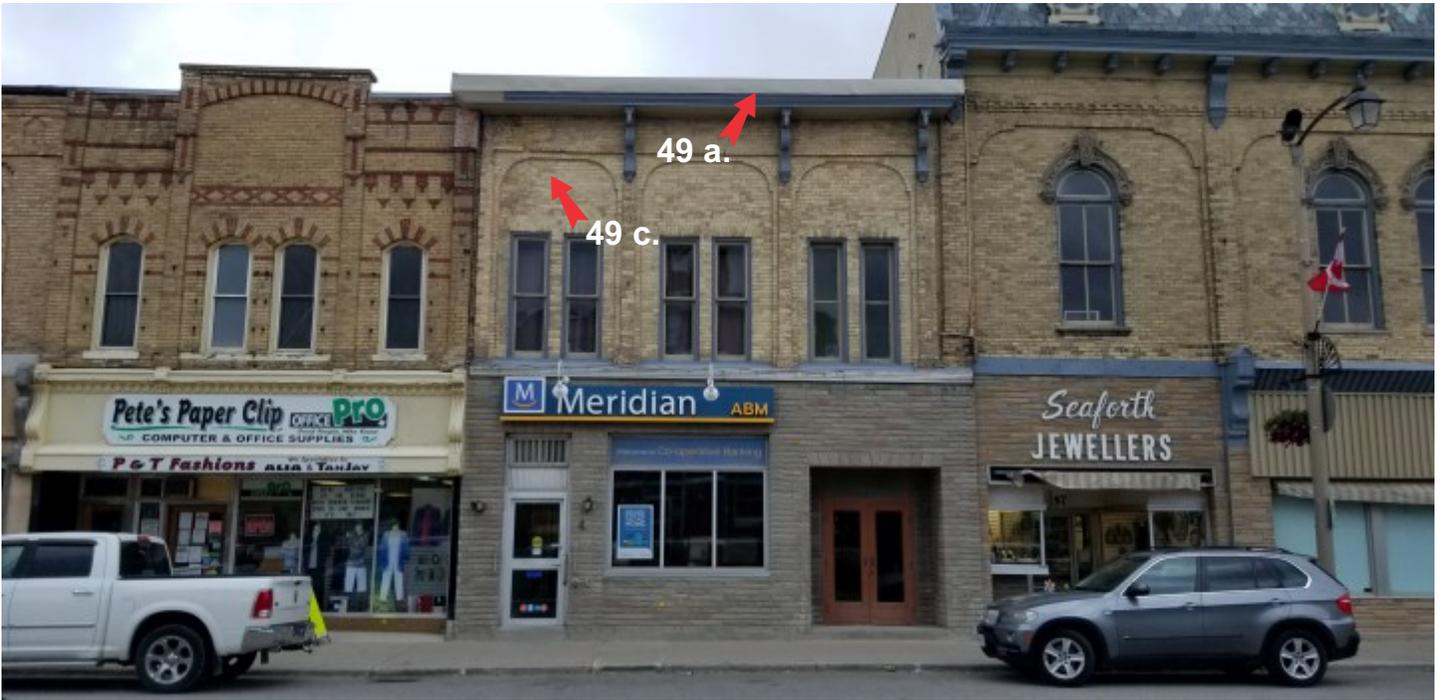
49 a. The flashing located at the upper roof parapet wall appears to be in fair condition, however, it has been installed rather awkwardly, especially to the south where it is wrapped around the soffit, which could in the future hold moisture and water against the wooden soffit. The flashing also covers a character defining cornice moulding which is unsympathetic to the heritage fabric of the building.

49 d. The flashing at the fascia board location is in poor condition and should be repaired or replaced wholesale.

49 e. Areas denoted require proper flashing to stop erosion and cracking of the form-a-stone material below.

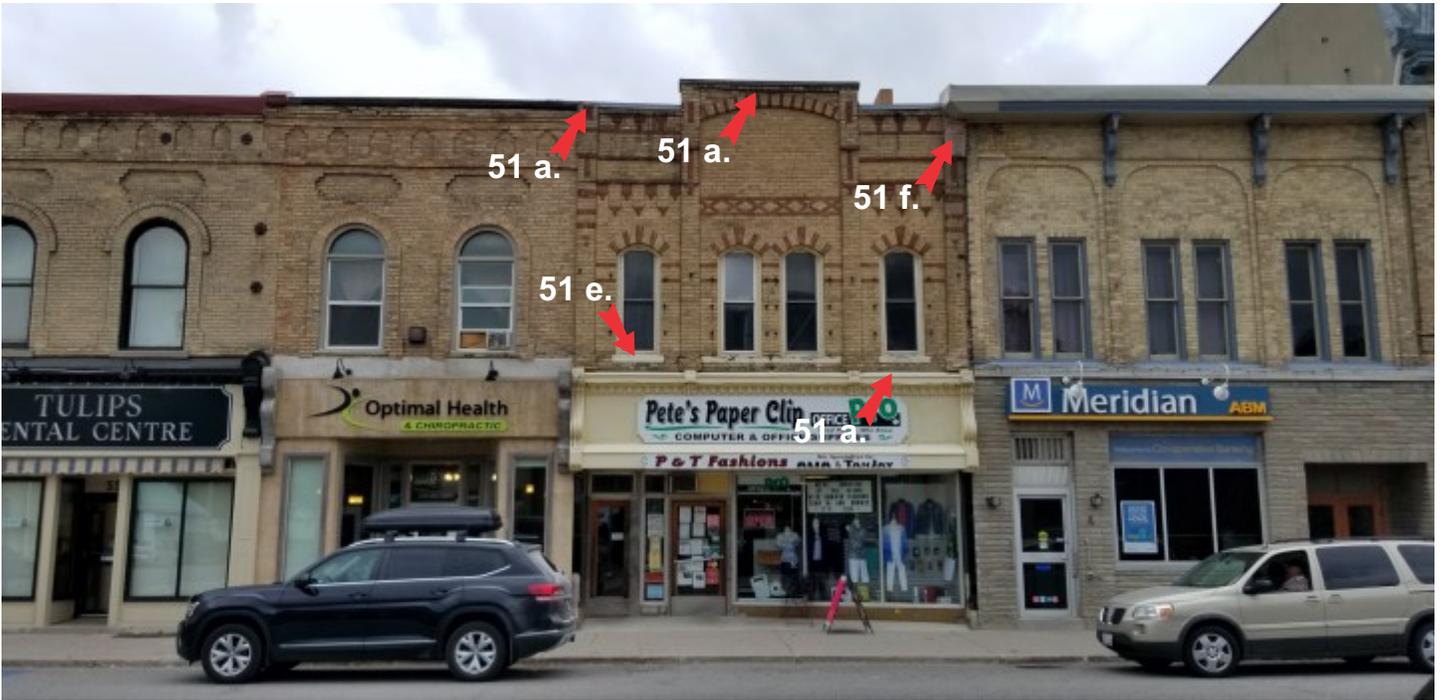
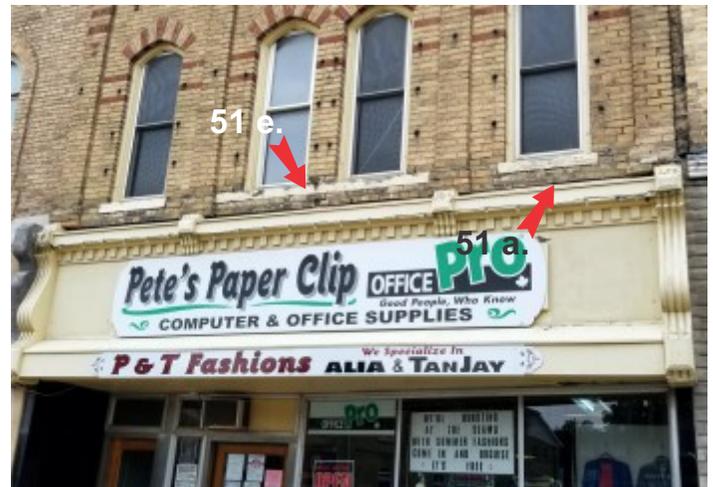
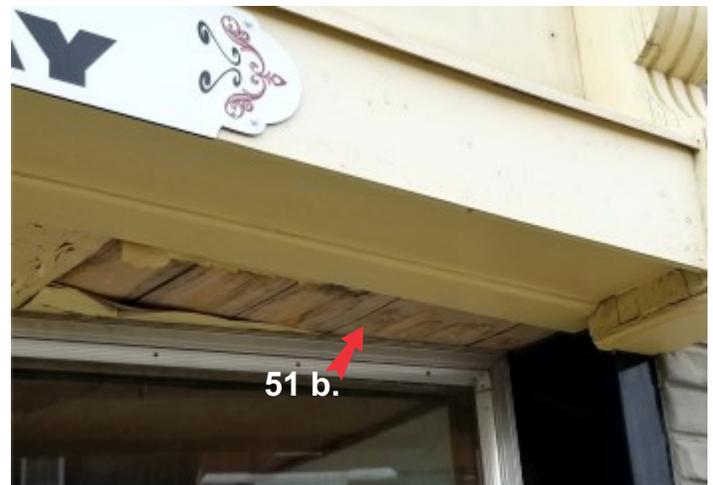
51 a. The flashing located at the upper roof parapet wall appears to be in very poor condition. The projecting fascia/frieze board shows some areas of deterioration and may have not been caulked properly or let into the brick work and may be allowing water to find its way between the flashing and the masonry units, which will inevitably cause problem with damp and spalling of masonry units.

51 f. A section of the upper pilaster is covered with plywood. If this is covering-up damage to the brick work repair as noted above.

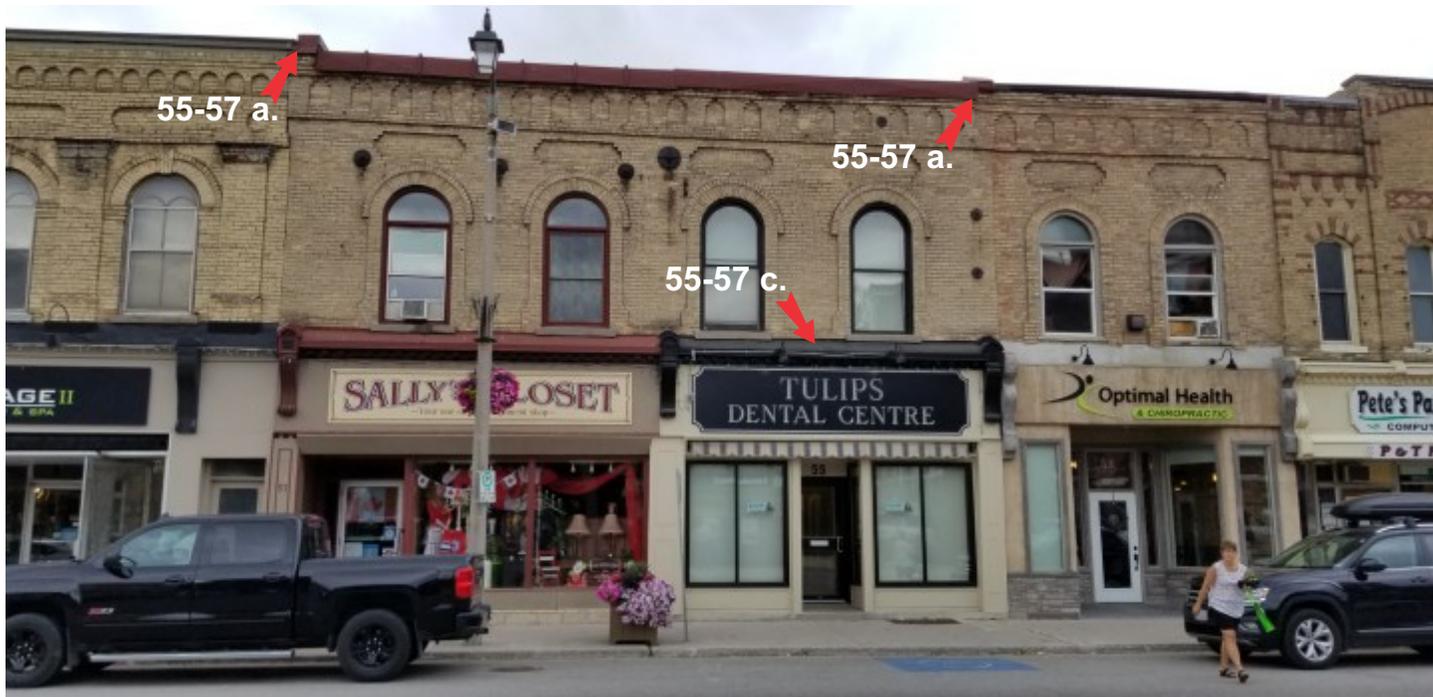
55-57 a. The flashing located at the upper roof parapet wall appears to be in good condition. Some areas are not executed very well and may cause water issues in the future and should be repaired and or replaced specifically the bookend junction between the north and south buildings.

55-57 d. There are draw rods and plates on the second-floor façade. These should be inspected that they are not loose and or corroded rendering them non-functioning. Replace if necessary, however, this is not a DIY project! A professional familiar with this support system must be engaged.
