Building Pathology Report

Seaforth, Ontario

Prepared By Dr. Christopher Cooper

Revision Date: July 30, 2018

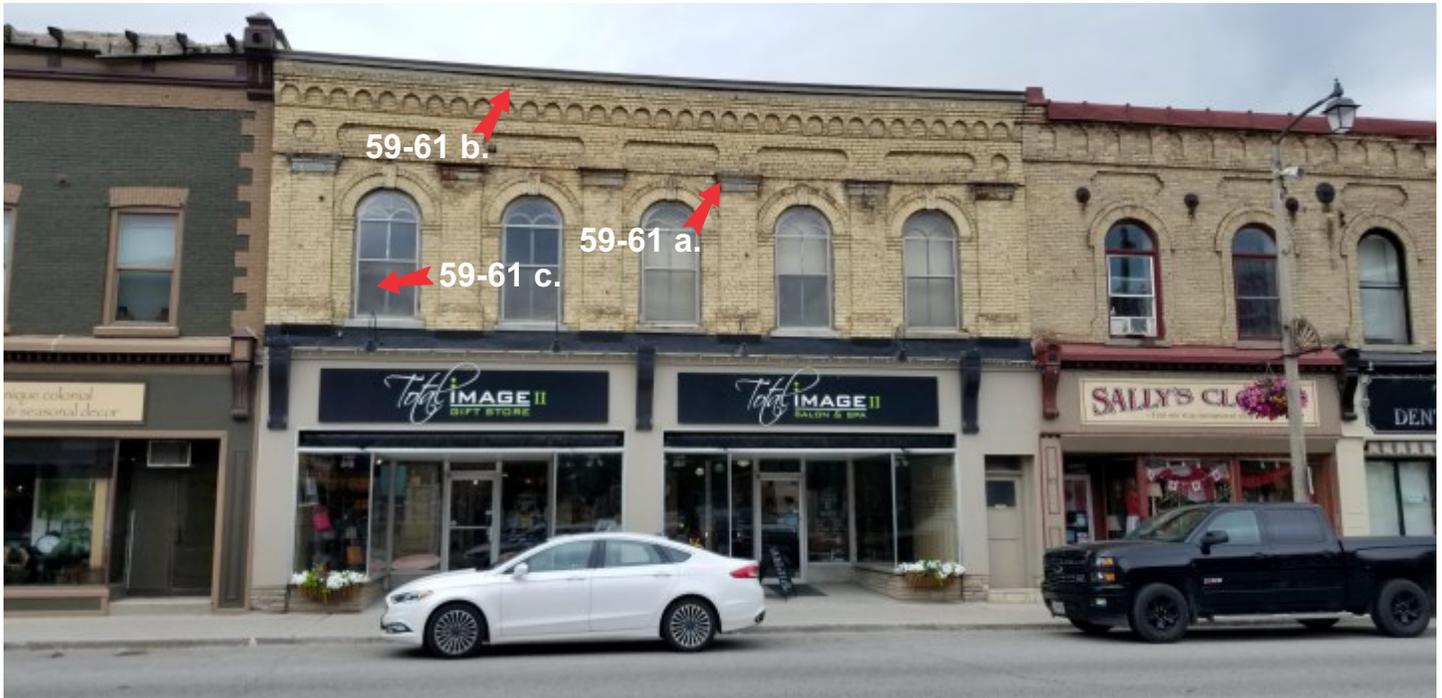
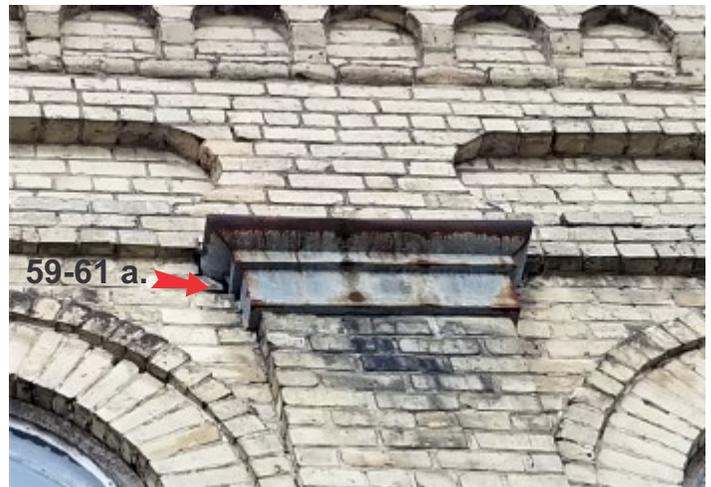
59-61 a. This building has very unique metal capitols on the brick pilasters. These need to be scraped, wire brushed then primed and painted to protect from corrosion. I noted mortar missing... keeping these joints properly pointed is very important to arrest the corrosion of the metal and stopping any water from getting behind the capitols. Repointing of the brick works should be done utilizing only lime-based mortar devoid of any cement.

59-61 d. The joint between this building and the adjacent building should be kept well pointed with lime mortar to not allow water to penetrate, which could create a spall condition.

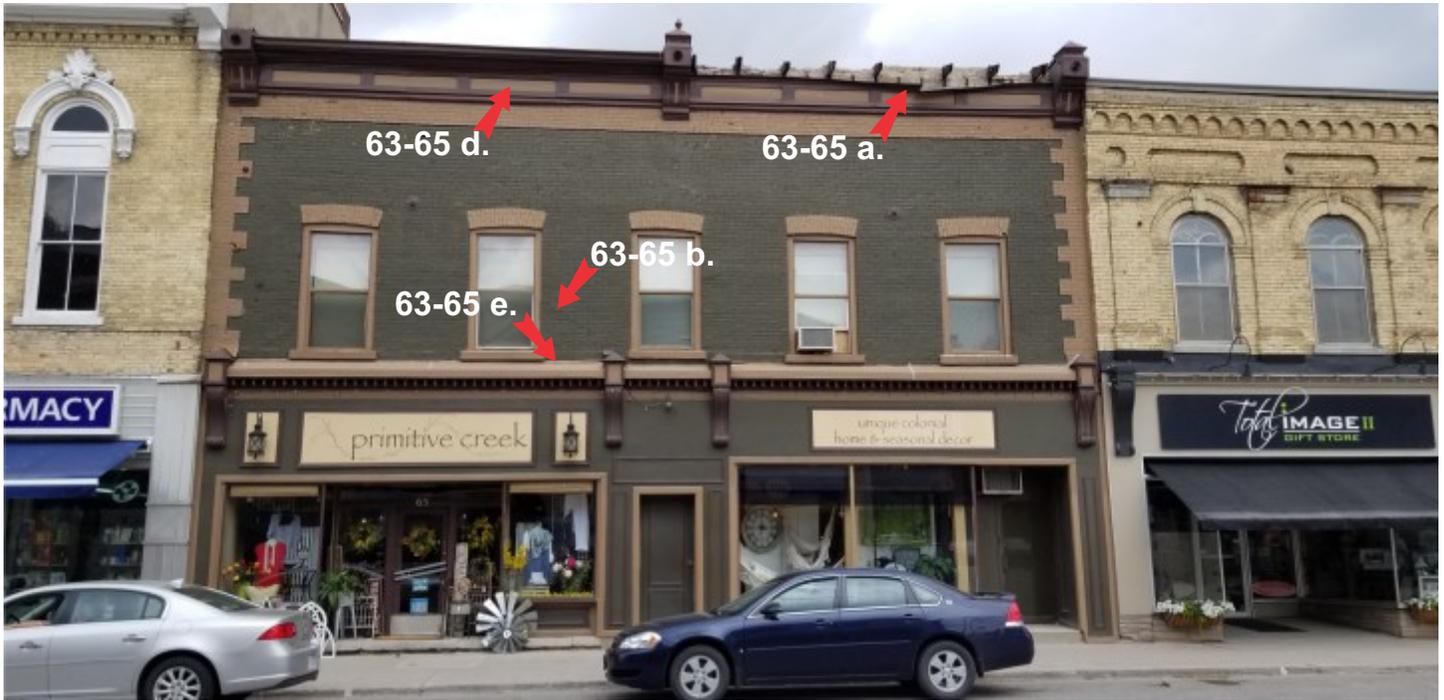
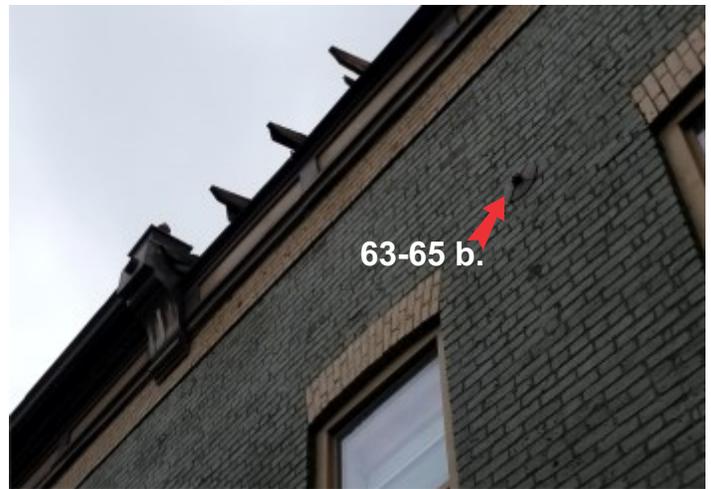
63-65 a. Clearly there has been a complete failure of the fascia and soffit. This may be due to weakening of the brick and brick mortar from a former fire (building was once three storeys). Extreme heat from a fire can destroy lime mortar rendering it structurally un-sound. However, this could also be an issue with leaking flashing and water dislodging the masonry through freeze and thaw actions. A thorough inspection with respects to the structural integrity of the existing brick works need to be done prior to implementing repair works. Repointing of the brick works should be done utilizing only lime-based mortar devoid of any cement as it will not bond properly to the existing masonry.

63-65 e. The projecting fascia board flashing is well executed, inspect periodically to see if it has been caulked properly or let into the brick work. If not properly sealed it may be allowing water to find its way between the flashing and the masonry units, which will inevitably cause problem with damp and spalling of masonry units.

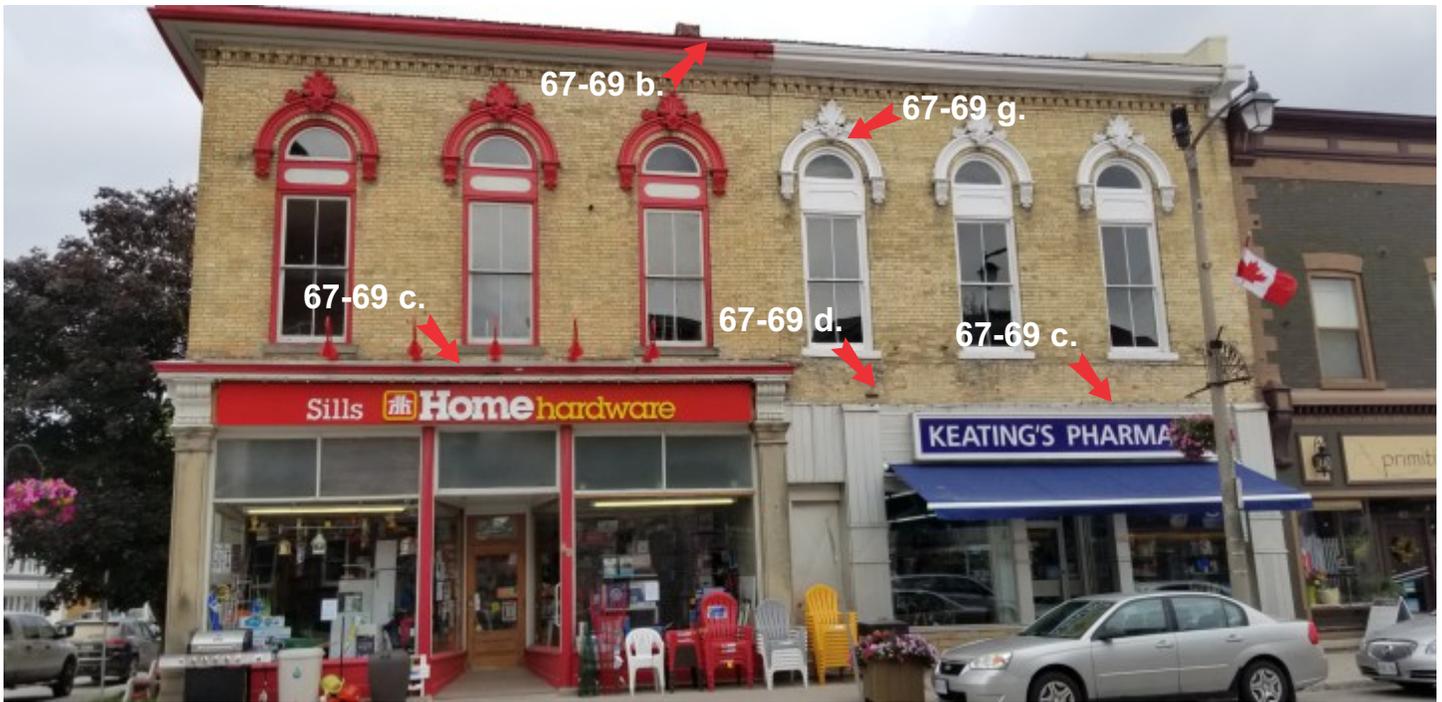
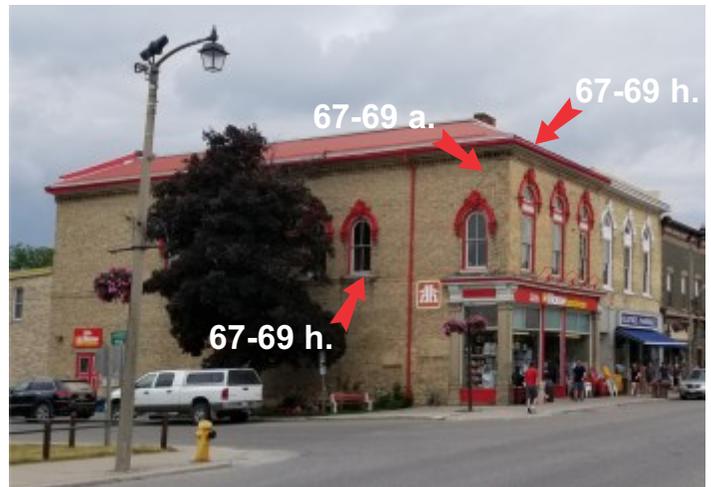
67-69 a. The exterior brick work has a very pronounced pyramidal crack on the south east corner. Many of these types of cracks may have appeared in the first decade after original construction due in part to excessive shrinkage of wooden window frames and lintels. However, it can also indicate a problem with rot and the masonry has shifted. This crack should be filled with a all lime based mortar and inspected regularly to see if the crack reopens or widens. Keep an eye on widening cracks or bulges and engage a professional structural engineer to provide remedy immediately.

67-69 h. The roof on the Main Street facade side, needs to be replaced, as the asphalt shingles have long since come to the end of its service life.

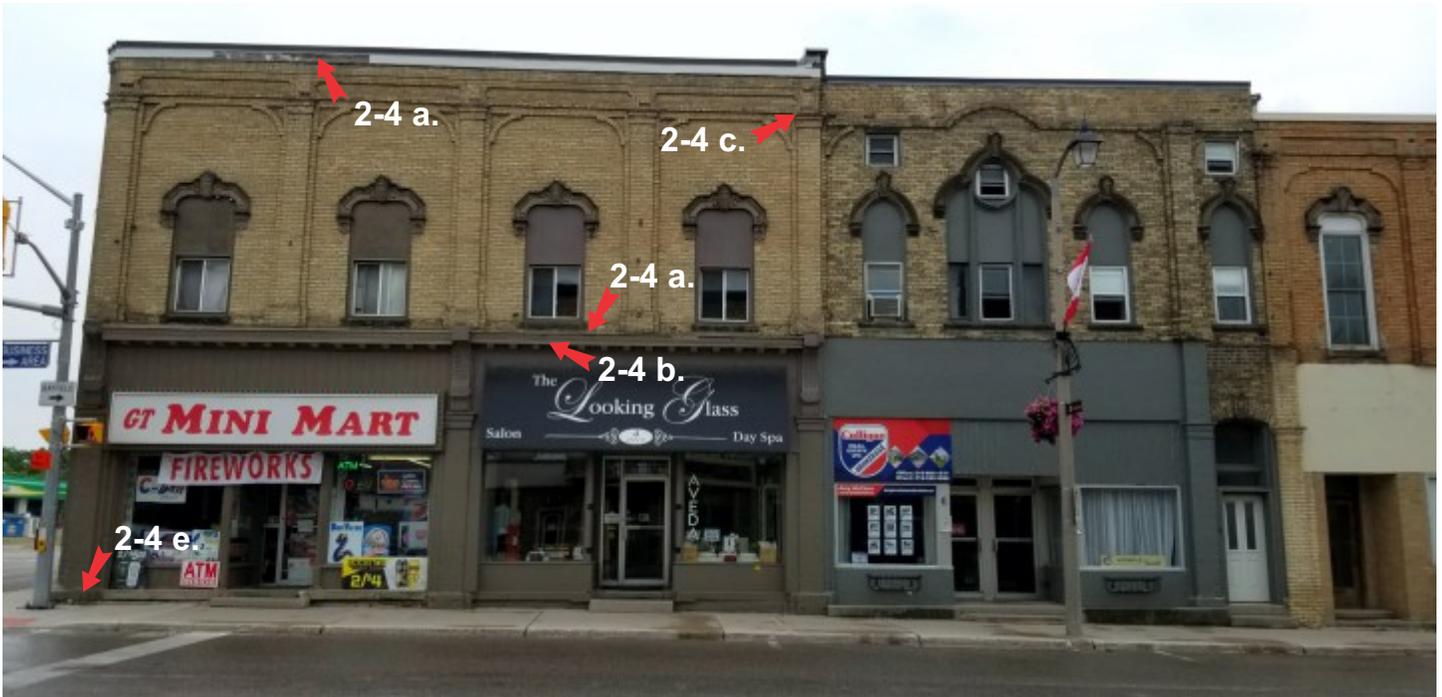
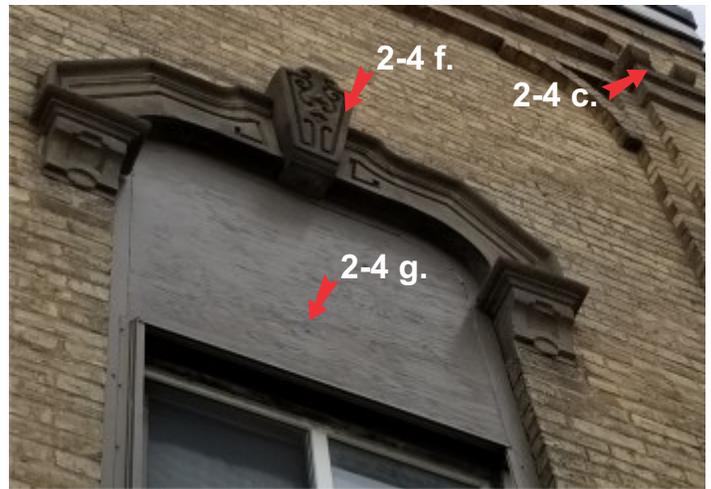
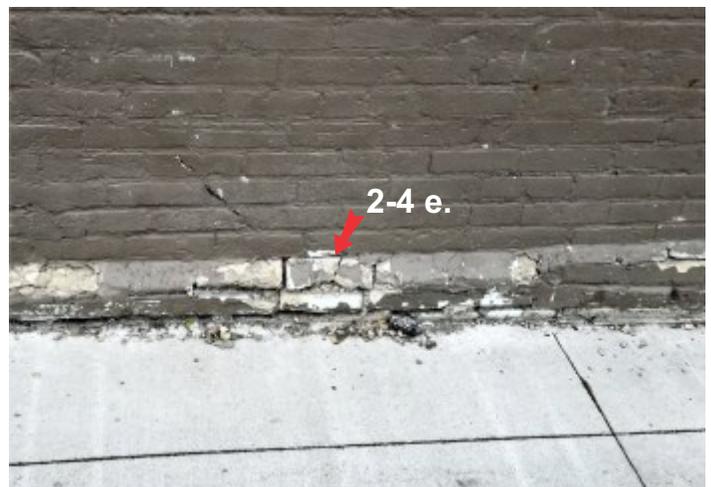
2-4 a. The flashing located at the upper roof parapet wall and above the fascia board shows severe areas of deterioration and may have not been caulked properly. I have noted that the flashing at the junction of this building and the building to the south may not have been caulked or let into the masonry properly and may be allowing water to find its way between the flashing and the masonry units, which will inevitably cause problem with damp and spalling of masonry units.

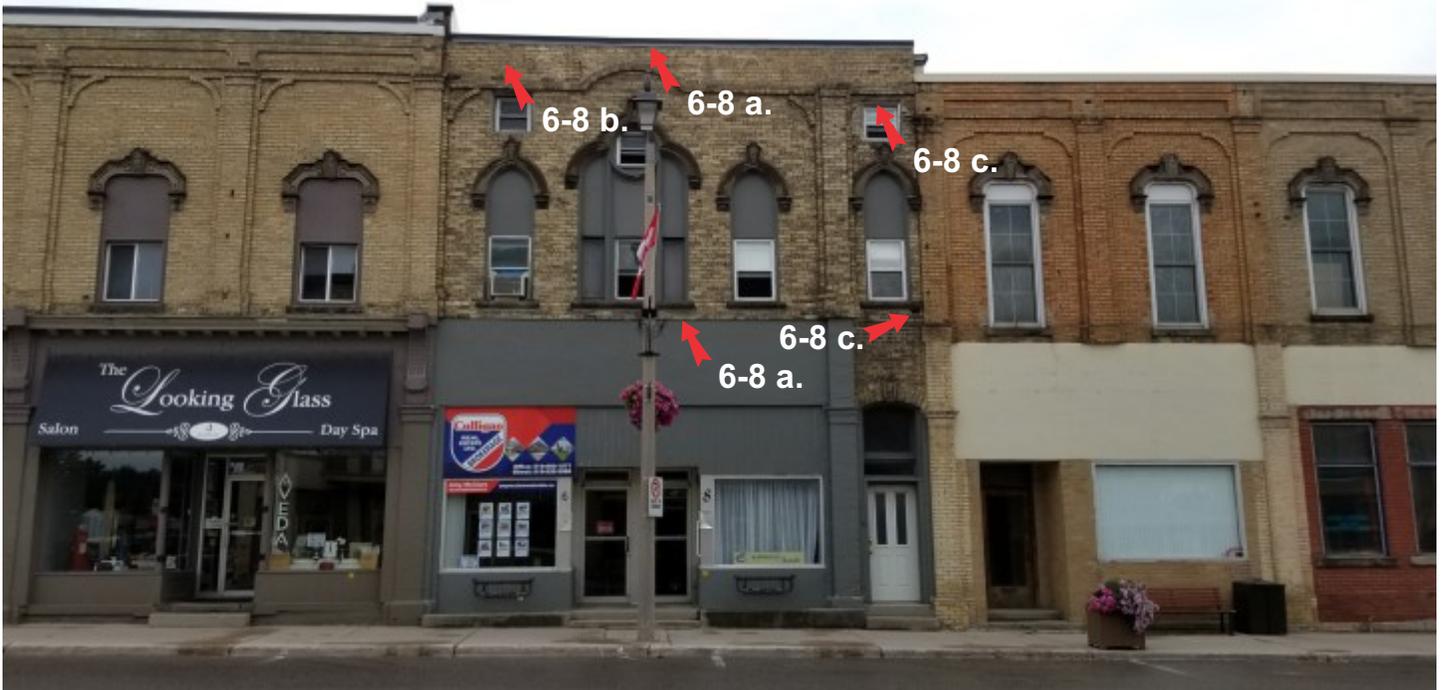
6-8 a. The flashing located at the upper roof parapet wall and above the fascia board shows areas of deterioration and may have not been caulked properly. I have noted that the flashing at the junction of this building and the building to the north may not have been caulked or let into the masonry properly and may be allowing water to find its way between the flashing and the masonry units, which will inevitably cause problem with damp and spalling of masonry units.

6-8 f. The joint between this building and the adjacent building should be kept well pointed with lime mortar to not allow water to penetrate, which could create a spall condition.

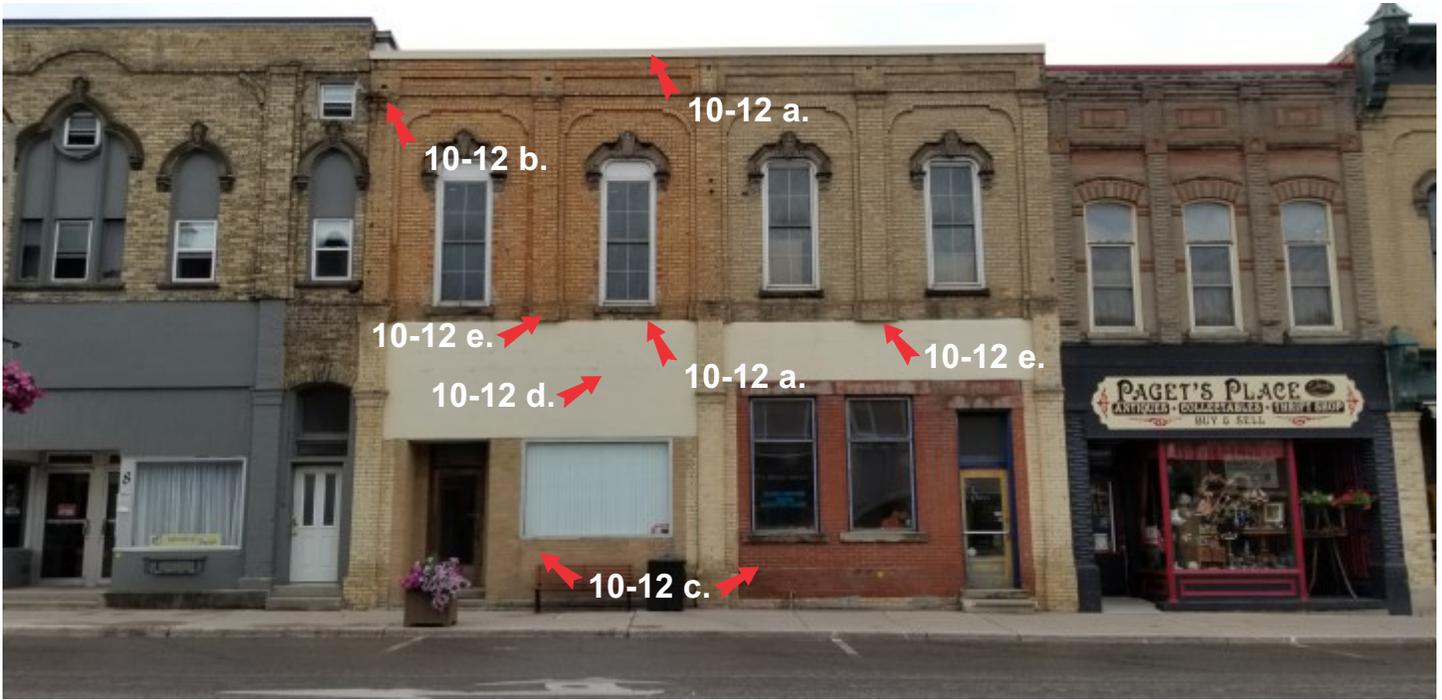
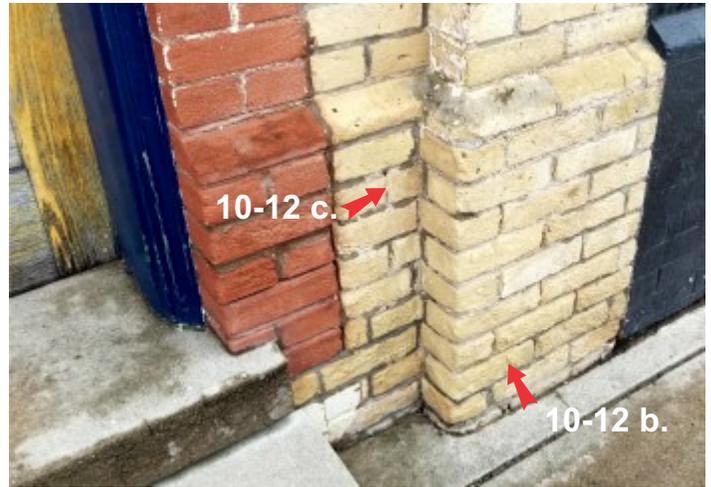
10-12 a. The flashing located at the upper roof parapet wall and above the fascia board shows areas of deterioration and may have not been pointed or caulked properly. I have noted that there is no flashing present at the junction of the fascia board and second level masonry, this condition could be allowing water to find its way between the flashing and the concrete pargetting, which will inevitably cause a problem with damp and spalling of underlying masonry units.

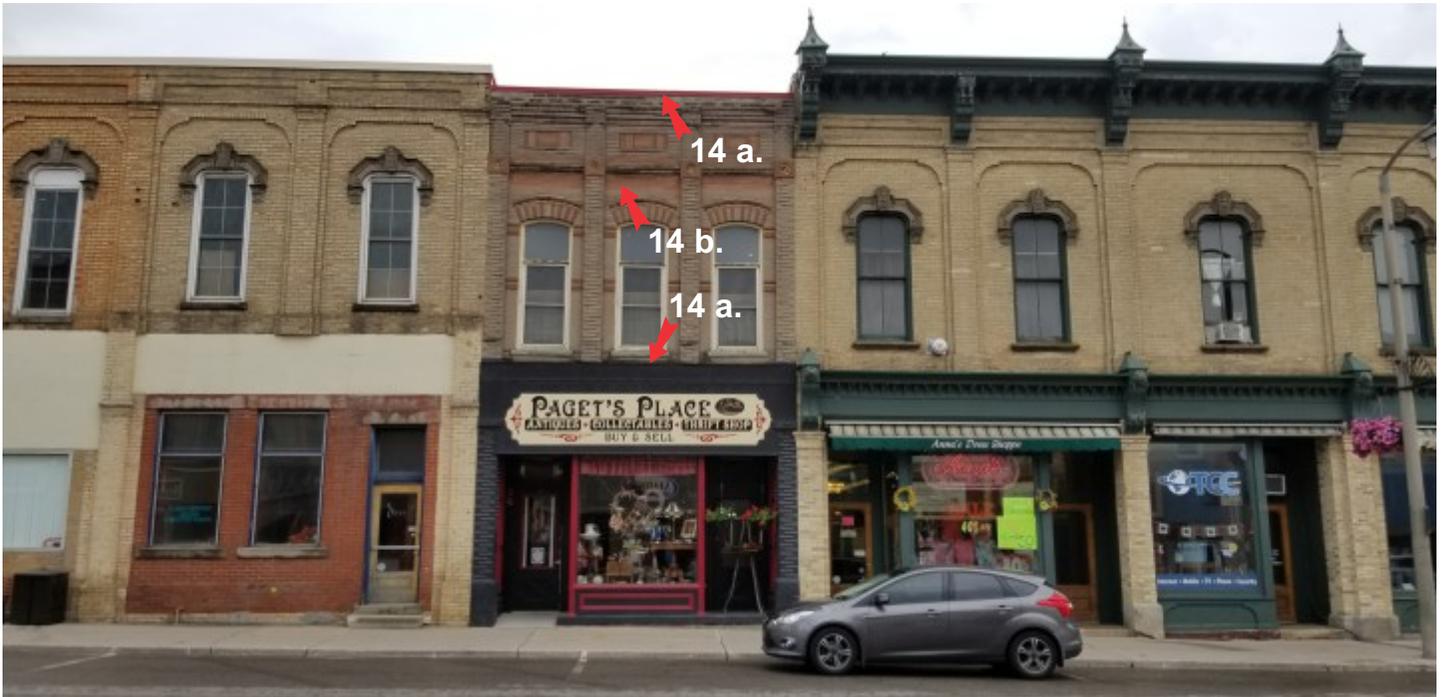
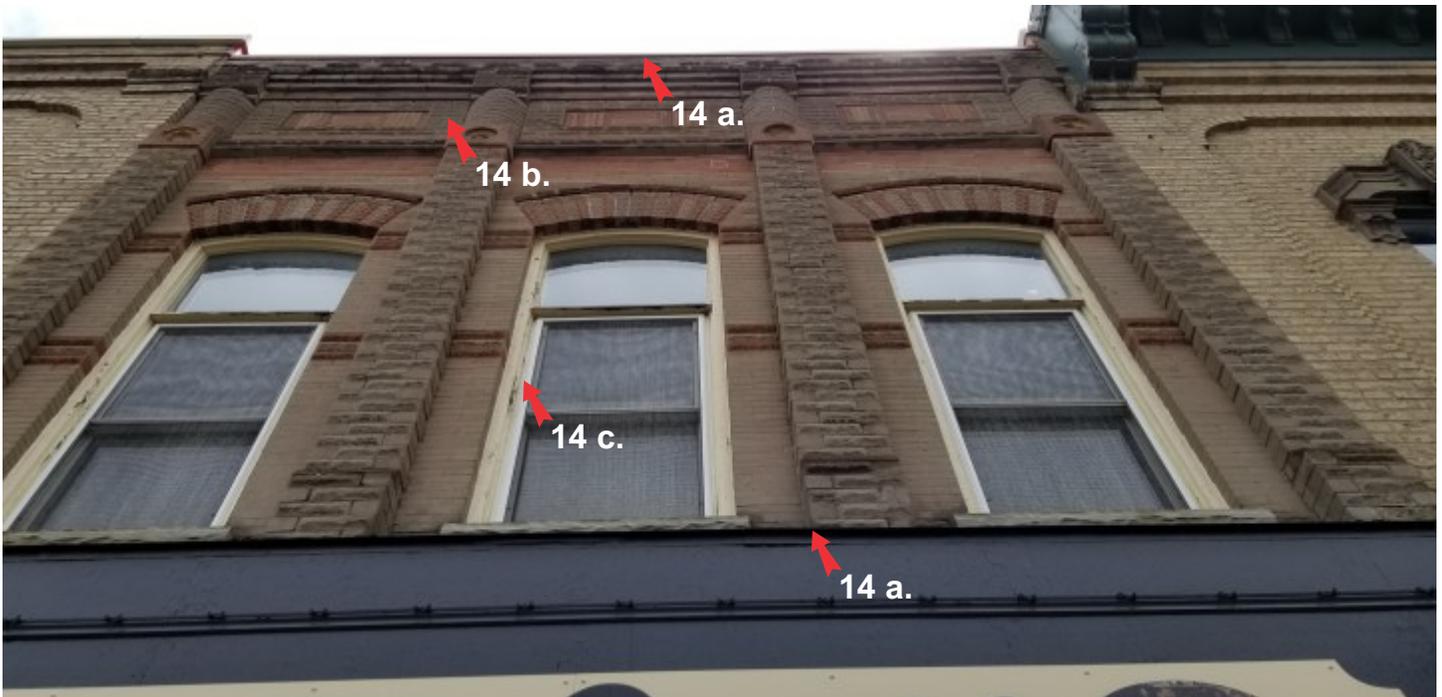
14 a. The flashing located at the upper roof parapet wall and above the fascia board appear to be in good condition, however, regular inspection of these areas for deterioration is prudent. Make certain these areas have been pointed or caulked properly as this condition could be allowing water to find its way between the flashing and the underlying masonry units, which will inevitably cause problem with damp and spalling.

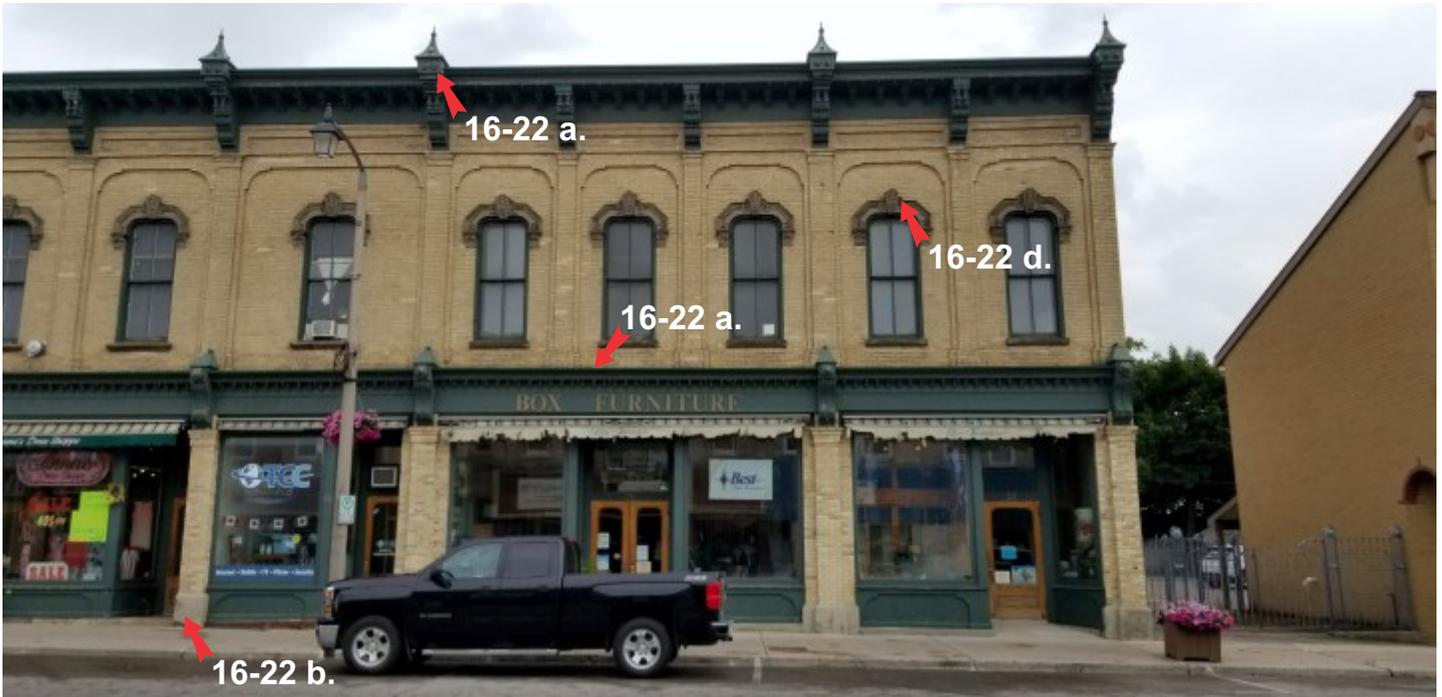
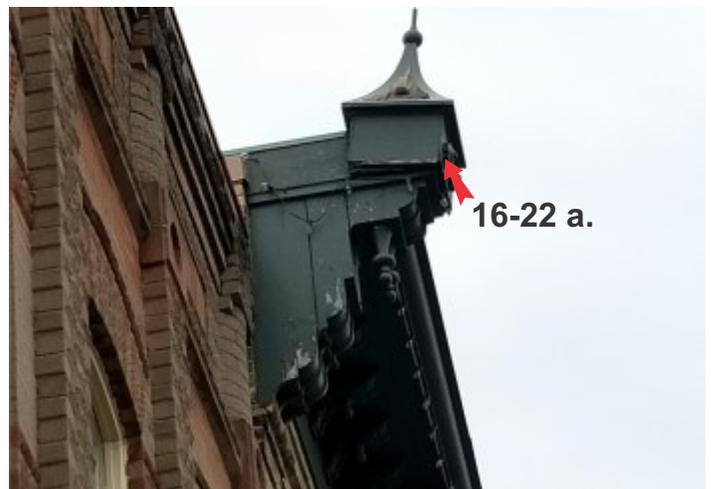
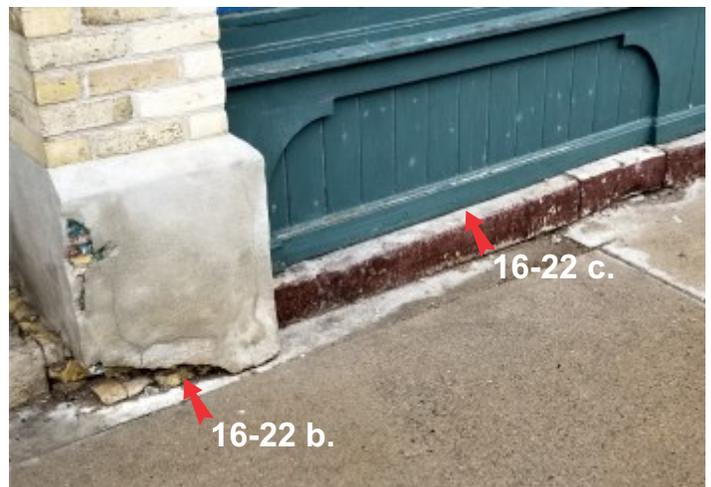
16-22 a. This building has a beautiful cornice with outstanding console brackets and corbels. Several of the boxed console brackets are in miserable condition especially the console to the north. The flashing at the rear of this console is not adequate allowing copious amounts of water to enter from the rear creating a cuboidal rot situation. All of the consoles need to be inspected for integrity and several will need to be replaced wholesale immediately before they become dislodged and pose a threat to pedestrians and property below. The lower flashing located at the fascia board on the first level should be inspected for integrity and repaired or replaced as necessary. All areas of painted timber (i.e. fascia board and original window trim) should be scraped and repainted as required with regular maintenance. If there are any areas of cuboidal wet rot, those areas that are simple flat sections of timber should be replaced wholesale with like material. Any areas with remarkable architectural moulding and detail should have any areas of cuboidal wet rot repaired with a two-part epoxy system.

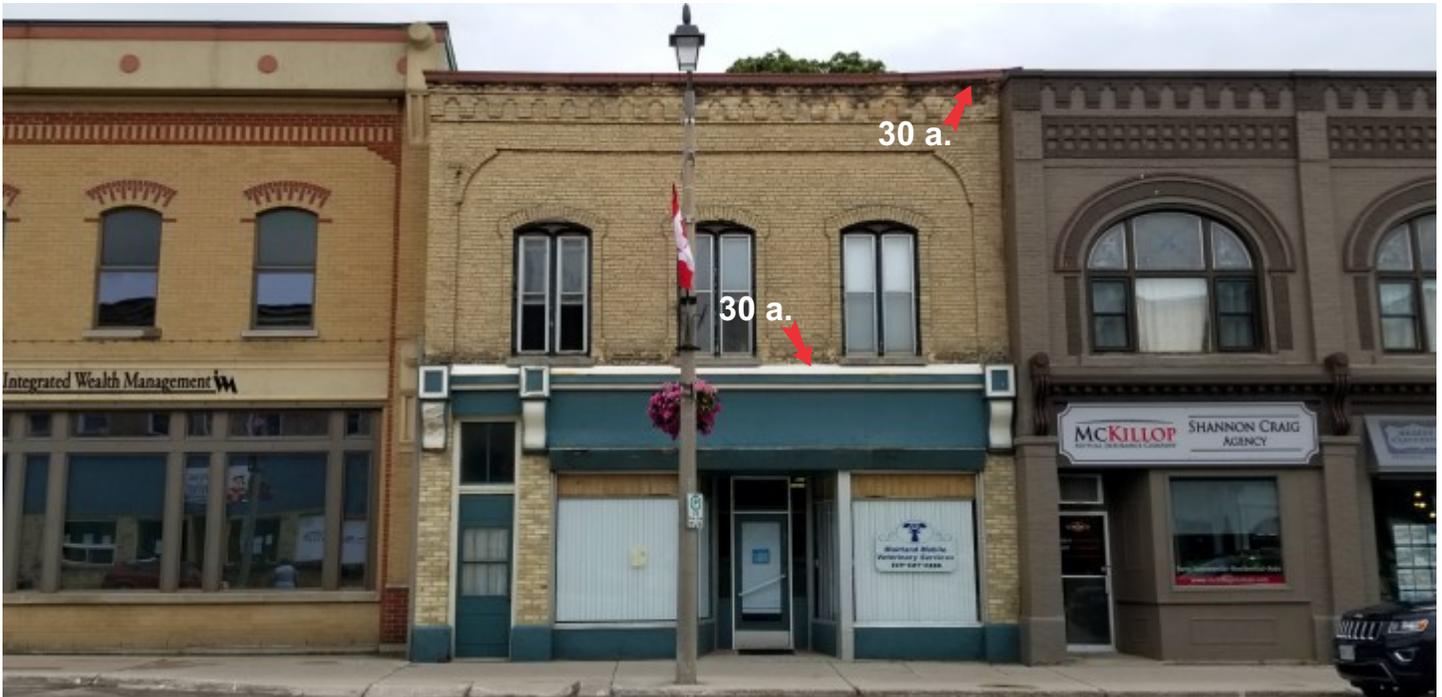
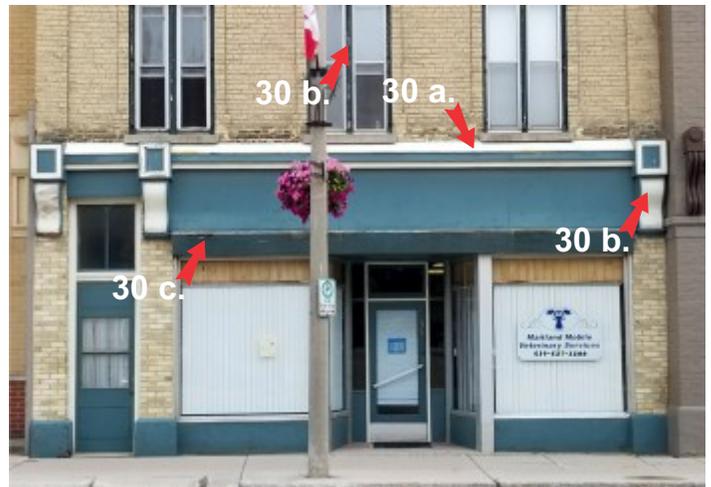
30 a. The flashing located at the upper roof parapet wall and above the fascia board appear to be in a condition of poor (at parapet) and good (at fascia board). Regular inspection of these areas for deterioration is prudent. Make certain these areas have been pointed or caulked properly as this condition could be allowing water to find its way between the flashing and the underlying masonry units, which will inevitably cause problem with damp and spalling.

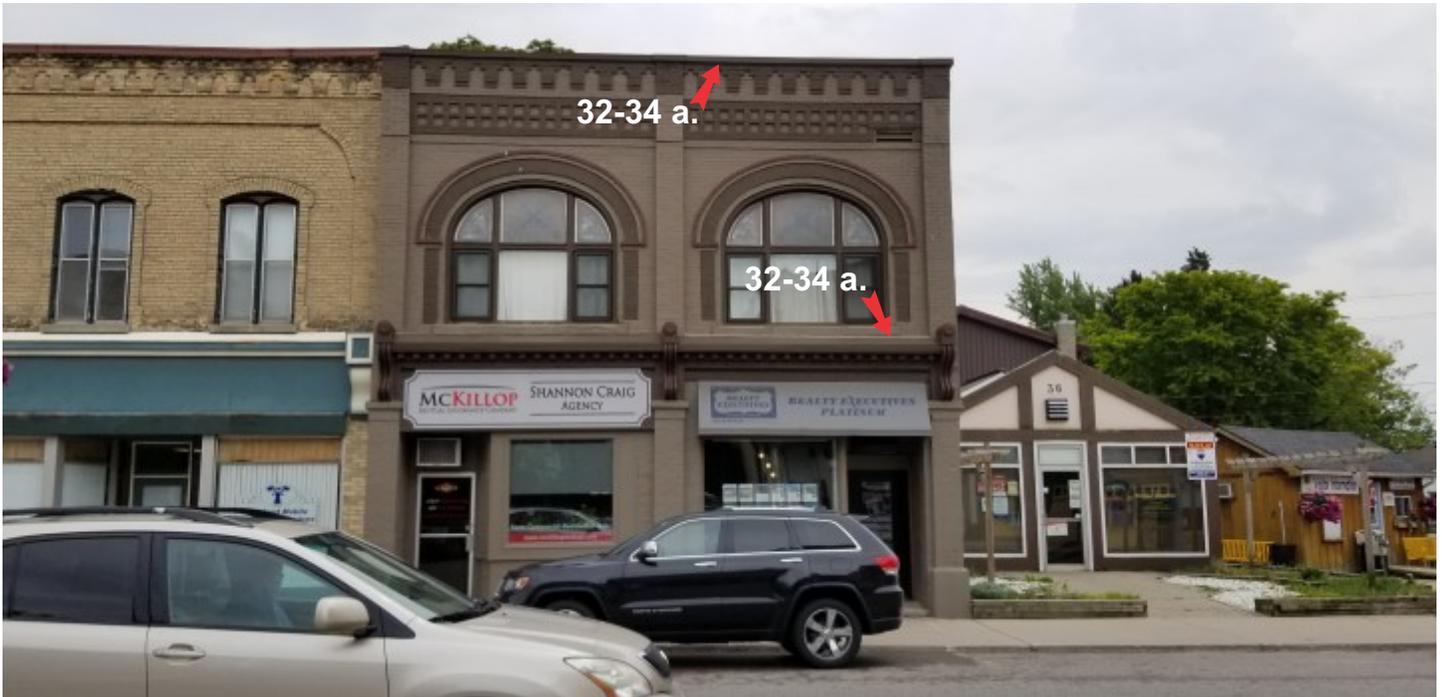
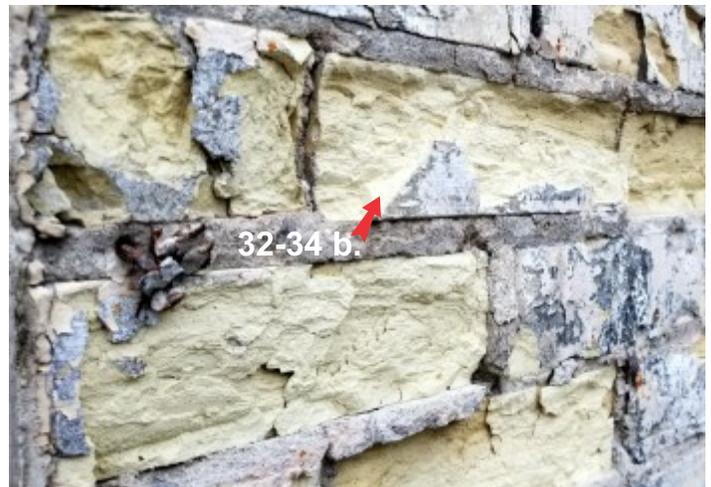
32-34 a. The flashing located at the upper roof parapet wall and above the fascia board appear to be in good condition. Regular inspection of these areas for deterioration is prudent. Make certain these areas have been pointed or caulked properly as this condition could be allowing water to find its way between the flashing and the underlying masonry units, which will inevitably cause problem with damp and spalling.

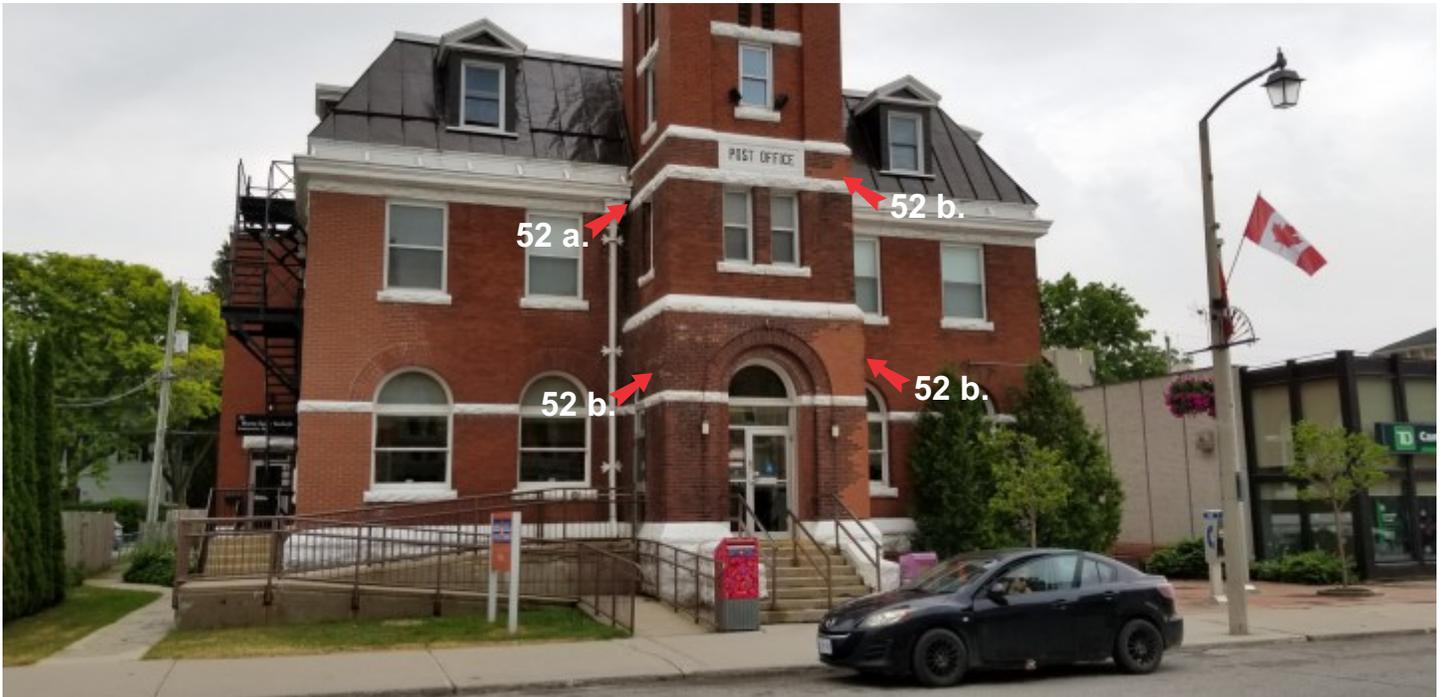
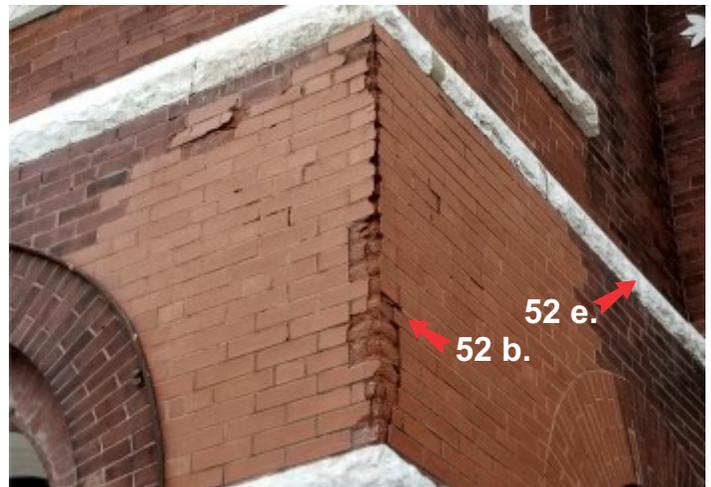
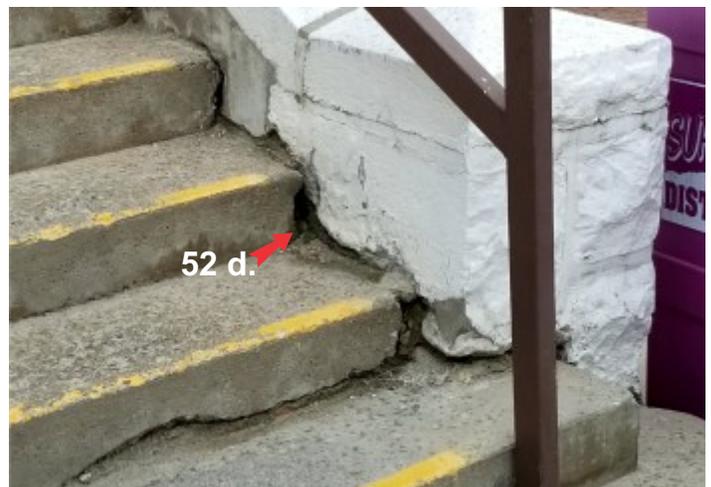
52 a. Much of the flashing on the building is well executed, however, in areas at the termination of the gutter against a perpendicular wall surface there needs to be a proper flashing let into the brick works or an adequate splash guard installed. I noted some deterioration and water staining of the adjacent walls. Verify that the gutters are all flowing properly and are not leaking against the masonry units. Should down-spots be exiting overland rather than into a footing weep tile or storm sewer?

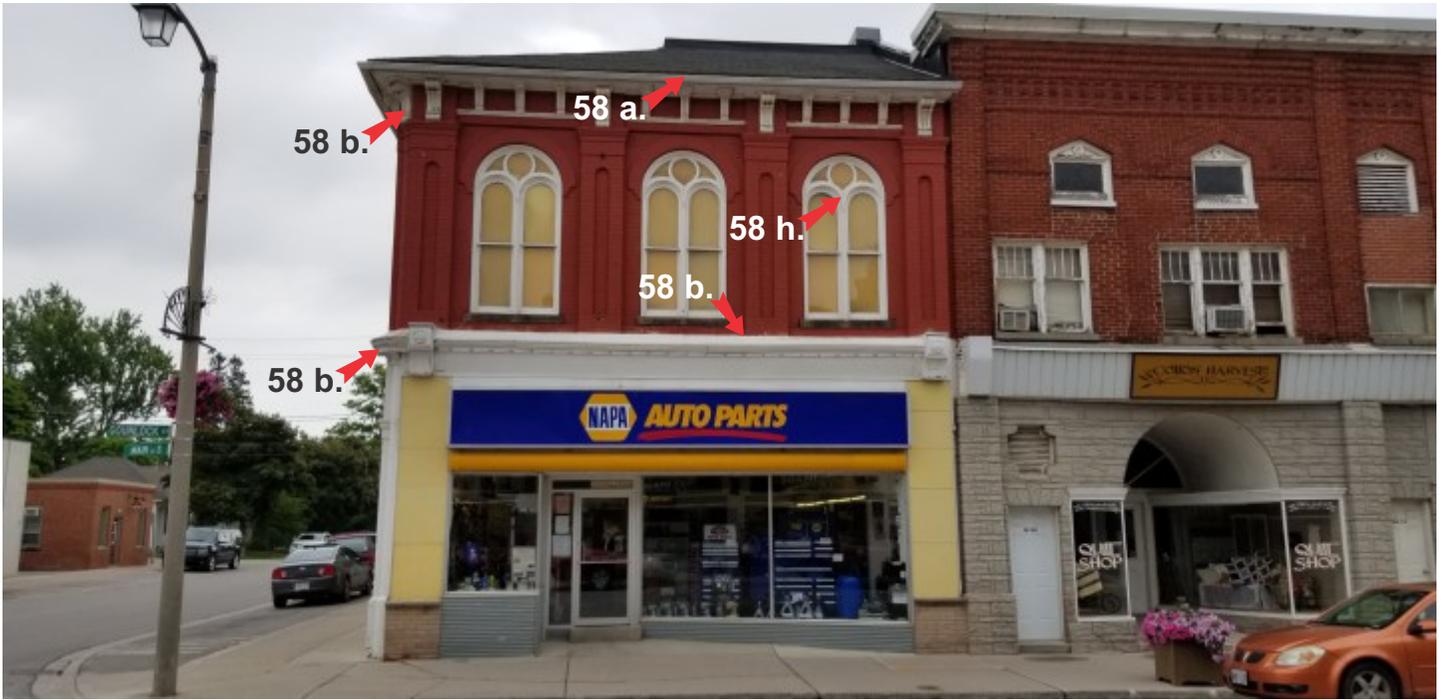
58 a. Regularly inspect eavestroughs for leaks and repair or replace as necessary.

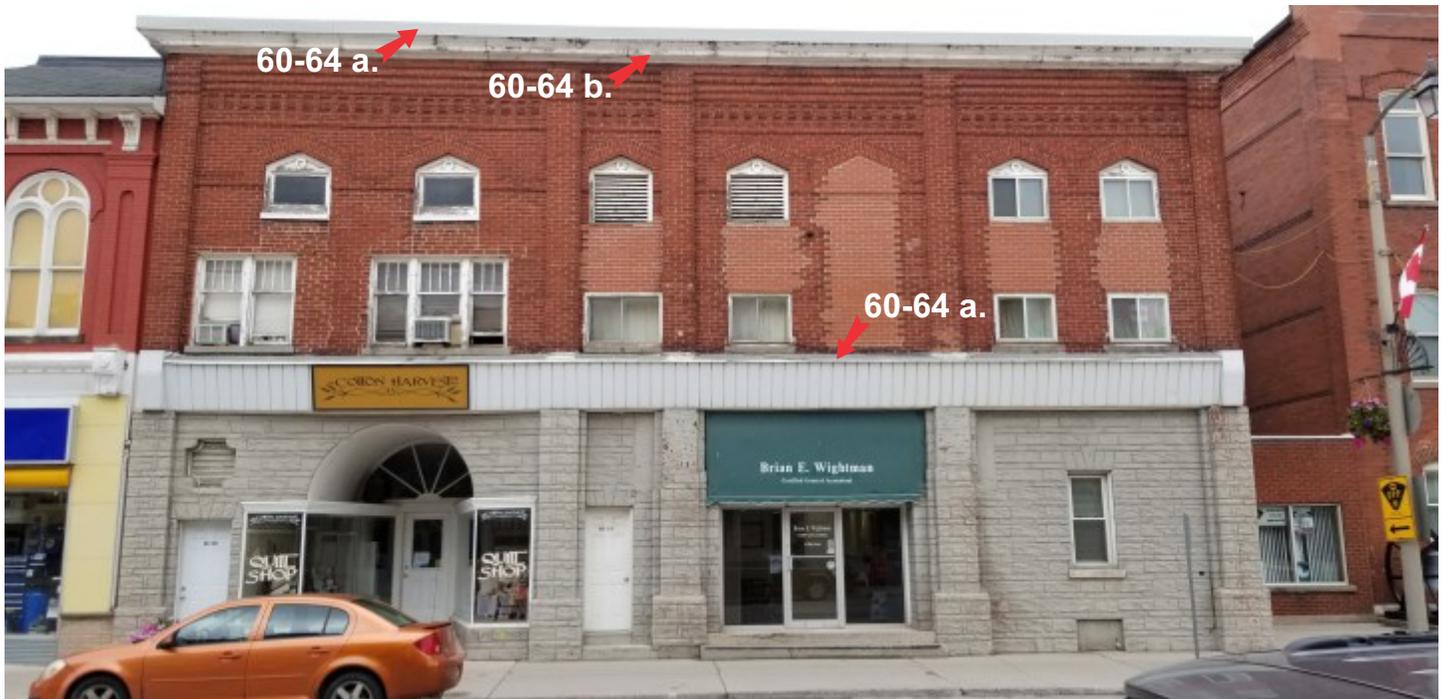
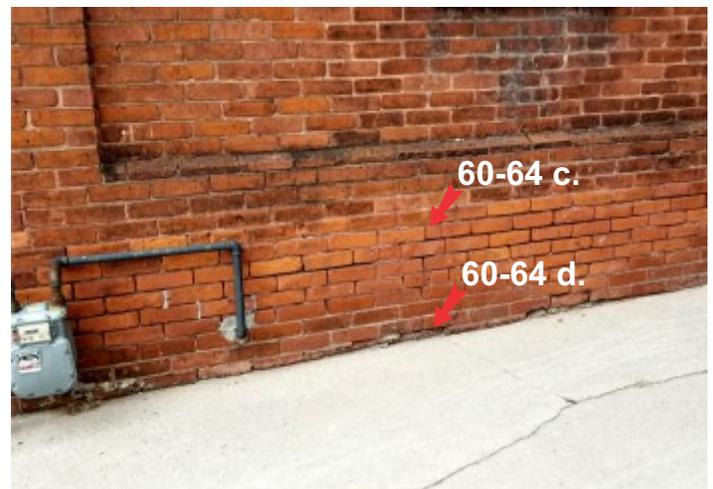
60-64 a. The upper parapet flashing appears to be in good condition. The lower fascia board flashing is deteriorating and should be inspected that it is adequately caulked or let into the masonry with an all lime-based mortar.

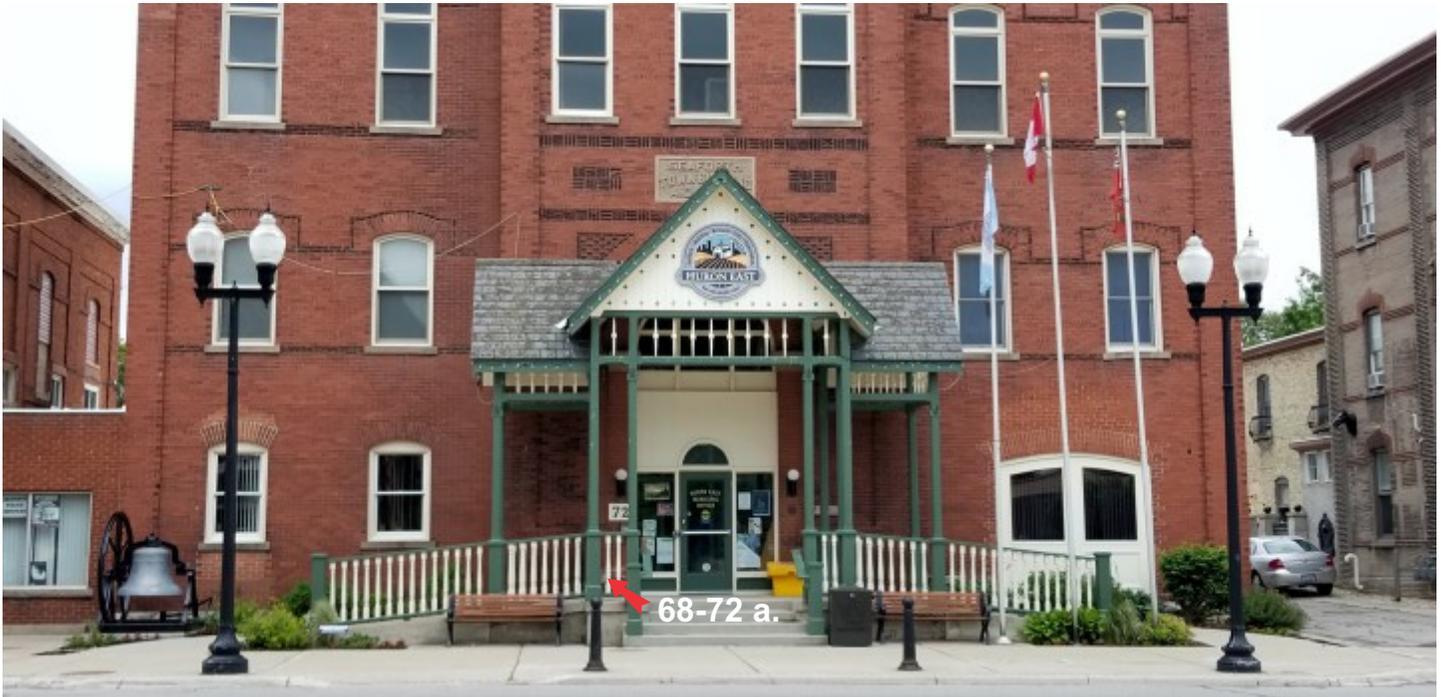
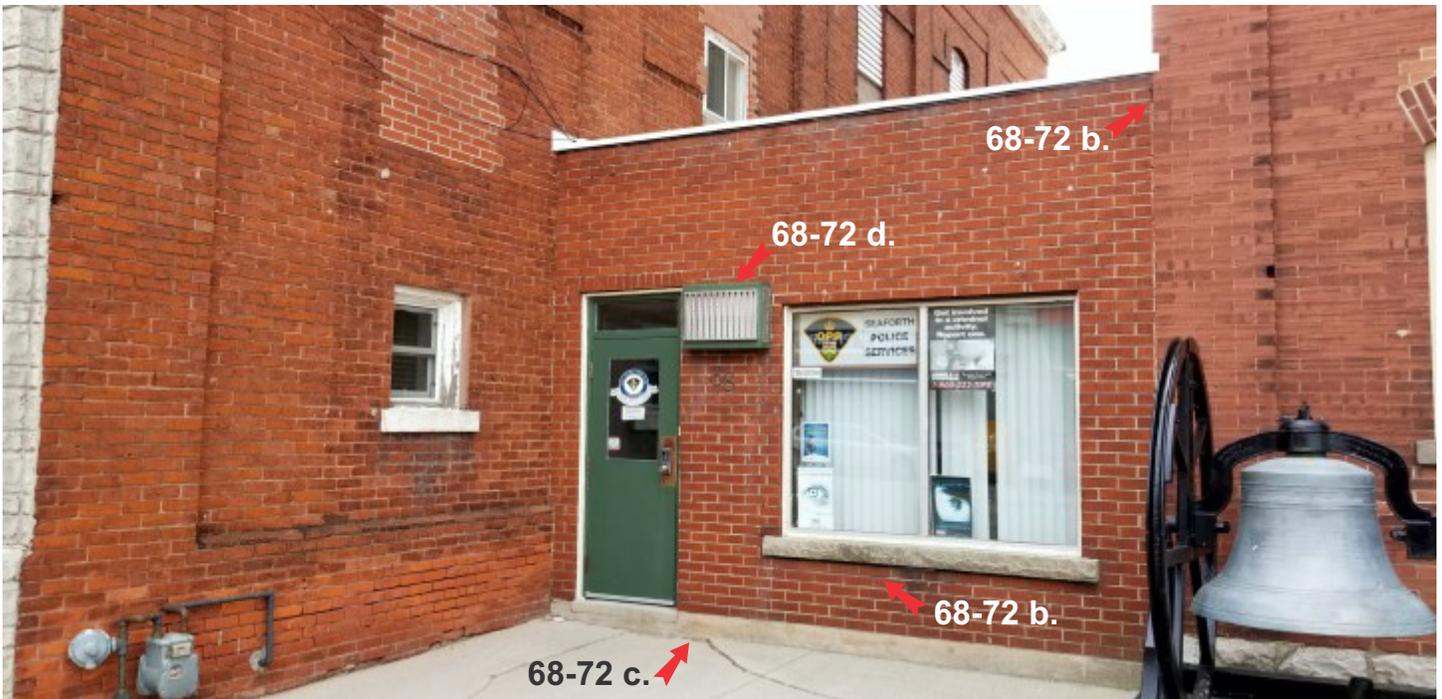
68-72 a. 72 Main Street is well maintained and has very few issues of note. However, some thought should be given to the use of salt as a de-icer during the winter months as it is very damaging to clay brick and lime mortar as the area of salt efflorescence indicates at the front entrance.
