Building Pathology Report

Seaforth, Ontario

Prepared By Dr. Christopher Cooper

Revision Date: July 30, 2018

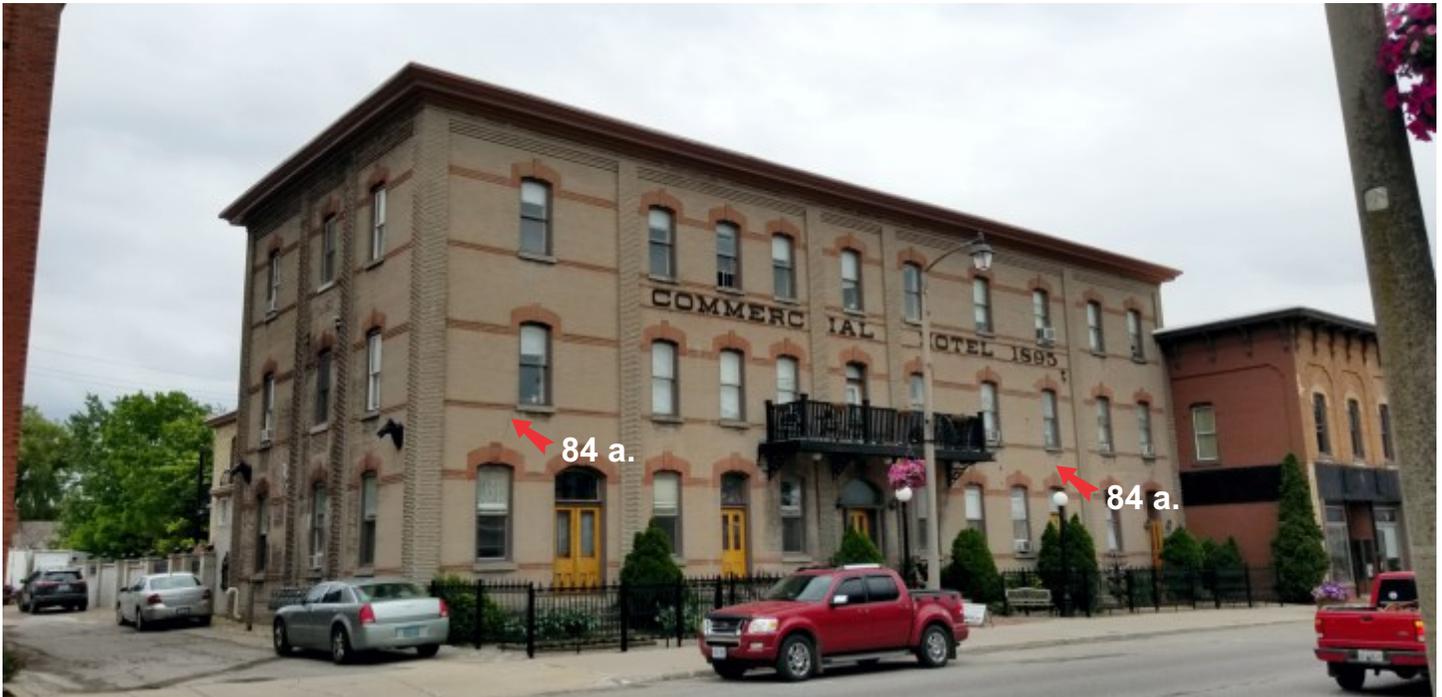
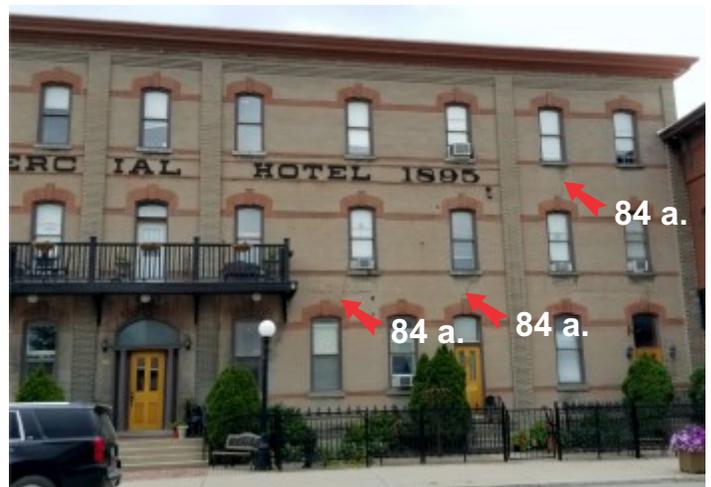
84 a. The exterior brick work has a few areas with pronounced pyramidal cracks. Many of these types of cracks may have appeared in the first decade after original construction due in part to excessive shrinkage of wooden window frames and lintels. However, it can also indicate a problem with rot and the masonry has shifted. Keep pyramidal cracks well pointed with an all lime-based mortar, consult a structural engineer if the crack widens or becomes unstable.

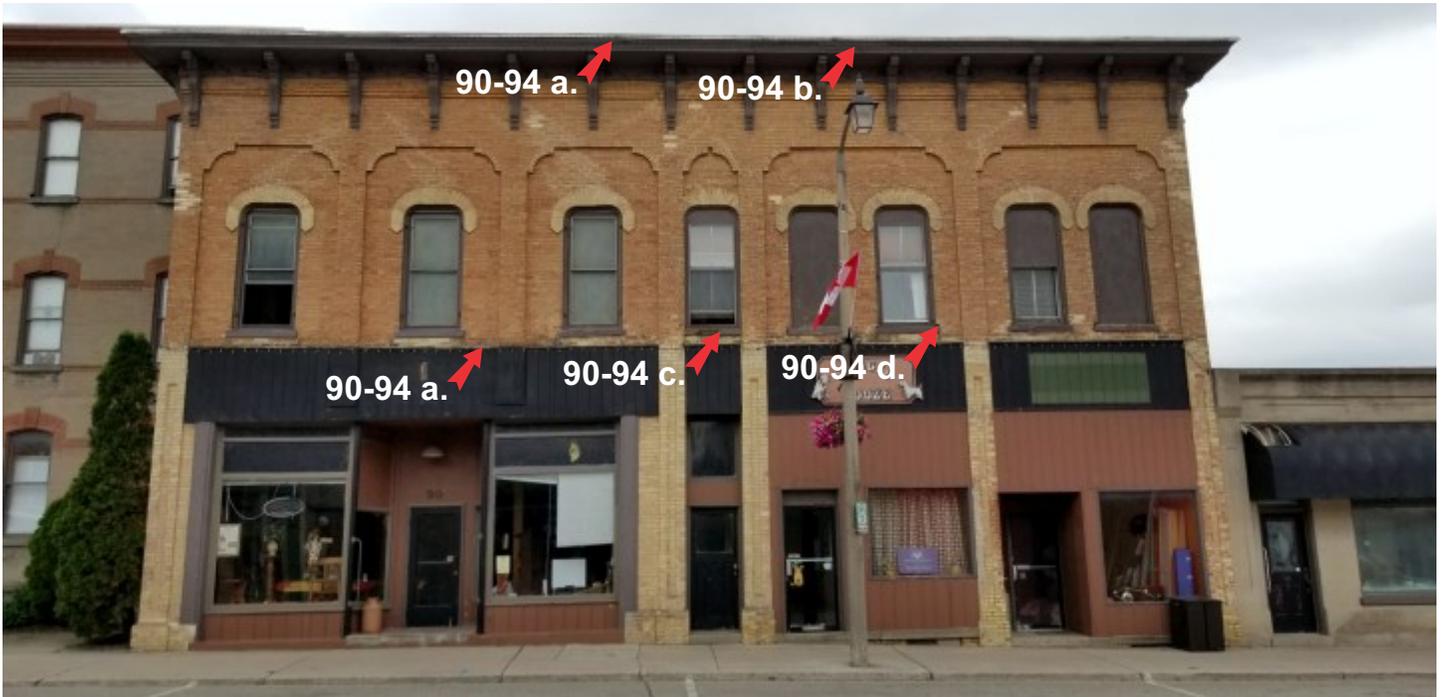
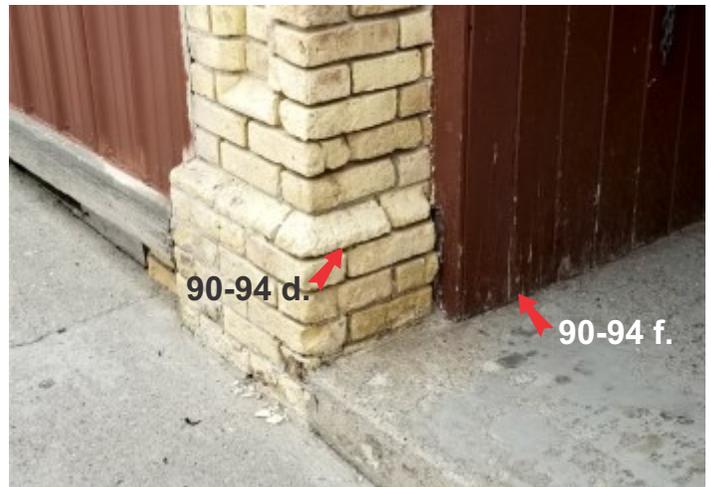
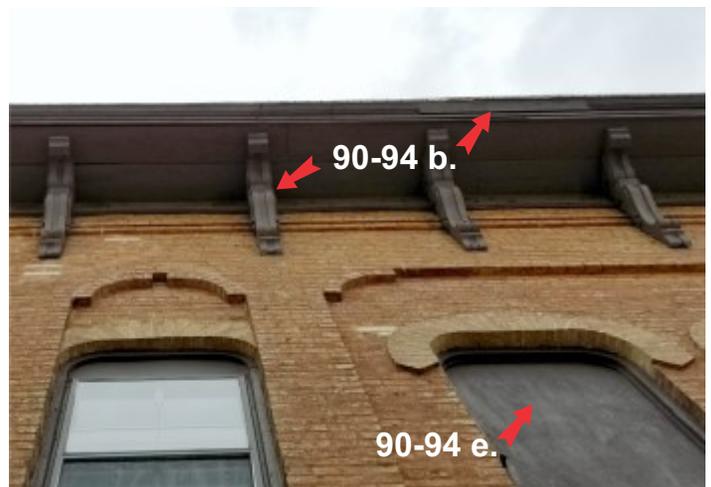
90-94 a. The upper parapet flashing appears to be in good condition. The lower fascia board flashing is in poor condition and should be inspected that it is adequately caulked or let into the masonry with an all lime-based mortar.

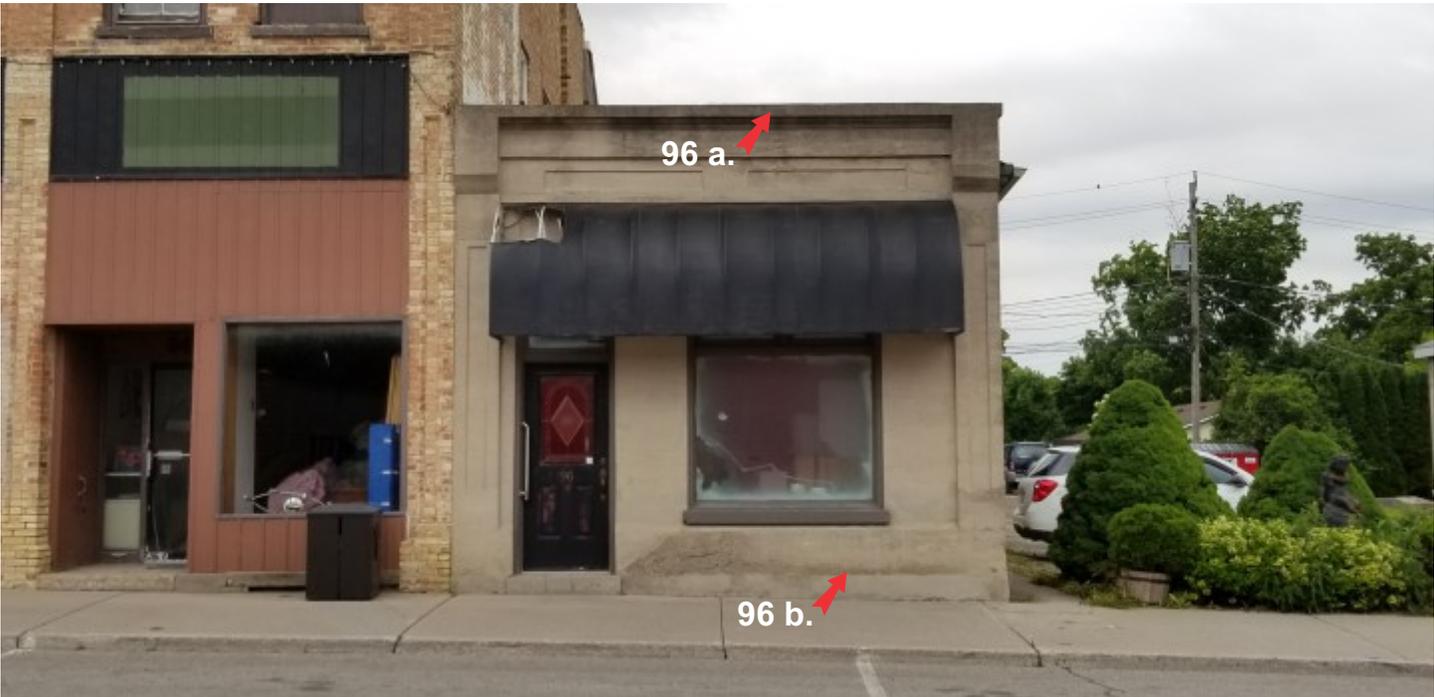
96 a. This building is very interesting as it is built in pre-cast concrete. The upper concrete parapet wall should be inspected periodically for cracks and fishers that may allow water to enter the wall which could cause considerable damage in a freeze and thaw cycle. Keep any flashing in good order and well caulked or let into the masonry.

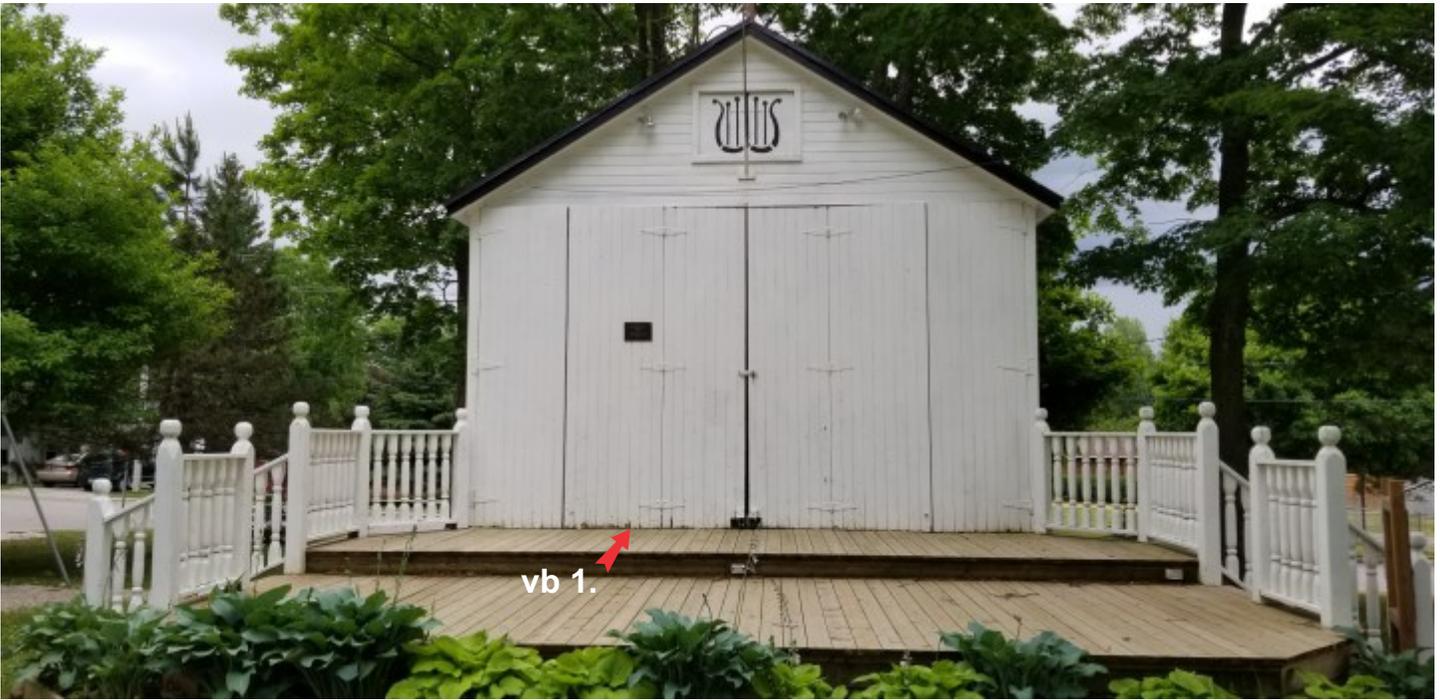
vb 1. The bottom of the bi-fold doors should be trimmed back 2" to remove rot and to keep the wood from contacting the wood deck which will prematurely rot the bottom of the doors. Provide a proper door sweep to the bottoms of the doors to stop accumulation of debris and snow from entering the interior of the building.

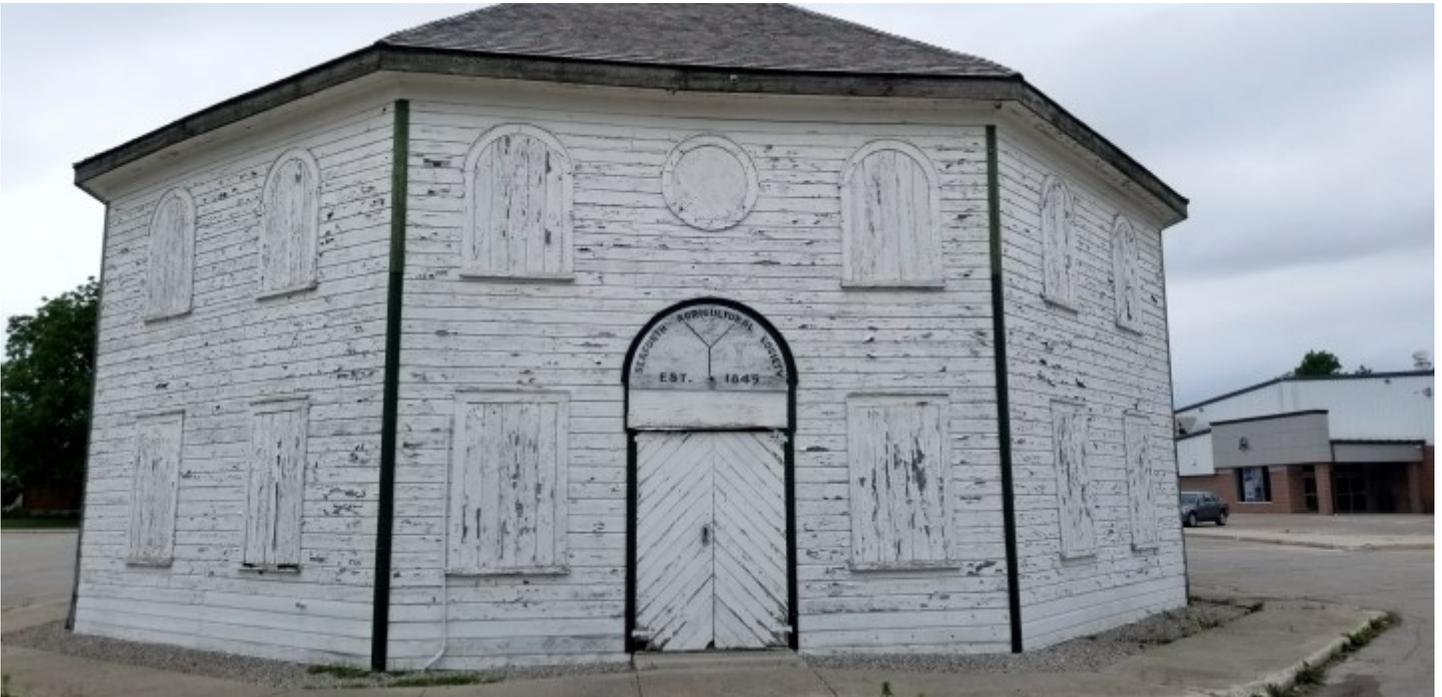
This building is of great historic significance and is a very rare building type. This building has significant issues with rot and water damage. This building requires a complete and separate Pathology report to build a conservation plan for future works.
