Building Pathology Report

Seaforth, Ontario

Prepared By Dr. Christopher Cooper

Revision Date: July 30, 2018

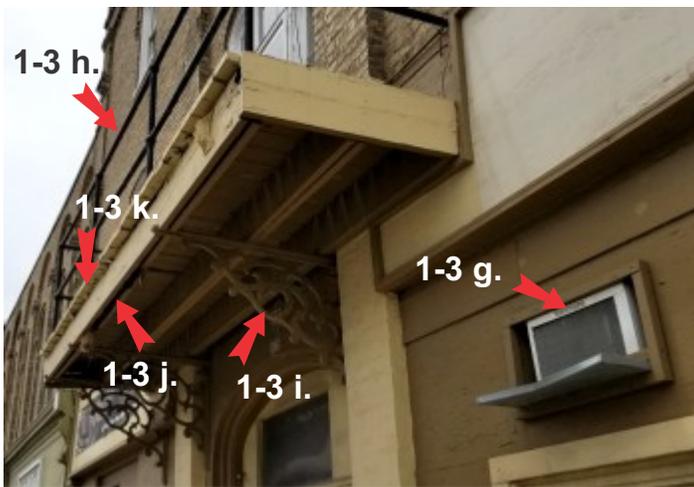
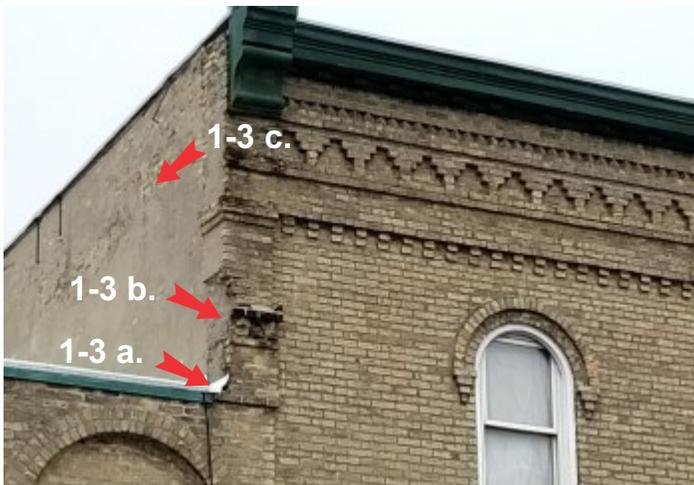
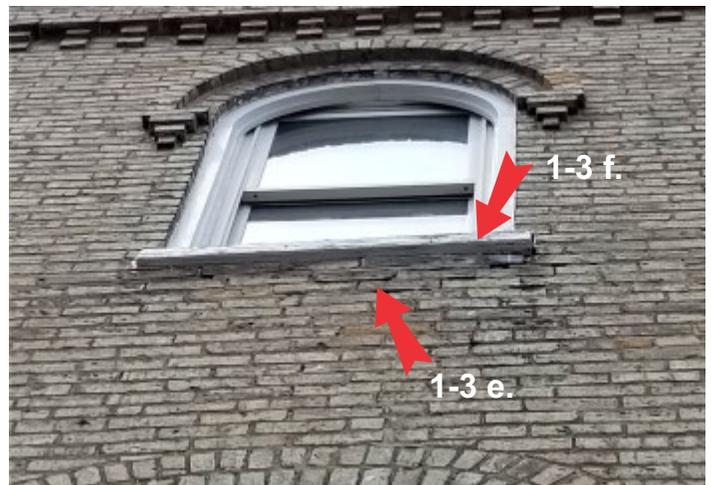
1-3 a. The flashing located at the upper roof parapet wall and above the fascia board shows some areas of deterioration and may have not been caulked properly. I have noted that the flashing at the junction of this building and the building to the south may not have been caulked or let into the masonry properly and may be allowing water to find its way between the flashing and the masonry units, which will inevitably cause problem with damp and spalling of masonry units.

1-3 b. The main above-grade masonry exterior cladding is in fair condition with several areas of deterioration due to miss-managed roof water, however, cement has been used to fill voids in the original all lime-based mortar which is very damaging. Water and soluble salts which destroy lime mortar must be kept in check therefore keeping these joints properly pointed is very important to the health of the exterior brick cladding. Repointing of the brick works should be done utilizing only lime-based mortar devoid of any cement. Any spalled (broken-off) brick or washed out mortar should first be investigated as to the reason why they have spalled or washed out i.e. broken or cracked caulking around windows, Portland cement, landscape material too close to masonry, bad eavestroughs and downspouts or flashing, generally spalled masonry, and washed out mortar are a symptom of a moisture problem and should be repaired (water issues) as a priority.

1-3 c. Ancillary side walls were traditionally pargeted with a suction bond of lime mortar. Concrete pargetting will hold copious amounts of moisture between the soft brick and the concrete parget itself causing massive spalling issues destroying the underlining brick during freeze and thaw cycles. Cementitious materials should be removed wholesale and the entire wall pargeted with an all lime suction bond to allow the transmission of moisture to the exterior.

1-3 d. All the main structural masonry support pilasters have deterioration at its base where it comes in contact with the sidewalk. This problem is due to freeze and thaw cycles and soluble salts (winter road salt) destroying the masonry units. Water and soluble salts which destroy lime mortar must be kept in check therefore keeping these joints properly pointed is very important to the health of the exterior brick cladding.

1-3 e. A significant bulge in the masonry below the sill noted, is a clear indicator of water finding its way between the wythes of the brick below. An investigation of the brick mortar and caulking will need to be made to see where the water is entering the brick wythes. This area may need to be rebuilt if the mortar has failed.

1-3 f. The building has timber sub-sills under the majority of the existing windows. There are signs of deterioration and loss of the paint surface. These sub-sills should be scraped, and any areas of rot repaired with a two-part epoxy system and repainted. Sills and sub-sills should never be caulked on the bottom as this can create issues with the passage of moisture which can rot out the sill and the sub-sill.

1-3 i. These cast-iron brackets are lovely and very character defining. However, one bracket is missing to the north allowing no support for the balcony above. These brackets should be inspected thoroughly to see if they are anchored securely and not corroded.

1-3 jk. Much of the decking and the sub-structure is fraught with cuboidal wet rot and is very unsafe. The balcony needs to be replaced wholesale and should not have access to it by human occupants until these issues are remediated.

Repointing of the brick works should be done utilizing only lime-based mortar devoid of any cement. And, a regular yearly maintenance routine will need to be employed to keep the mortar in check and repair as necessary.

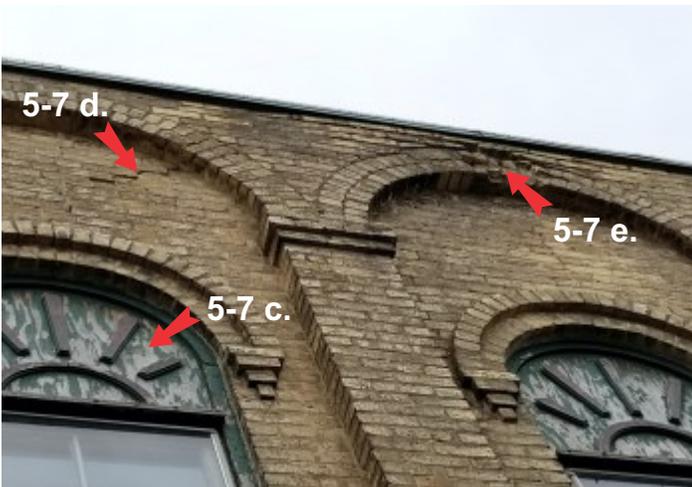
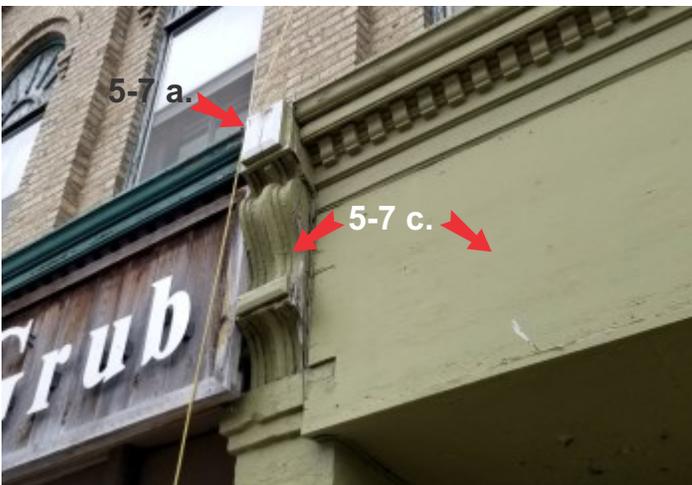
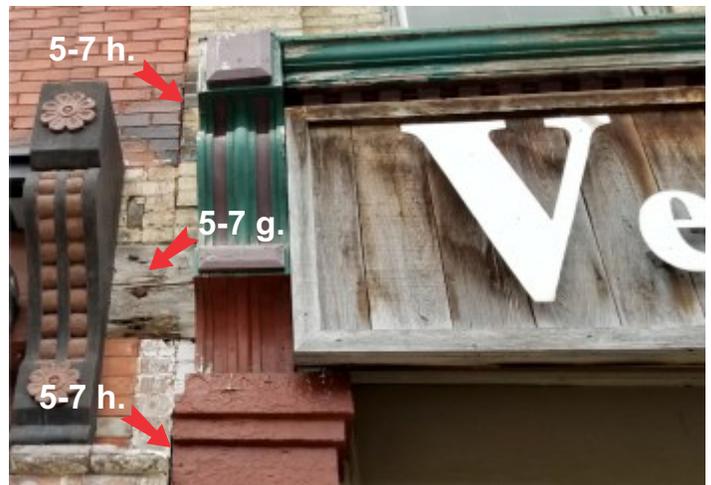
5-7 a. The flashing located at the upper roof parapet wall and above the fascia board and console bracket flashing shows some areas of deterioration and may have not been caulked properly. I have noted that the flashing at the junction of this building and the building to the south may not have been caulked or let into the masonry properly and may be allowing water to find its way between the flashing and the masonry units, which will inevitably cause problem with damp and spalling of masonry units.

5-7 b. All the main structural masonry support pilaster plinth has deterioration at its base where it comes in contact with the sidewalk. This problem is due to freeze and thaw cycles and soluble salts (winter road salt) destroying the masonry units. Water and soluble salts which destroy lime mortar must be kept in check therefore keeping these joints properly pointed is very important to the health of the exterior brick cladding. Repointing of the brick works should be done utilizing only lime-based mortar devoid of any cement. And, a regular yearly maintenance routine will need to be employed to keep the mortar in check and repair as necessary.

5-7 d. The exterior brick work has many areas over windows with pronounced pyramidal cracks. Many of these types of cracks may have appeared in the first decade after original construction due in part to excessive shrinkage of wooden window frames and lintels. However, it can also indicate a problem with rot and the masonry has shifted.

5-7 e. The main above-grade masonry exterior cladding is in fair condition with several areas of deterioration due to miss-managed roof water, however, cement has been used to fill voids in the original all lime-based mortar which is very damaging. Water and soluble salts which destroy lime mortar must be kept in check therefore keeping these joints properly pointed is

very important to the health of the exterior brick cladding. Repointing of the brick works should be done utilizing only lime-based mortar devoid of any cement. Any spalled (broken-off) brick or washed out mortar should first be investigated to the reason why they have spalled or washed out i.e. broken or cracked caulking around windows, Portland cement, landscape material too close to masonry, bad eavestroughs and downspouts or flashing, generally spalled masonry, and washed out mortar are a symptom of a moisture problem and should be repaired (water issues) as a priority.

5-7 f. This building employs cast-iron columns to support the main beam which in-turn supports the upper levels. Some signs of corrosion have been noted. These columns should be inspected more closely to see if they still have structural integrity at their bases. Rust should be wire-brushed and the whole of the column kept well painted.

5-7 g. The main timber beam supporting the upper levels is exposed and shows signs of deterioration. This should have a paint film applied to protect it from the elements. Any rot areas should be repaired with a two-part epoxy or replaced wholesale.

5-7 h. The joint between this building and the adjacent building should be kept well pointed with lime mortar to not allow water to penetrate, which could create a spall condition.

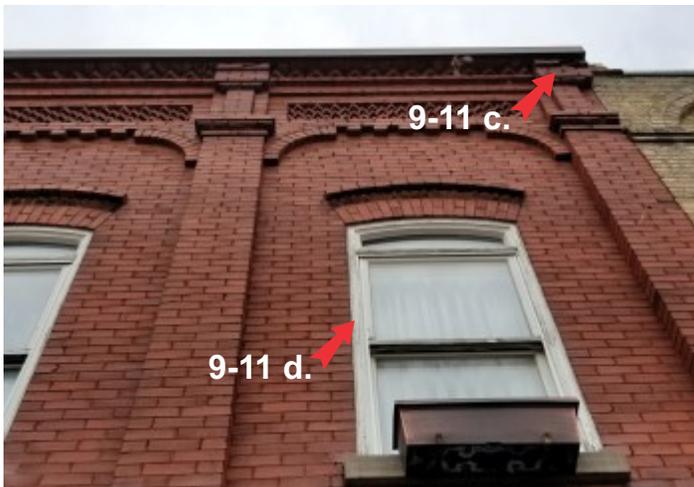
9-11 a. All the main structural masonry support pilaster plinth has deterioration at its base where it comes in contact with the sidewalk. This problem is due to freeze and thaw cycles and soluble salts (winter road salt) destroying the masonry units. Water and soluble salts which destroy lime mortar must be kept in check therefore keeping these joints properly pointed is very important to the health of the exterior brick cladding. Repointing of the brick works should be done utilizing only lime-based mortar devoid of any cement. And, a regular yearly maintenance routine will need to be employed to keep the mortar in check and repair as necessary.

9-11 b. The flashing located at the upper roof parapet wall appears to be in excellent condition. However, the fascia board and console bracket flashing shows some areas of deterioration and may have not been caulked properly or let into the brick work and may be allowing water to find its way between the flashing and the masonry units, which will inevitably cause a problem with damp and spalling of masonry units.

9-11 c. The main above-grade masonry exterior cladding is in very good condition! However, there are several areas of deterioration due to (former) mismanaged roof water. Water and soluble salts which

destroy lime mortar must be kept in check therefore keeping these joints properly pointed is very important to the health of the exterior brick cladding. Repointing of the brick works should be done utilizing only lime-based mortar devoid of any cement. Any spalled (broken-off) brick or washed out mortar should first be investigated to the reason why they have spalled or washed out i.e. broken or cracked caulking around windows, Portland cement, landscape material too close to masonry, bad eavestroughs and downspouts or flashing, generally spalled masonry, and washed out mortar are a symptom of a moisture problem and should be repaired (water issues) as a priority.

9-11 d. All areas of painted timber (i.e. console brackets and original window trim) should be scraped and repainted.

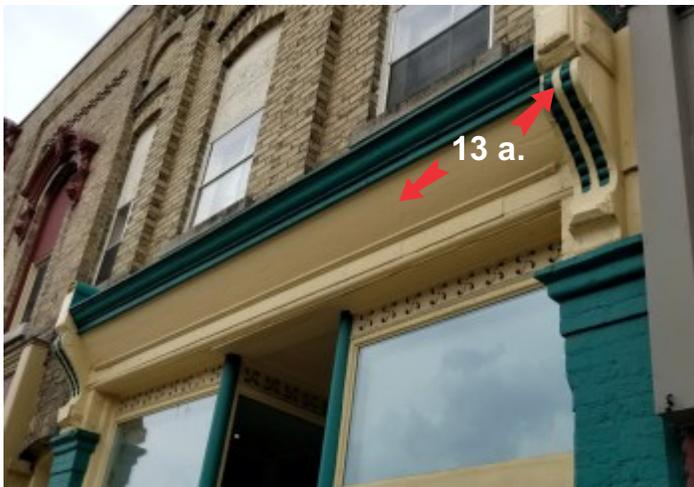
13 a. All areas of painted timber (i.e. console brackets and original window trim) should be scraped and repainted. If there are any areas of cuboidal wet rot, those areas that are simple flat sections of timber should be replaced wholesale with like material. Any areas with remarkable architectural moulding and detail should have any areas of cuboidal wet rot repaired with a two-part epoxy system.

13 b. All the main structural masonry support pilaster plinth has deterioration at its base where it comes in contact with the sidewalk. This problem is due to freeze and thaw cycles and soluble salts (winter road salt) destroying the masonry units. Water and soluble salts which destroy lime mortar must be kept in check therefore keeping these joints properly pointed is very important to the health of the exterior brick cladding. Repointing of the brick works should be done utilizing only lime-based mortar devoid of any cement. And, a regular yearly maintenance routine will need to be employed to keep the mortar in check and repair as necessary.

13 c. The flashing located at the upper roof parapet wall appears to be in excellent condition. However, the fascia board and console bracket flashing shows some areas of deterioration and may have not been caulked properly or let into the brick work and may be allowing water to find its way between the flashing and the masonry units, which will inevitably cause problem with damp and spalling of masonry units.

13 d. This building employs cast-iron columns to support the main beam which in turn supports the upper levels. Some signs of corrosion have been noted. These columns should be inspected more closely to

see if they still have structural integrity at their bases. Rust should be wire-brushed and the whole of the column kept well painted.

13 e. Many areas on this building are using plywood to fill-in upper portions of windows. Interior or construction grade plywood is not a satisfactory material unless it is rated for exterior uses such as MDO (medium density overlaid plywood).

13 f. The main above-grade masonry exterior cladding is in very good condition! However, there are several areas of deterioration due to (former) mismanaged roof water. Water and soluble salts which destroy lime mortar must be kept in check therefore keeping these joints properly pointed is very important to the health of the exterior brick cladding. Repointing of the brick works should be done utilizing only lime-based mortar devoid of any cement. Any spalled (broken-off) brick or washed out mortar should first be investigated to the reason why they have spalled or washed out i.e. broken or cracked caulking around windows, Portland cement, landscape material too close to masonry, bad eavestroughs and downspouts or flashing, generally spalled masonry, and washed out mortar are symptoms of a moisture problem and should be repaired (water issues) as a priority.

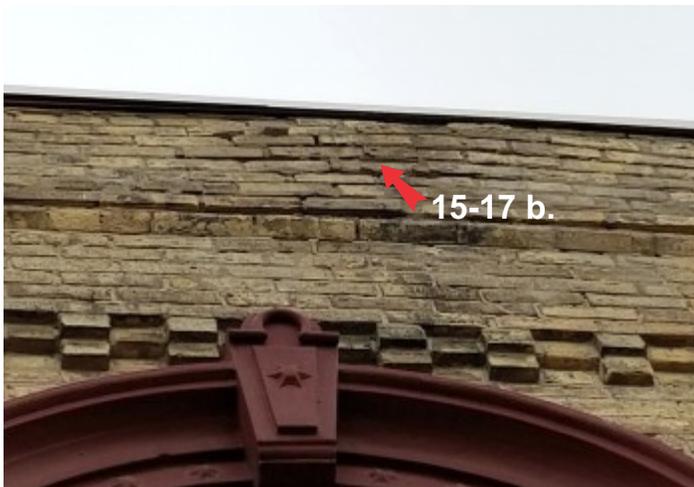
15-17 a. The flashing located at the upper roof parapet wall appears to be in good condition. However, the fascia board flashing shows some areas of deterioration and may have not been caulked properly or let into the brick work and may be allowing water to find its way between the flashing and the masonry units, which will inevitably cause problem with damp and spalling of masonry units.

15-17 b. The main above-grade masonry exterior cladding is in fair condition! However, there are several areas of deterioration due to miss-managed roof water, possibly in the past. Water and soluble salts which destroy lime mortar must be kept in check therefore keeping these joints properly pointed is very important to the health of the exterior brick cladding. Repointing of the brick works should be done utilizing only lime-based mortar devoid of any cement. Any spalled (broken-off) brick or washed out mortar should first be investigated to the reason why they have spalled or washed out i.e. broken or cracked caulking around windows, Portland cement, landscape material too close to masonry, bad eavestroughs and

downspouts or flashing, generally spalled masonry, and washed out mortar are a symptom of a moisture problem and should be repaired (water issues) as a priority. There is a considerable bulge in the wall which could indicate freeze and thaw damage which should be addressed to reset the affected areas.

15-17 c. This building has beautiful and very character defining cast iron hood mouldings and label-stops. As these are very heavy a periodical inspection should be made that they are affixed to the building properly e.g., metal fasteners let into the surrounding brick works are not corroded or missing.

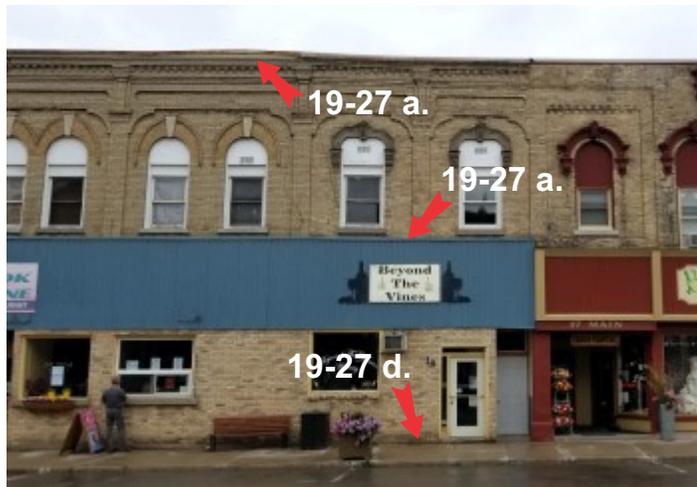
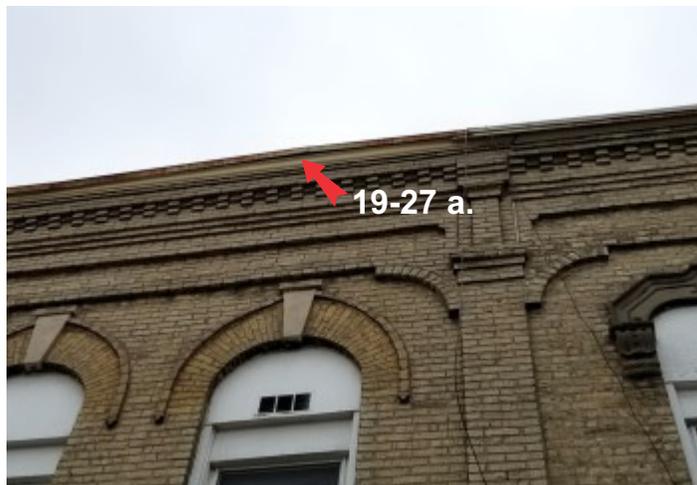
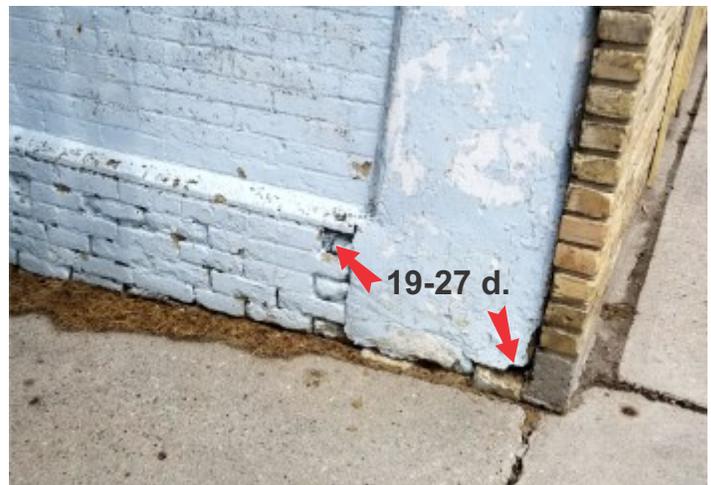
19-27 a. The flashing located at the upper roof parapet wall appears to be in very poor condition and needs to be replaced wholesale. The fascia board flashing shows some areas of deterioration and may have not been caulked properly or let into the brick work and may be allowing water to find its way between the flashing and the masonry units, which will inevitably cause problem with damp and spalling of masonry units.

19-27 b. The original brick sub-sill is in very poor condition. It has gone through many freeze and thaw cycles which has destroyed the sub-sill. This sill should be replaced wholesale.

19-27 c. All areas of painted timber should be scraped and repainted. If there are any areas of cuboidal wet rot, those areas that are simple flat sections of timber should be replaced wholesale with like material. Any areas with remarkable architectural moulding and detail should have any areas of cuboidal wet rot repaired with a two-part epoxy system.

19-27 d. A main structural masonry support pilaster plinth and other lowers sections of brick work

has deterioration at its base where it comes in contact with the sidewalk. This problem is due to freeze and thaw cycles and soluble salts (winter road salt) destroying the masonry units. Water and soluble salts which destroy lime mortar must be kept in check therefore keeping these joints properly pointed is very important to the health of the exterior brick cladding. Repointing of the brick works should be done utilizing only lime-based mortar devoid of any cement. And, a regular yearly maintenance routine will need to be employed to keep the mortar in check and repair as necessary.

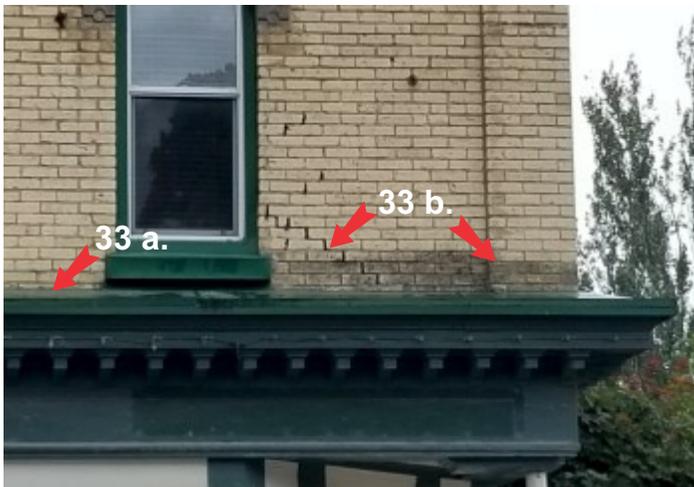
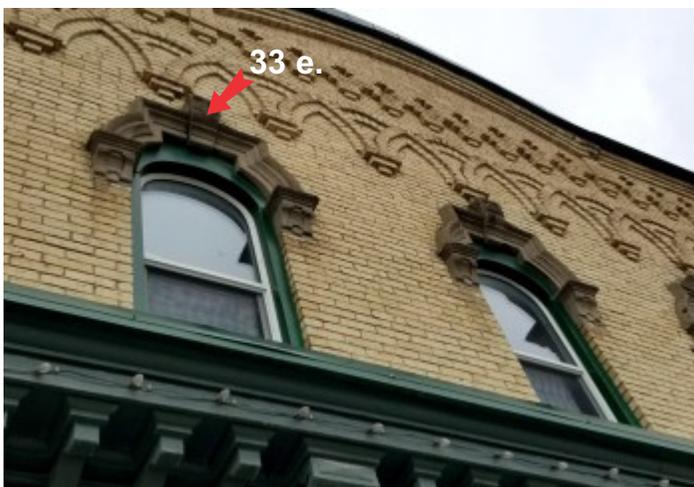
33 a. The flashing located at the upper roof parapet wall appears to be in excellent condition. However, the projecting fascia/frieze board shows some areas of deterioration and may have not been caulked properly or let into the brick work and may be allowing water to find its way between the flashing and the masonry units, which will inevitably cause problem with damp and spalling of masonry units.

33 b. The exterior brick work has a few areas with pronounced pyramidal cracks. Many of these types of cracks may have appeared in the first decade after original construction due in part to excessive shrinkage of wooden window frames and lintels. However, it can also indicate a problem with rot and the masonry has shifted.

33 c. This building has wooden elements in direct contact with masonry and concrete. Timber elements and masonry with the potential of sustained damp (e.g., sidewalks and in the instance a concrete or masonry plinth allowing ponding) will prematurely rot the timber. All timber should be terminated at least 1" above ground surface masonry.

33 d. Lower sections of brick work has deterioration at its base where it comes in contact with the sidewalk. This problem is due to freeze and thaw cycles and soluble salts (winter road salt) destroying the masonry units. Water and soluble salts which destroy lime mortar must be kept in check therefore keeping these joints properly pointed is very important to the health of the exterior brick cladding. Repointing of the brick works should be done utilizing only lime-based mortar devoid of any cement. And, a regular yearly maintenance routine will need to be employed to keep the mortar in check and repair as necessary.

33 f. I noted some area of brick which is painted, these areas should be touched up periodically.

33 g. All areas of painted timber should be scraped and repainted. If there are any areas of cuboidal wet rot, those areas that are simple flat sections of timber should be replaced wholesale with like material. Any areas with remarkable architectural moulding and detail should have any areas of cuboidal wet rot repaired with a two-part epoxy system.

33 h. This building has an exterior basement hatch. An inspection of the doors should be made periodically as to their structural integrity to be walked on by the public. Inspect to see if water is finding its way into the building and causing damage, replace or add flashing as needed.

33 i. This building employs a cast-iron columns to support the main beam which in-turn supports the upper levels. Some signs of corrosion have been noted. These columns should be inspected closer to see if they still have structural integrity at their bases. Rust should be wire-brushed and the whole of the column kept well painted.

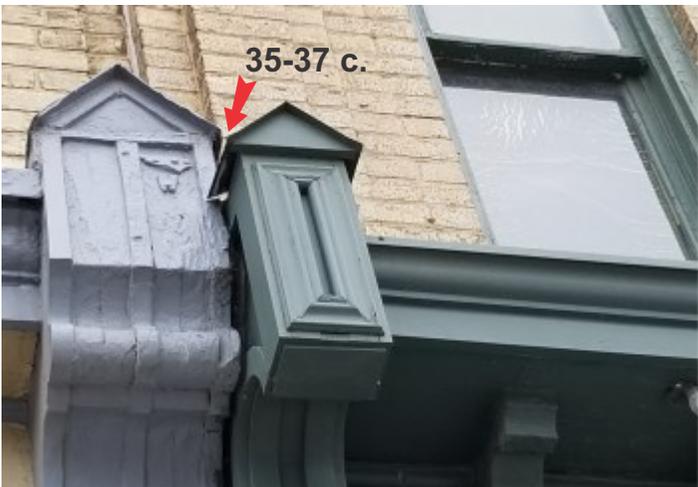
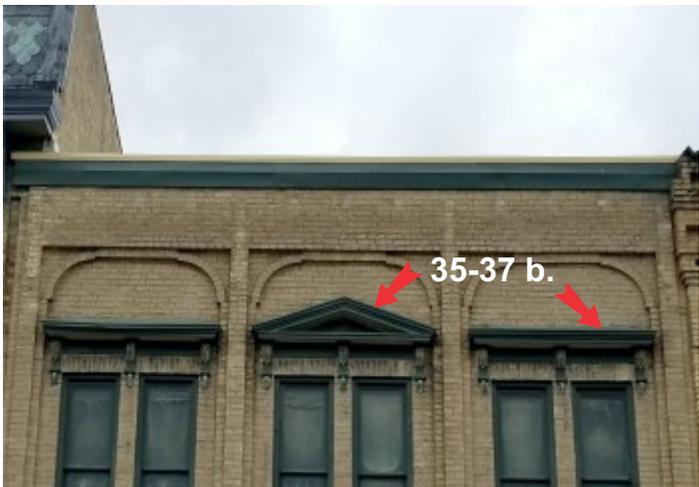
35-37 a. The flashing located at the upper roof parapet wall appears to be in excellent condition. However, the projecting fascia/frieze board may have not been caulked properly or let into the brick work and may be allowing water to find its way between the flashing and the masonry units, which will inevitably cause problem with damp and spalling of masonry units.

35-37 b. This building has beautiful and very character defining pediments above the second level windows. As these are very heavy a periodical inspection should be made that they are affixed to the building properly e.g., the flashing is in good repair and properly let into the surrounding brick works. The mortar around the flashing should be well pointed into the surrounding brick works and is not allowing water to get between the pediments and the underlying brick work which could become dislodged in a freeze and thaw cycle.

35-37 c. The console bracket shows some areas of deterioration to the south and may have not been flashed properly which can cause erosion of the neighbouring console bracket. Provide adequate flashing to protect both buildings console brackets from affecting each other.

35-37 d. The main above-grade masonry exterior cladding is in fair condition! However, there are several areas of deterioration due to miss-managed roof water, possibly in the past. Water and soluble salts which destroy lime mortar must be kept in check therefore keeping these joints properly pointed is very important to the health of the exterior brick cladding. Repointing of the brick works should be done utilizing only lime-based mortar devoid of any cement.

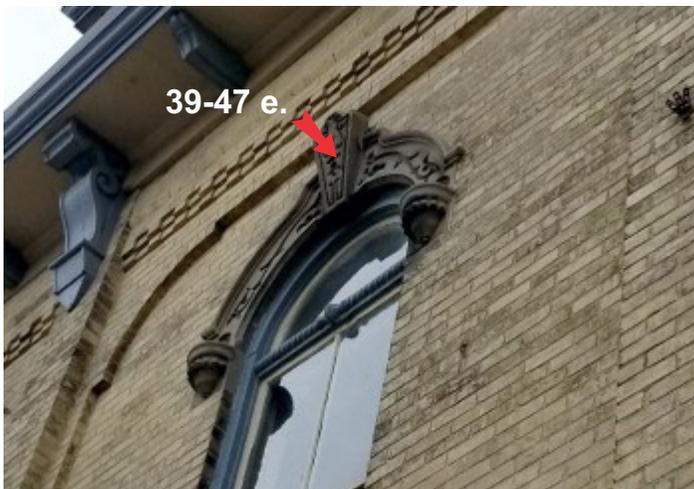
39-47 a. The flashing located at the upper roof parapet wall appears to be in fair condition, however, should be inspected for corrosion and or leaks on a regular basis. The fascia board and console bracket shows some areas of deterioration and may have not been caulked properly or let into the brick work and may be allowing water to find its way between the flashing and the masonry units, which will inevitably cause problem with damp and spalling of masonry units.

39-47 b. The slate roof in general looks to be in fair condition, however slate roofing has a life expectancy of between 75 and 130 years. I have noted some broken and missing tiles and some poorly executed flashing especially around the lucarnes (small dormers with oculus windows) on the mansard roof. Broken slate tiles should be professionally replaced as required and all flashing should be kept in check.

39-47 c. Some of the brick work on this building has been media blasted. Media blasting or water blasting is not acceptable on any heritage materials. Such unsympathetic works will destroy the brick work (as noted) as the masonry units are not hard enough to withstand such abrasive cleaning techniques. The entire wall will need to be pargeted with an all lime suction bond to allow the transmission of moisture to the exterior, or the brick needs to be replaced wholesale.

39-47 d. The console bracket shows some areas of deterioration and may have not been flashed properly which can cause erosion. Provide adequate flashing to protect the console brackets from rot etc. All areas of painted timber on the building as a whole should be scraped and repainted. If there are any areas of cuboidal wet rot, those areas that are simple flat sections of timber should be replaced wholesale with like material. Any areas with remarkable architectural moulding and detail should have any areas of cuboidal wet rot repaired with a two-part epoxy system.

well pointed into the surrounding brick works and is not allowing water to get between the mouldings and the underlying brick work which could become dislodged in a freeze and thaw cycle. On my visit a keystone (as noted) was separated from the wall.

39-47 f. All areas of painted timber (i.e. console brackets and original window trim) should be scraped and repainted. If there are any areas of cuboidal wet rot, those areas that are simple flat sections of timber should be replaced wholesale with like material. Any areas with remarkable architectural moulding and detail should have any areas of cuboidal wet rot repaired with a two-part epoxy system.

39-47 g. The main above-grade masonry exterior cladding is in fair condition! However, there are several areas of deterioration due to miss-managed roof water, possibly in the past. Water and soluble salts which destroy lime mortar must be kept in check therefore keeping these joints properly pointed is very important to the health of the exterior brick cladding. Repointing of the brick works should be done utilizing only lime-based mortar devoid of any cement.

39-47 h. In the accompanying image (2012) some ponding was detected on the projecting architrave / pediment. This area should be inspected for proper drainage and the integrity of the roofing material. A leak could cause a rot condition and failure.

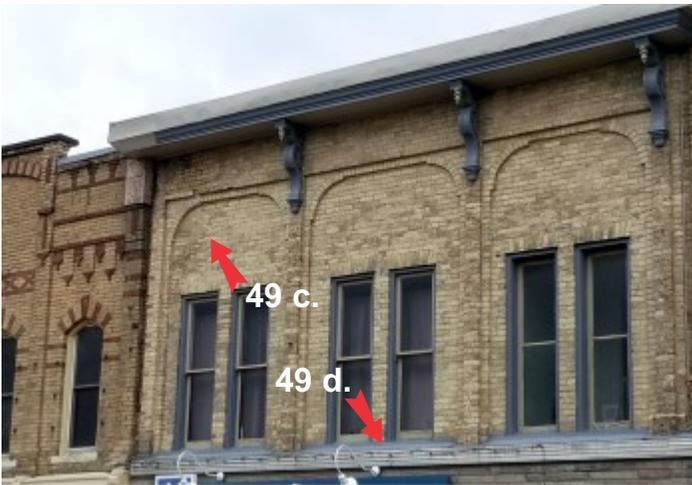
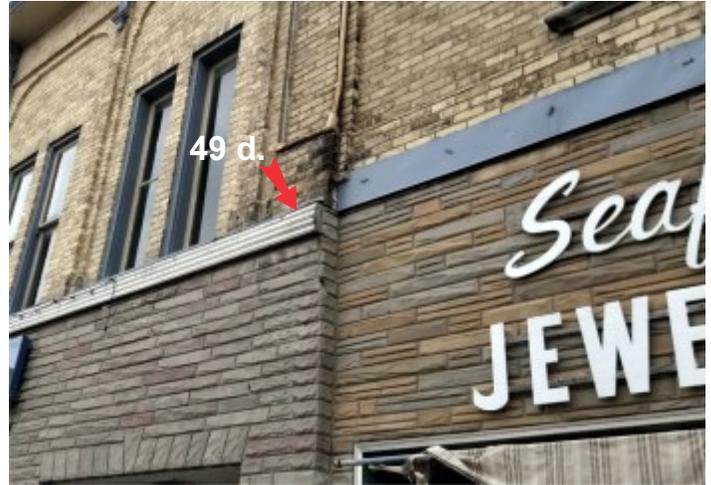
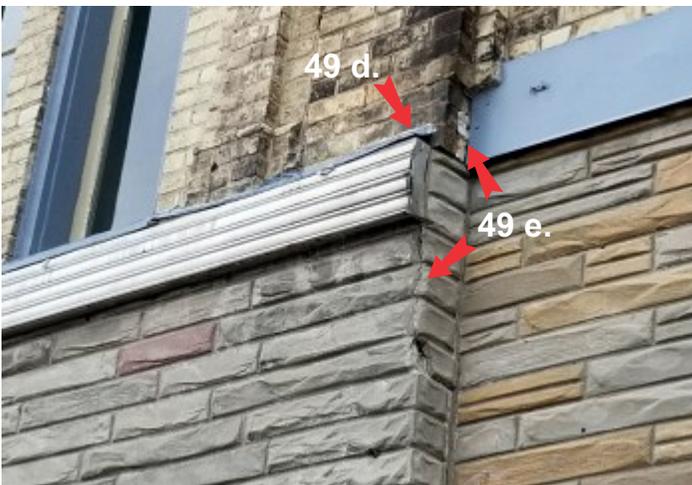
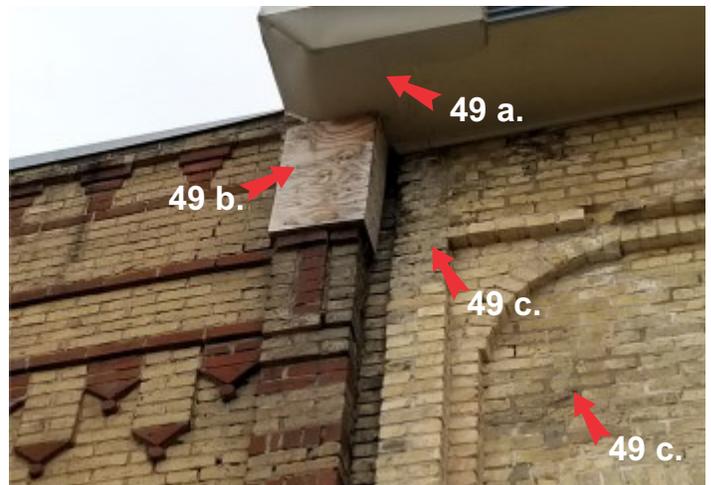
49 a. The flashing located at the upper roof parapet wall appears to be in fair condition, however, it has been installed rather awkwardly, especially to the south where it is wrapped around the soffit, which could in the future hold moisture and water against the wooden soffit. The flashing also covers a character defining cornice moulding which is unsympathetic to the heritage fabric of the building.

49 b. I am unsure why a piece of plywood has been added to the adjacent buildings pilaster.. see 51 Main Street.

49 c. The exterior brick work has a few areas with pronounced pyramidal cracks. Many of these types of cracks may have appeared in the first decade after original construction due in part to excessive shrinkage of wooden window frames and lintels. However, it can also indicate a problem with rot and the masonry has shifted. Keep pyramidal cracks well pointed with an all lime based mortar, consult a structural engineer if the crack widens or becomes unstable. The main above-grade masonry exterior cladding is in fair to poor condition! There are several areas of deterioration due to miss-managed roof water, possibly in the past.

49 d. The flashing at the fascia board location is in poor condition and should be repaired or replaced wholesale.

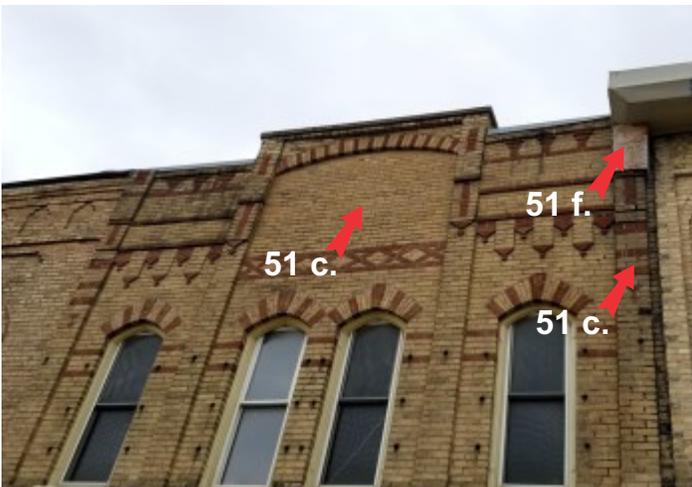
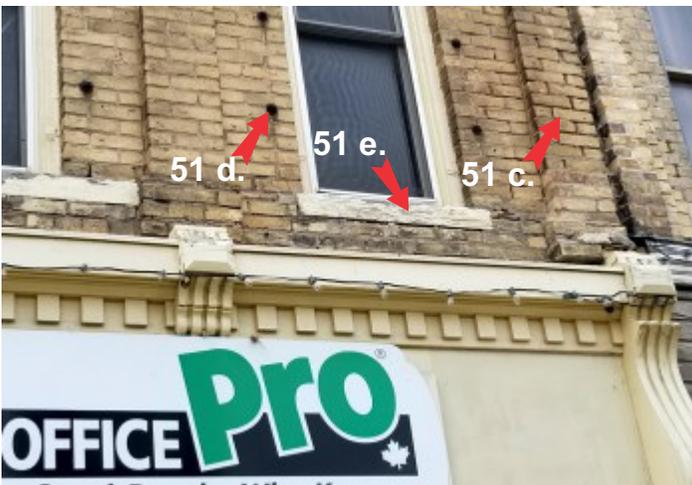
51 a. The flashing located at the upper roof parapet wall appears to be in very poor condition. The projecting fascia/frieze board shows some areas of deterioration and may have not been caulked properly or let into the brick work and may be allowing water to find its way between the flashing and the masonry units, which will inevitably cause problem with damp and spalling of masonry units.

51 b. As per 51 a., a definite leak is present in the flashing at the fascia/frieze board above. The flashing should be replaced or repaired immediately before greater damage is sustained.

51 c. The main above-grade masonry exterior cladding is in poor condition! There are several areas of deterioration due to miss-managed roof water, possibly in the past. Water and soluble salts which destroy lime mortar must be kept in check therefore keeping these joints properly pointed is very important to the health of the exterior brick cladding. Repointing of the brick works should be done utilizing only lime-based mortar devoid of any cement.

51 d. There are many small draw rods and plates on the second-floor façade. These should be inspected that they are not loose and or corroded rendering them non-functioning. Replace if necessary, however, this is not a DIY project! A professional familiar with this support system must be engaged.

51 e. The building has timber sub-sills under the majority of the existing windows. There are signs of deterioration and loss of the paint surface. These sub-sills should be scraped, and any areas of rot repaired with a two-part epoxy system and repainted. Sills and sub-sills should never be caulked on the bottom as this can create issues with the passage of moisture which can rot out the sill and the sub-sill. However, in this case the sub-sill should be pointed with an all lime based mortar below. Lime mortar allows the transmission of damaging moisture and water.

51 f. A section of the upper pilaster is covered with plywood. If this is covering-up damage to the brick work repair as noted above.

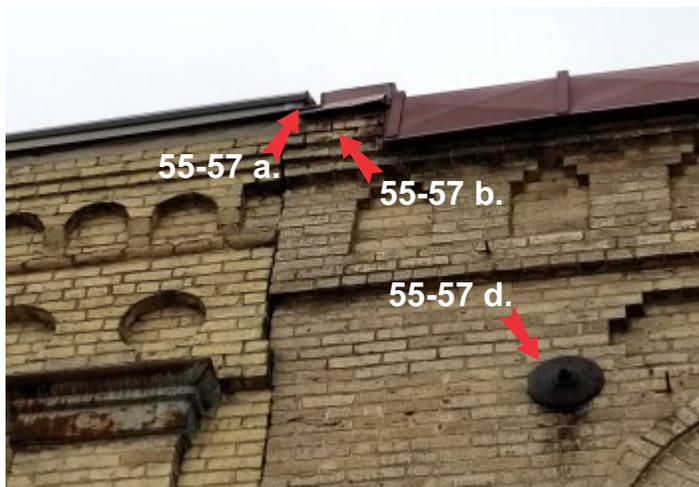
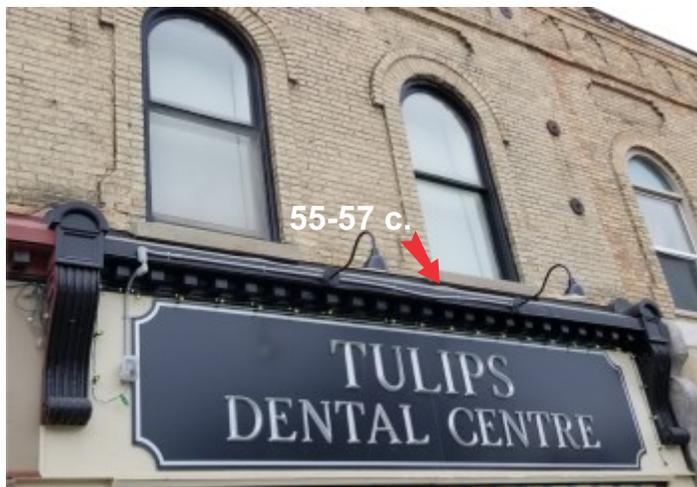
55-57 a. The flashing located at the upper roof parapet wall appears to be in good condition. Some areas are not executed very well and may cause water issues in the future and should be repaired and or replaced specifically the bookend junction between the north and south buildings.

55-57 b. The main above-grade masonry exterior cladding is in poor condition in some areas! There are several areas of deterioration due to miss-managed roof water, possibly a flashing issue. Water and soluble salts which destroy lime mortar must be kept in check therefore keeping these joints properly pointed is very important to the health of the exterior brick cladding. Repointing of the brick works should be done utilizing only lime-based mortar devoid of any cement.

55-57 c. The projecting fascia board flashing is bulged along its length, inspect to see if it has been caulked properly or let into the brick work. If not properly sealed it may be allowing water to find its way between the flashing and the masonry units, which will inevitably cause problem with damp and spalling of masonry units.

55-57 d. There are draw rods and plates on the second-floor façade. These should be inspected that they are not loose and or corroded rendering them non-functioning. Replace if necessary, however, this is not a DIY project! A professional familiar with this support system must be engaged.

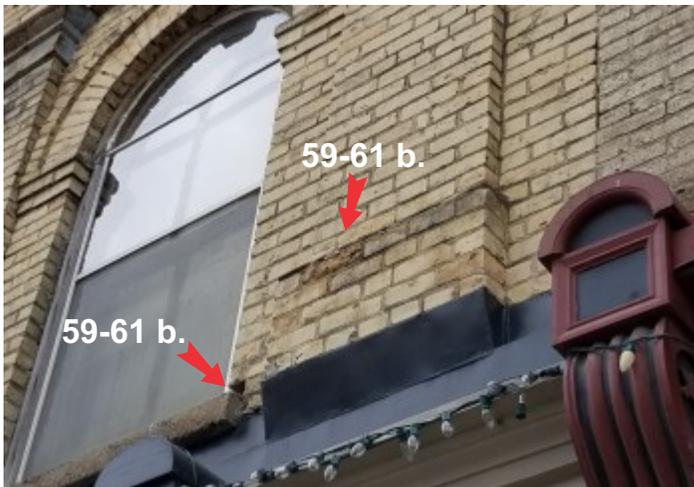
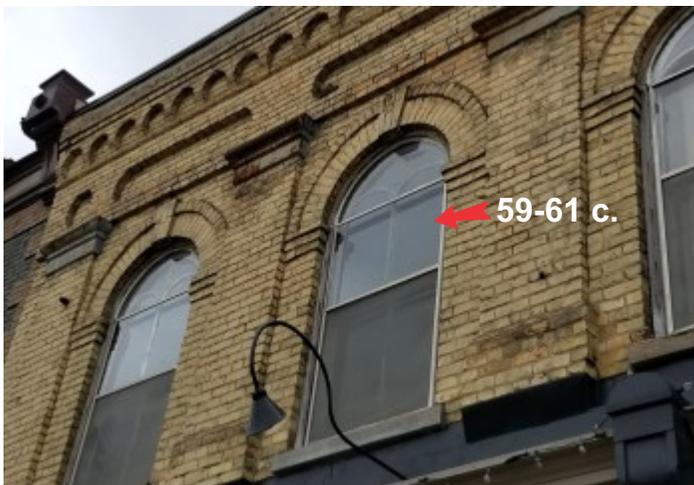
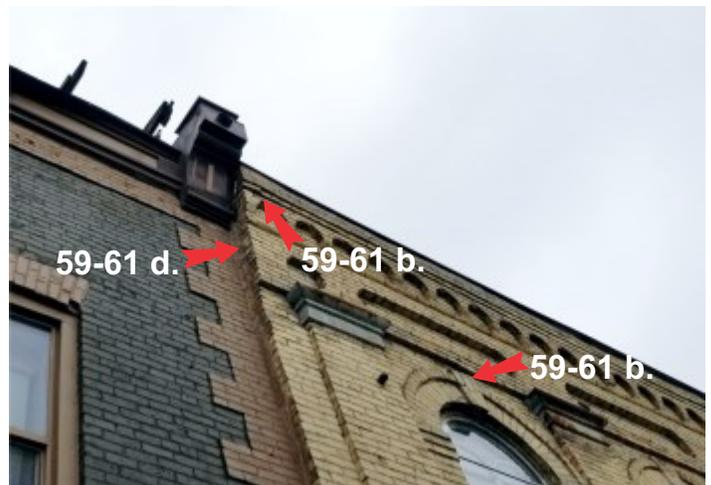
59-61 a. This building has very unique metal capitols on the brick pilasters. These need to be scraped, wire brushed then primed and painted to protect from corrosion. I noted mortar missing... keeping these joints properly pointed is very important to arrest the corrosion of the metal and stopping any water from getting behind the capitols. Repointing of the brick works should be done utilizing only lime-based mortar devoid of any cement.

59-61 b. The main above-grade masonry exterior cladding is in poor condition in some areas! There are several areas of deterioration due to miss-managed roof water. There may be loose bricks at the junction of the building located to the south. Water and soluble salts which destroy lime mortar must be kept in check therefore keeping these joints properly pointed is very important to the health of the exterior brick cladding. Repointing of the brick works should be done utilizing only lime-based mortar devoid of any cement. The exterior brick work has a few areas with pronounced pyramidal cracks. Many of these types of cracks may have appeared in the first decade after original construction due in part to excessive shrinkage of wooden window frames and lintels. However, it can also indicate a problem with rot and the masonry has shifted. Keep pyramidal cracks well pointed with an all lime based mortar, consult a structural engineer if the crack widens or becomes unstable.

59-61 c. The upper level windows are very character defining and rare and should be restored at all costs and fitted with an appropriate custom wood storm, which will render the windows more energy efficient than any replacement.

59-61 d. The joint between this building and the adjacent building should be kept well pointed with lime mortar to not allow water to penetrate, which could create a spall condition.

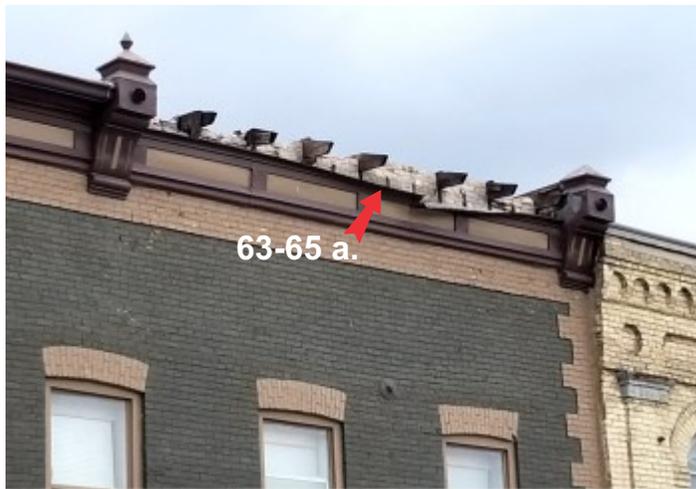
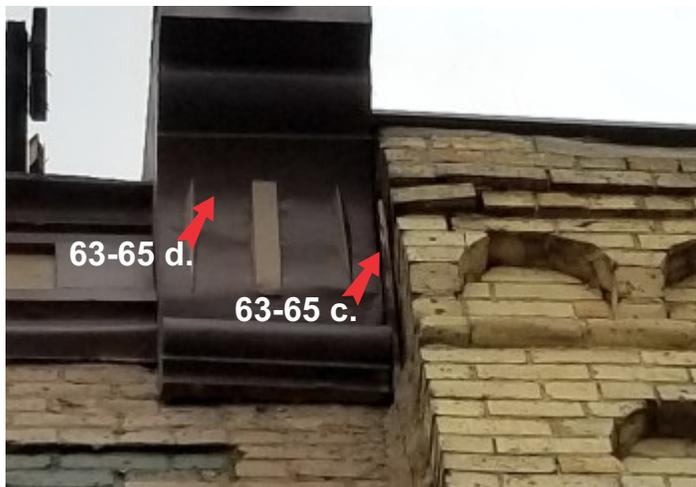
63-65 a. Clearly there has been a complete failure of the fascia and soffit. This may be due to weakening of the brick and brick mortar from a former fire (building was once three storeys). Extreme heat from a fire can destroy lime mortar rendering it structurally un-sound. However, this could also be an issue with leaking flashing and water dislodging the masonry through freeze and thaw actions. A thorough inspection with respects to the structural integrity of the existing brick works need to be done prior to implementing repair works. Repointing of the brick works should be done utilizing only lime-based mortar devoid of any cement as it will not bond properly to the existing masonry.

63-65 b. There are draw rods and plates on the second-floor façade. These should be inspected that they are not loose and or corroded rendering them non-functioning. Replace if necessary, however, this is not a DIY project! A professional familiar with this support system must be engaged. The building has a definite bow in the façade where the draw rods and plates are located with pronounced pyramidal cracks which has been repaired at some point and may be stable. Keep an eye on widening cracks or bulges and engage a professional structural engineer to provide remedy immediately.

63-65 c. The joint between this building and the adjacent building should be kept well pointed with lime mortar to not allow water to penetrate, which could create a spall condition.

63-65 d. The metal soffit, fascia and console brackets are very character defining and should be maintained as they have been. I trust the missing sections blown down in the wind storm has been retained for restoration and re-installation.

63-65 e. The projecting fascia board flashing is well executed, inspect periodically to see if it has been caulked properly or let into the brick work. If not properly sealed it may be allowing water to find its way between the flashing and the masonry units, which will inevitably cause problem with damp and spalling of masonry units.

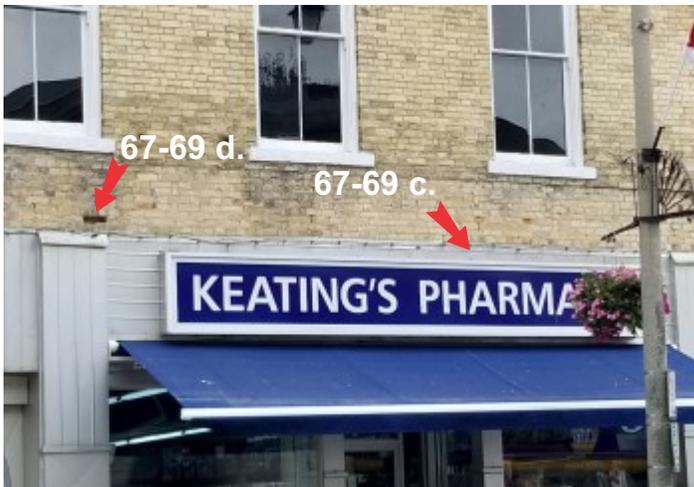
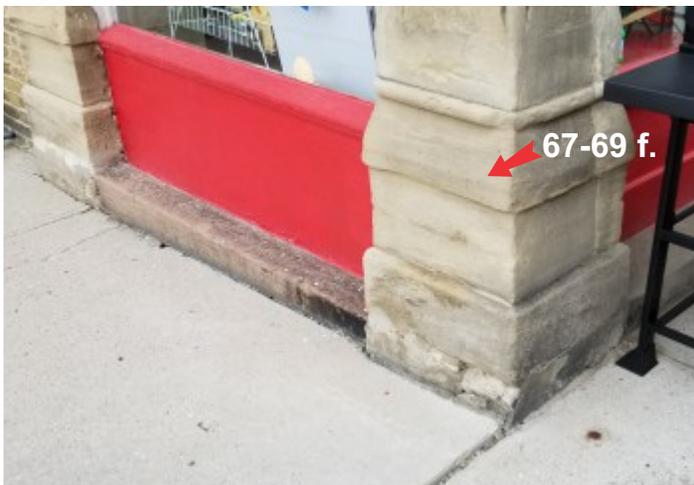
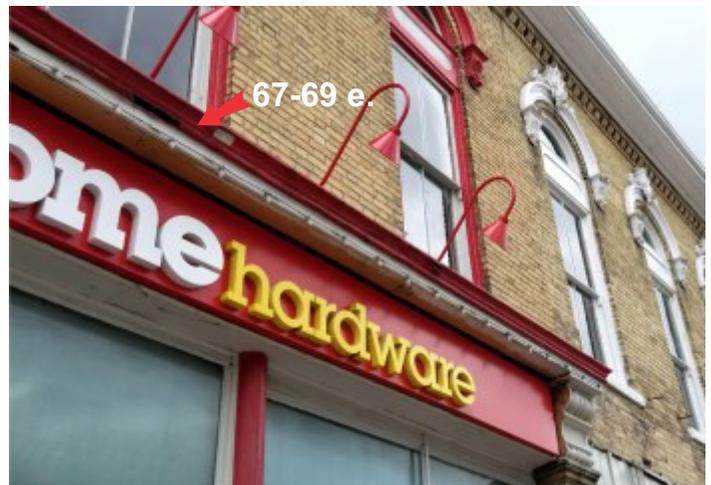
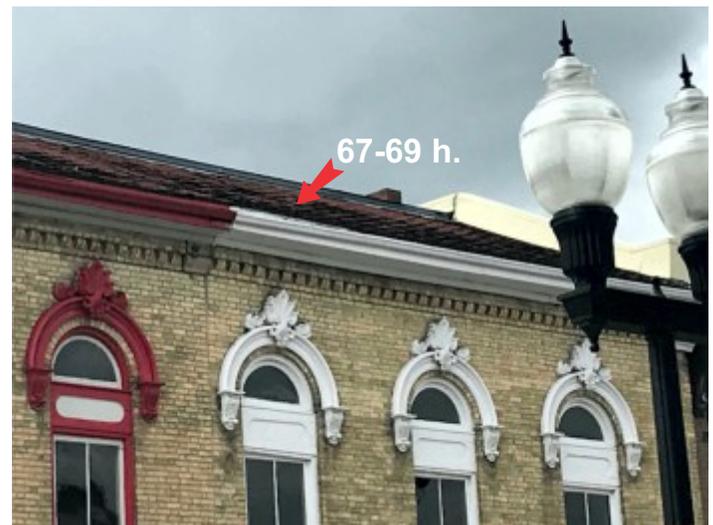
67-69 a. The exterior brick work has a very pronounced pyramidal crack on the south east corner. Many of these types of cracks may have appeared in the first decade after original construction due in part to excessive shrinkage of wooden window frames and lintels. However, it can also indicate a problem with rot and the masonry has shifted. This crack should be filled with a all lime based mortar and inspected regularly to see if the crack reopens or widens. Keep an eye on widening cracks or bulges and engage a professional structural engineer to provide remedy immediately.

67-69 b. Regularly inspect eavestroughs for leaks and repair or replace as necessary.

67-69 c. The projecting fascia board flashing is in fair condition, inspect periodically to see if it has been caulked properly or let into the brick work. If not properly sealed it may be allowing water to find its way between the flashing and the masonry units, which will inevitably cause problem with damp and spalling of masonry units.

67-69 d. The main above-grade masonry exterior cladding is in fair condition with a few deteriorated and in some cases missing bricks. Water and soluble salts which destroy lime mortar must be kept in check therefore keeping these joints properly pointed is very important to the health of the exterior brick cladding. Repointing of the brick works should be done utilizing only lime-based mortar devoid of any cement.

67-69 e. All areas of painted timber (i.e. console brackets and original window trim) should be scraped and repainted. If there are any areas of cuboidal wet rot, those areas that are simple flat sections of timber should be replaced wholesale with like material. Any areas with remarkable architectural moulding (as noted) and detail should have any areas of cuboidal wet rot repaired with a two-part epoxy system.

67-69 g. This building has beautiful and very character defining cast iron hood mouldings and label-stops. As these are very heavy a periodical inspection should be made that they are affixed to the building properly e.g., metal fasteners let into the surrounding brick works are not corroded or missing.

67-69 h. The roof on the Main Street facade side, needs to be replaced, as the asphalt shingles have long since come to the end of its service life.
