Building Pathology Report

Seaforth, Ontario

Prepared By Dr. Christopher Cooper

Revision Date: July 30, 2018

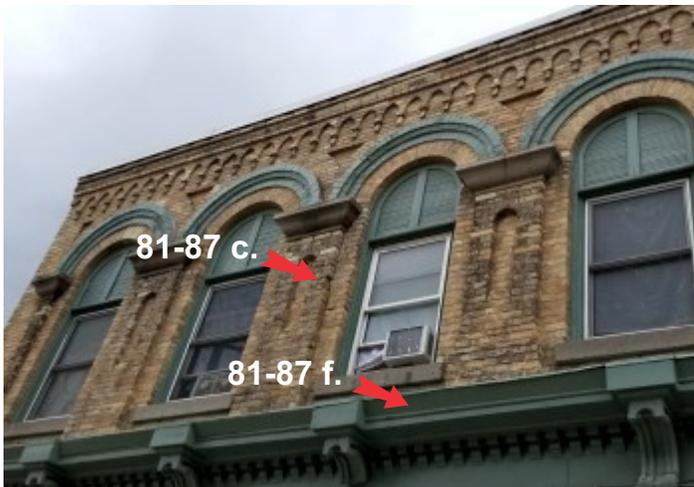
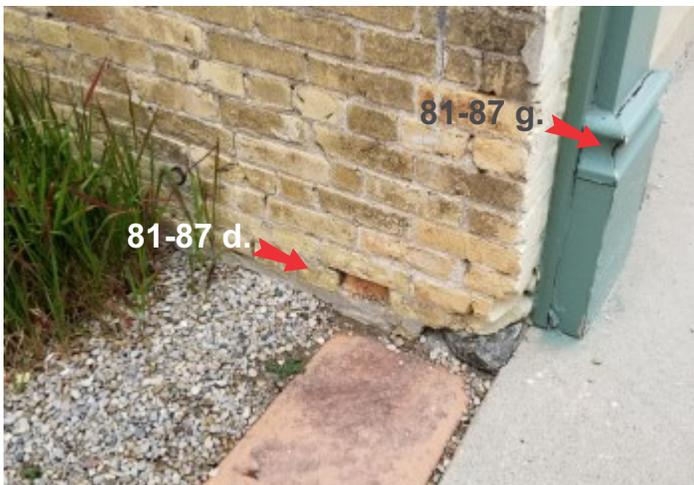
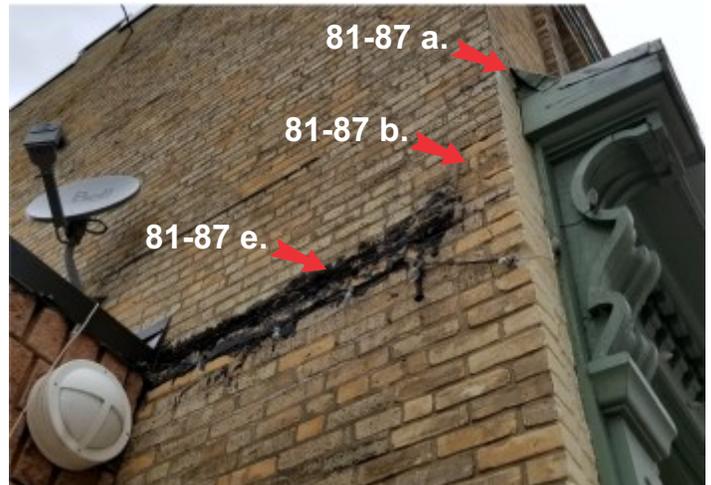
Note: 81 Main Street has no obvious signs of deterioration or conditions that warrant dialogue.

81-87 a. The flashing located at the upper roof parapet wall and above the fascia board and console brackets appear to be in good condition. A periodic inspection of the caulking and or mortar should be done regularly.

81-87 b. There is a stress crack located on the side wall of the building. This crack should be filled with an all lime based mortar and inspected regularly to see if the crack reopens or widens. Keep an eye on widening cracks or bulges and engage a professional structural engineer to provide remedy immediately.

81-87 f. All areas of painted timber (i.e. console brackets, window louvers and original window trim) should be scraped and repainted. If there are any areas of cuboidal wet rot, those areas that are simple flat sections of timber should be replaced wholesale with like material. Any areas with remarkable architectural moulding (as noted) and detail should have any areas of cuboidal wet rot repaired with a two-part epoxy system.

81-87 g. This building has wooden elements in direct contact with masonry and concrete. Timber elements and masonry with the potential of sustained damp (e.g., sidewalks) will prematurely rot the timber, all timber should be terminated at least 1" above ground surface masonry.

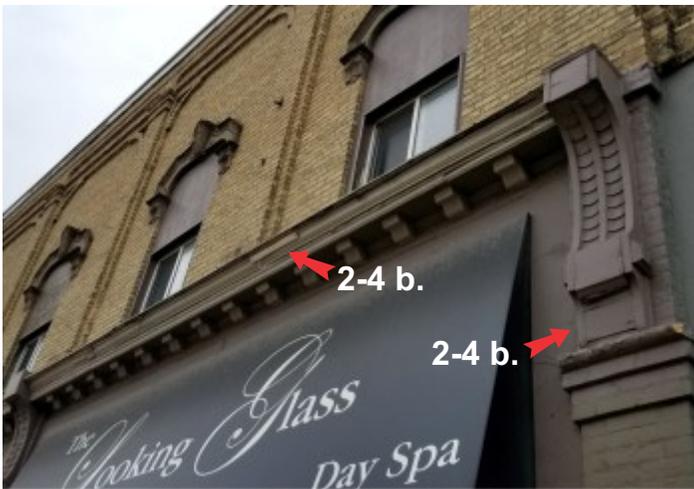
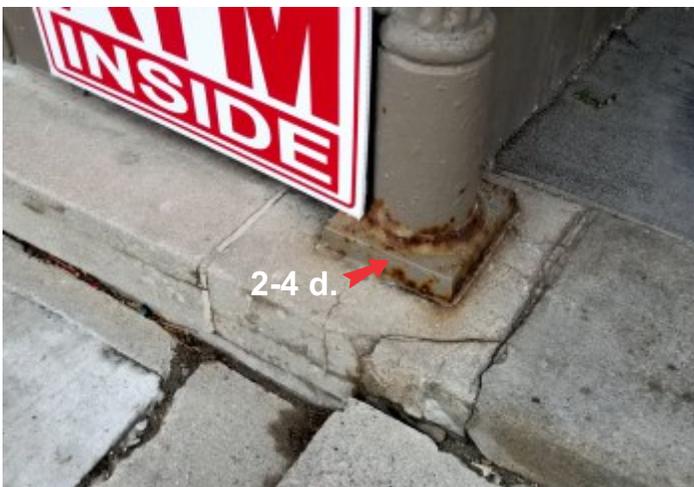
2-4 a. The flashing located at the upper roof parapet wall and above the fascia board shows severe areas of deterioration and may have not been caulked properly. I have noted that the flashing at the junction of this building and the building to the south may not have been caulked or let into the masonry properly and may be allowing water to find its way between the flashing and the masonry units, which will inevitably cause problem with damp and spalling of masonry units.

2-4 b. All areas of painted timber (i.e. console brackets and original window trim) should be scraped and repainted. If there are any areas of cuboidal wet rot, those areas that are simple flat sections of timber should be replaced wholesale with like material. Any areas with remarkable architectural moulding (as noted) and detail should have any areas of cuboidal wet rot repaired with a two-part epoxy system.

2-4 d. This building employs cast-iron columns to support the main beam which in-turn supports the upper levels. Some signs of corrosion have been noted. These columns should be inspected closer to see if they still have structural integrity at their bases. Rust should be wire-brushed and the whole of the column kept well painted.

2-4 e. The main structural masonry support pilasters and masonry have deterioration at its base where it comes in contact with the sidewalk. This problem is due to freeze and thaw cycles and soluble salts (winter road salt) destroying the masonry units. Water and soluble

salts which destroy lime mortar must be kept in check therefore keeping these joints properly pointed is very important to the health of the exterior brick cladding. Repointing of the brick works should be done utilizing only lime-based mortar devoid of any cement. And, a regular yearly maintenance routine will need to be employed to keep the mortar in check and repair as necessary.

2-4 f. This building has beautiful and very character defining cast or cut stone hood mouldings and label-stops with a central key stone. As these are very heavy and usually are installed in several sections a periodical inspection should be made that they are affixed to the building properly e.g., the mortar is well pointed into the surrounding brick works and is not allowing water to get between the mouldings and the underlying brick work which could become dislodged in a freeze and thaw cycle.

2-4 g. Many areas on this building are using plywood as cladding or to fill-in upper portions of windows. Interior or construction grade plywood is not a satisfactory material unless it is rated for exterior uses such as MDO (medium density overlaid plywood). All areas of painted timber (i.e. console brackets) should be scraped, repaired and repainted.

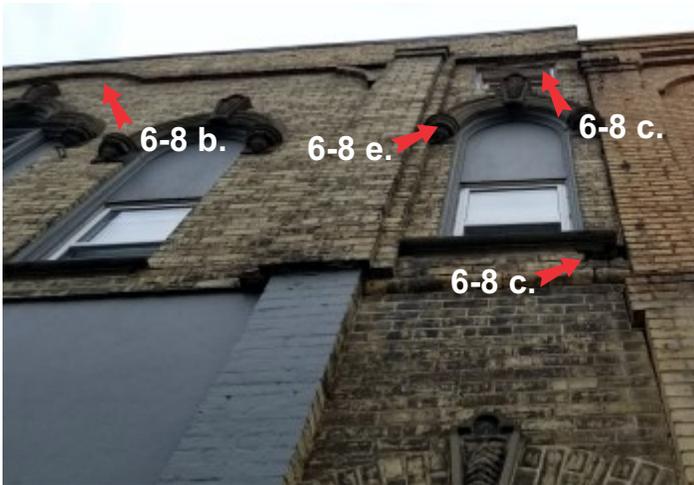
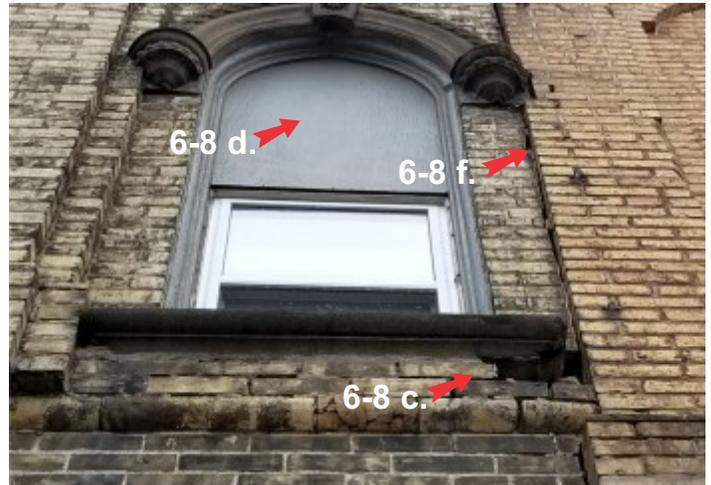
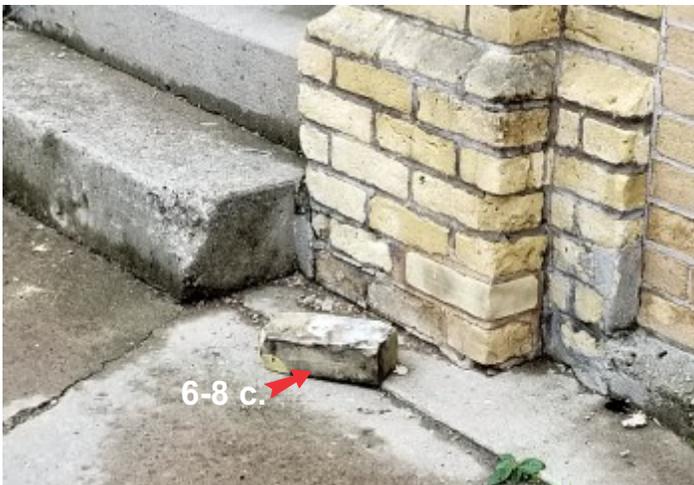
6-8 a. The flashing located at the upper roof parapet wall and above the fascia board shows areas of deterioration and may have not been caulked properly. I have noted that the flashing at the junction of this building and the building to the north may not have been caulked or let into the masonry properly and may be allowing water to find its way between the flashing and the masonry units, which will inevitably cause problem with damp and spalling of masonry units.

6-8 b. There are several areas of erosion of masonry units, most likely from a poorly installed parapet flashing in the history of the building. Water and soluble salts which destroy lime mortar must be kept in check therefore keeping these joints properly pointed is very important to the health of the exterior brick cladding. Repointing of the brick works should be done utilizing only lime-based mortar devoid of any cement.

6-8 c. On the day of my inspection, a brick had very recently fell from the area noted on the previous page. keeping these joints properly pointed is very important to the health of the exterior brick cladding. Repointing of the brick works should be done utilizing only lime-based mortar devoid of any cement. Emergency repairs should be made prior to winter of this year as this could be dangerous for pedestrians.

6-8 d. Many areas on this building are using plywood as cladding or to fill-in upper portions of windows. Interior or construction grade plywood is not a satisfactory material unless it is rated for exterior uses such as MDO (medium density overlaid plywood). All areas of painted timber (i.e. console brackets) should be scraped, repaired and repainted.

6-8 f. The joint between this building and the adjacent building should be kept well pointed with lime mortar to not allow water to penetrate, which could create a spall condition.

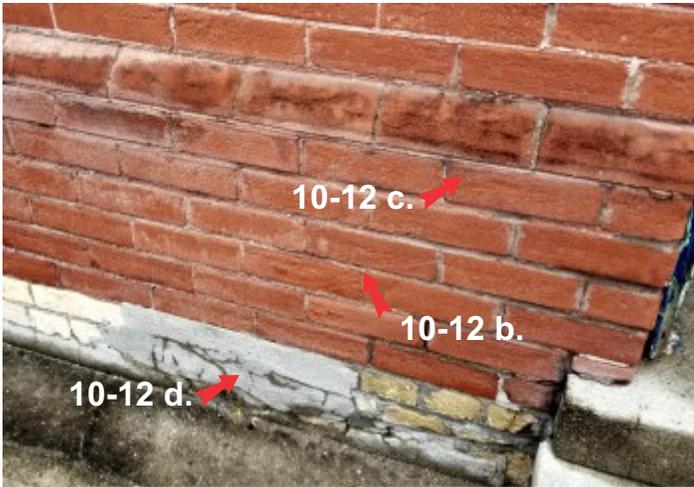
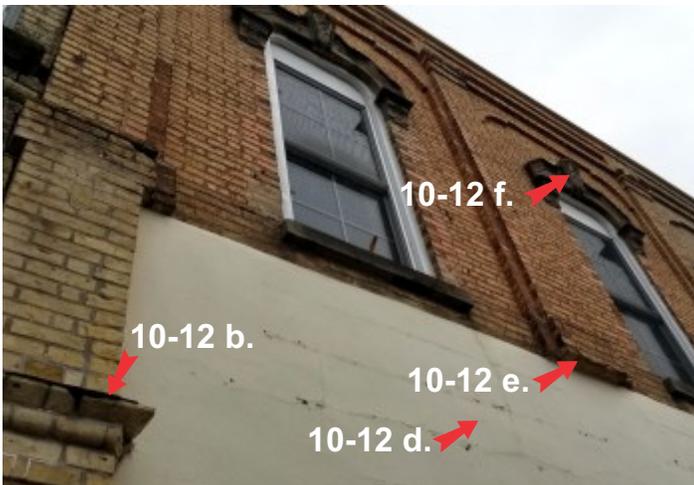
10-12 a. The flashing located at the upper roof parapet wall and above the fascia board shows areas of deterioration and may have not been pointed or caulked properly. I have noted that there is no flashing present at the junction of the fascia board and second level masonry, this condition could be allowing water to find its way between the flashing and the concrete pargetting, which will inevitably cause a problem with damp and spalling of underlying masonry units.

10-12 b. On the day of my inspection, I noted the poor condition of the brick work and mortar with brick units missing and or heavily eroded. Keeping these joints properly pointed is very important to the health of the exterior brick cladding. Repointing of the brick works should be done utilizing only lime-based mortar devoid of any cement. Emergency repairs should be made prior to winter of this year as this could be dangerous for pedestrians.

10-12 c. Some of the brick work on this building has been media blasted. Media blasting or water blasting is not acceptable on any heritage materials. Such unsympathetic works will destroy the brick work (as noted) as the masonry units are not hard enough to withstand such abrasive cleaning techniques. The entire wall will need to be pargeted with an all lime suction bond to allow the transmission of moisture to the exterior, or the brick needs to be replaced wholesale.

10-12 d. The fascia board area has been pargeted in what looks like concrete. Concrete pargetting will hold copious amounts of moisture between the soft brick and the concrete parget itself causing massive spalling issues destroying the underlining brick during freeze and thaw cycles. Cementitious materials should

be removed wholesale and the entire wall pargeted with an all lime suction bond to allow the transmission of moisture to the exterior.

10-12 e. I noted a strange condition whereas the pilaster faces have been removed during a renovation. Have the upper levels of these pilasters been supported adequately?

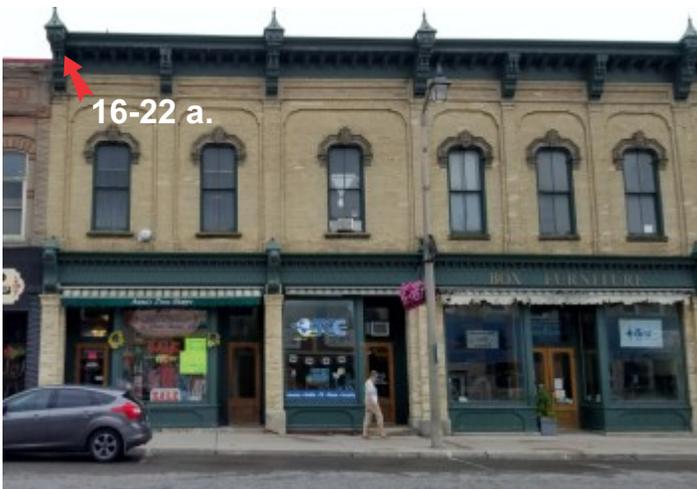
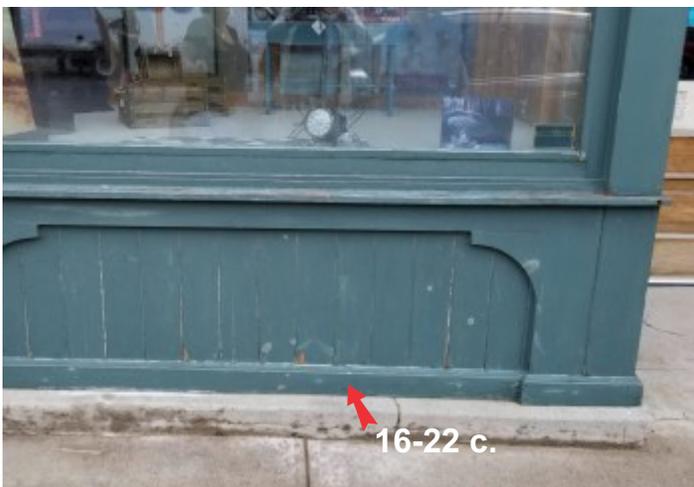
16-22 a. This building has a beautiful cornice with outstanding console brackets and corbels. Several of the boxed console brackets are in miserable condition especially the console to the north. The flashing at the rear of this console is not adequate allowing copious amounts of water to enter from the rear creating a cuboidal rot situation. All of the consoles need to be inspected for integrity and several will need to be replaced wholesale immediately before they become dislodged and pose a threat to pedestrians and property below. The lower flashing located at the fascia board on the first level should be inspected for integrity and repaired or replaced as necessary. All areas of painted timber (i.e. fascia board and original window trim) should be scraped and repainted as required with regular maintenance. If there are any areas of cuboidal wet rot, those areas that are simple flat sections of timber should be replaced wholesale with like material. Any areas with remarkable architectural moulding and detail should have any areas of cuboidal wet rot repaired with a two-part epoxy system.

16-22 b. The main structural masonry support pilasters have deterioration at its base where it comes in contact with the sidewalk. This problem is due to freeze and thaw cycles and soluble salts (winter road salt) destroying the masonry units. Water and soluble salts which destroy lime mortar must be kept in check therefore keeping these joints properly pointed is very important to the health of the exterior brick cladding.

Repointing of the brick works should be done utilizing only lime-based mortar devoid of any cement. And, a regular yearly maintenance routine will need to be employed to keep the mortar in check and repair as necessary.

16-22 c. This building has wooden elements in direct contact with masonry and concrete. Timber elements and masonry with the potential of sustained damp (e.g., sidewalks) will prematurely rot the timber, all timber should be terminated at least 1" above ground surface masonry.

16-22 d. This building has beautiful and very character defining cast or cut stone hood mouldings and label-stops with a central key stone. As these are very heavy and usually are installed in several sections a periodical inspection should be made that they are affixed to the building properly e.g., the mortar is well pointed into the surrounding brick works and is not allowing water to get between the mouldings and the underlying brick work which could become dislodged in a freeze and thaw cycle.

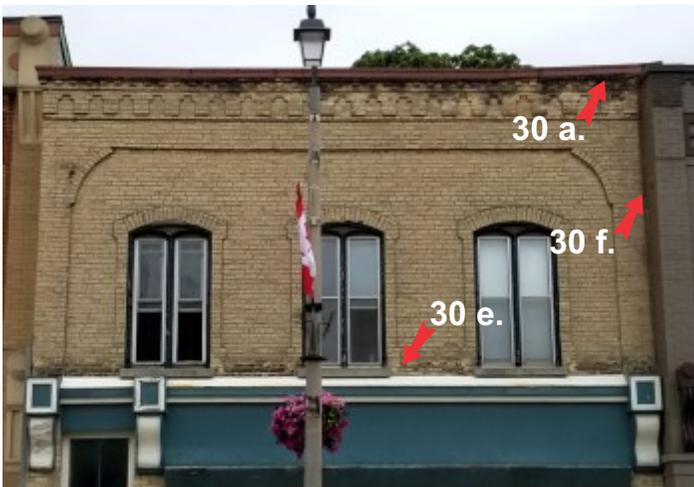
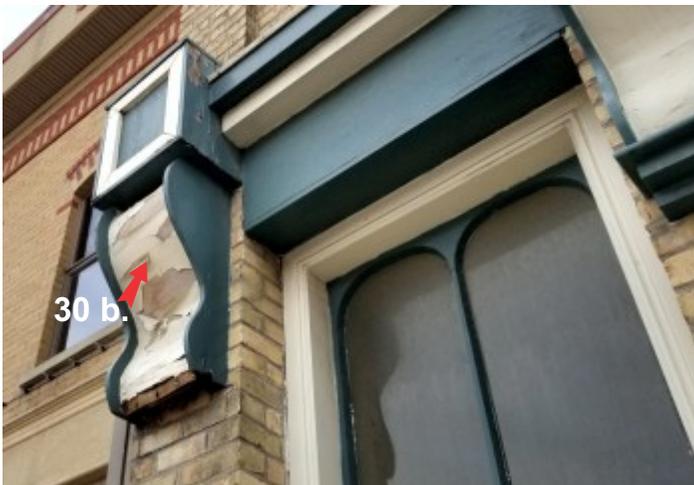
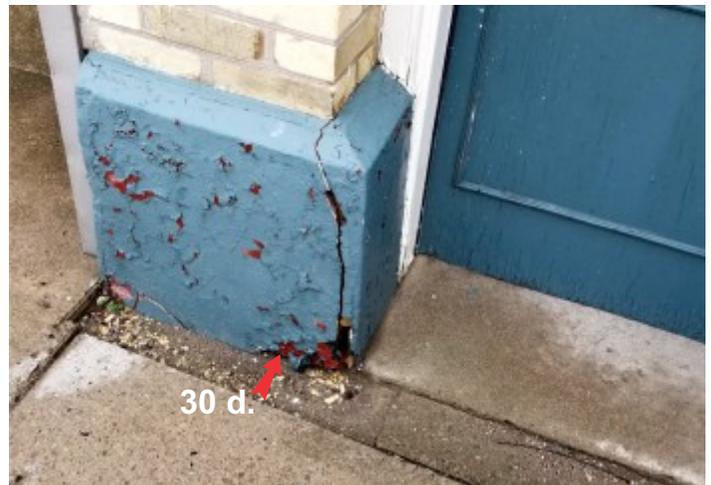
30 a. The flashing located at the upper roof parapet wall and above the fascia board appear to be in a condition of poor (at parapet) and good (at fascia board). Regular inspection of these areas for deterioration is prudent. Make certain these areas have been pointed or caulked properly as this condition could be allowing water to find its way between the flashing and the underlying masonry units, which will inevitably cause problem with damp and spalling.

30 b. All areas of painted timber (i.e. fascia board, console brackets and original window trim) should be scraped and repainted as required with regular maintenance. If there are any areas of cuboidal wet rot, those areas that are simple flat sections of timber should be replaced wholesale with like material. Any areas with remarkable architectural moulding and detail should have any areas of cuboidal wet rot repaired with a two-part epoxy system.

30 c. Many areas on this building are using plywood as cladding and fascia board, with many areas of rot. Interior or construction grade plywood is not a satisfactory material unless it is rated for exterior uses such as MDO (medium density overlaid plywood). All areas of painted timber (i.e. console brackets) should be scraped, repaired and repainted.

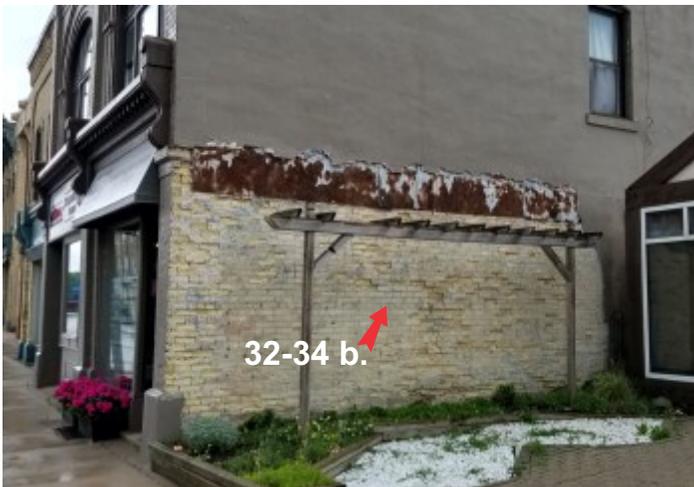
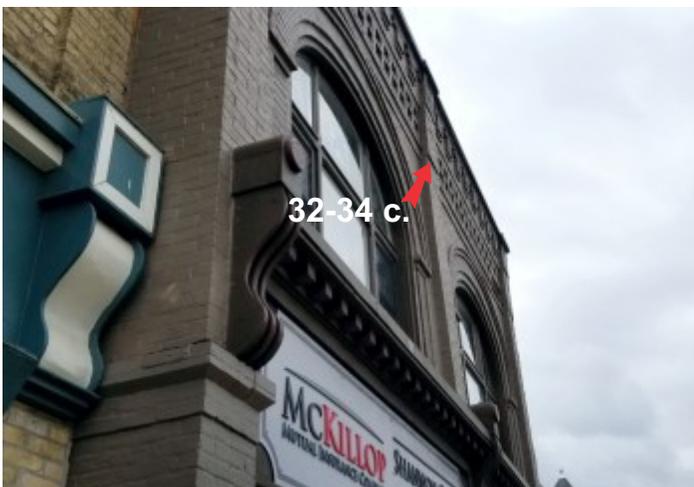
32-34 a. The flashing located at the upper roof parapet wall and above the fascia board appear to be in good condition. Regular inspection of these areas for deterioration is prudent. Make certain these areas have been pointed or caulked properly as this condition could be allowing water to find its way between the flashing and the underlying masonry units, which will inevitably cause problem with damp and spalling.

32-34 b. Ancillary side walls were traditionally pargeted with a suction bond of lime mortar. Concrete pargetting will hold copious amounts of moisture between the soft brick and the concrete parget itself causing massive spalling issues destroying the underlining brick during freeze and thaw cycles. Cementitious materials should be removed wholesale and the entire wall pargeted with an all lime suction bond to allow the transmission of moisture to the exterior. This building has a severe problem which will

need to be addressed immediately. The upper level of existing concrete pargetting has the potential of collapsing causing damage to the adjacent property or pedestrians.

32-34 c. I noted during my inspection that the upper level has a distinct lean. This may have appeared soon after original construction, however, could be a symptom of a more serious structural condition.

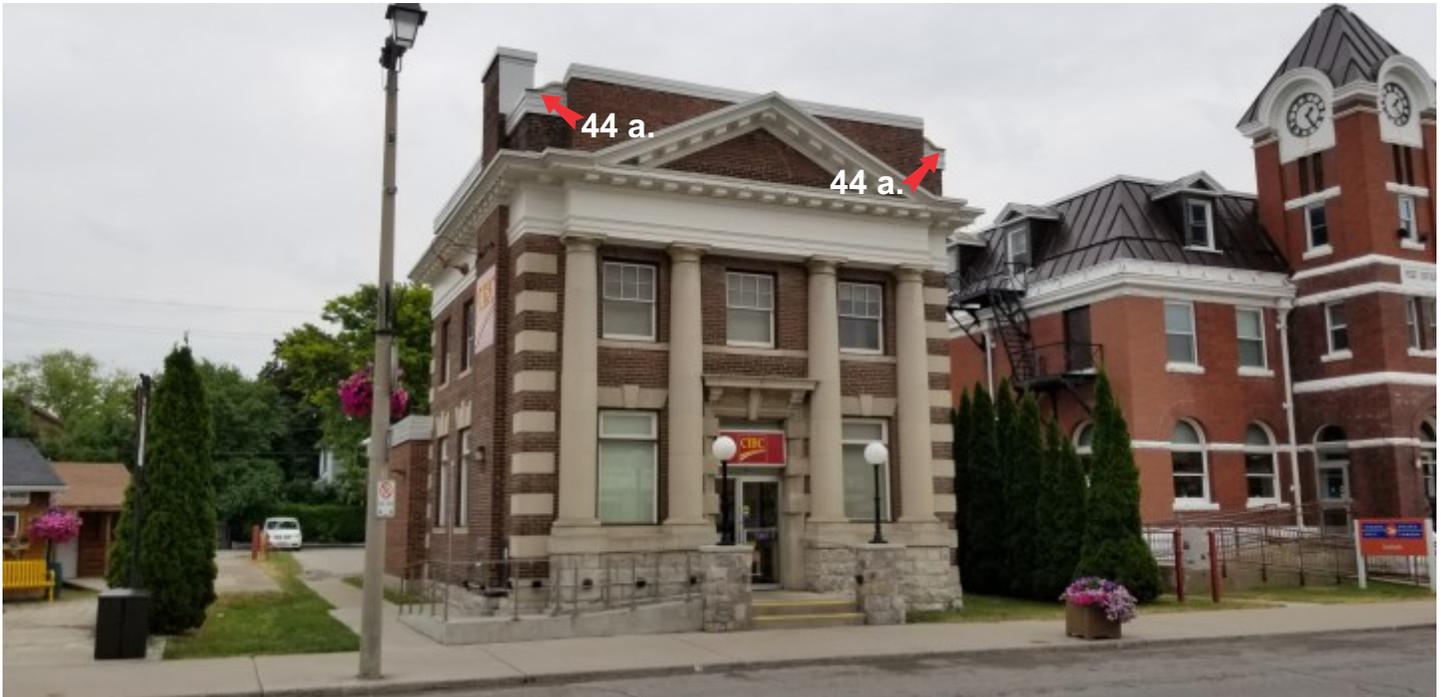
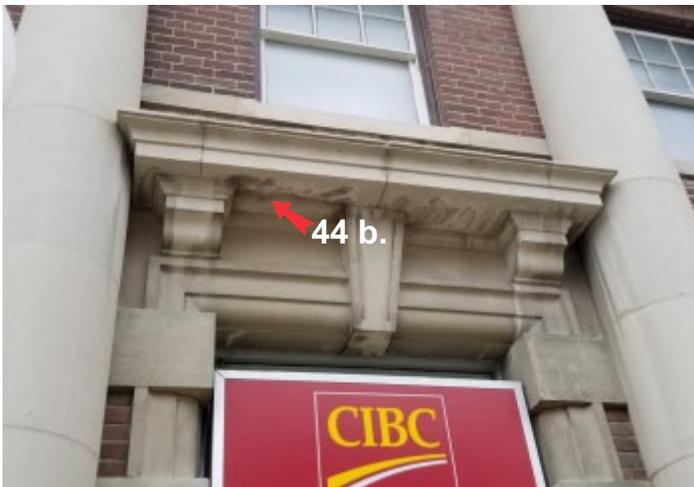
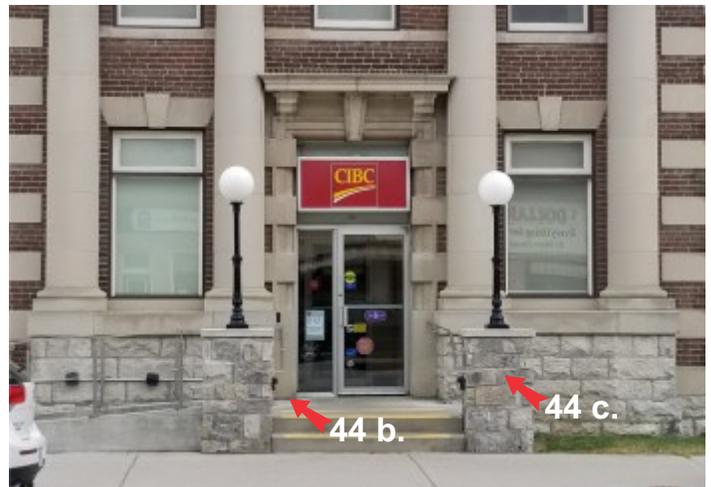
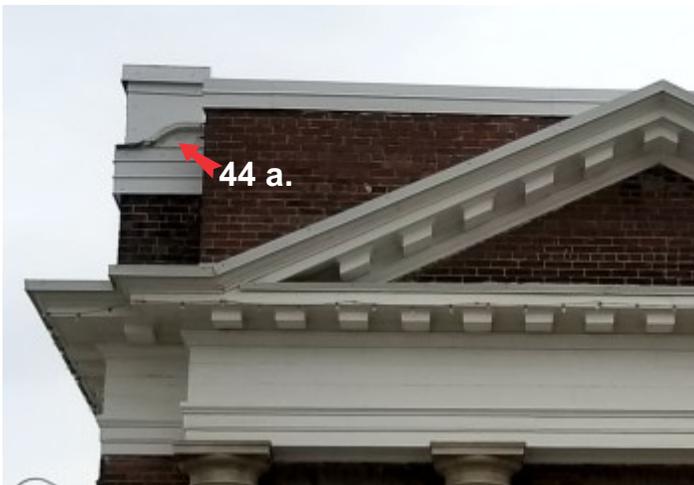
Note: This building is very well maintained with very few issues.

44 a. I noted a few areas of cuboidal wet rot that needs attention. After repair, make certain that the flashing is adequately protecting timber elements. All areas of painted timber should be scraped and repainted as required with regular maintenance. If there are any areas of cuboidal wet rot, those areas that are simple flat sections of timber should be replaced wholesale with like material. Any areas with remarkable architectural moulding and detail should have any areas of cuboidal wet rot repaired with a two-part epoxy system.

to completely restore these affected areas back to their original condition. Some spalling of the stone is also evident along the front steps from the use of salt in the winter months.

44.c During regular maintenance cycles the brick masonry units, rusticated stone works and decorative cut stone works should be inspected for any deterioration of mortar joints and re-pointed with an all lime based mortar to match.

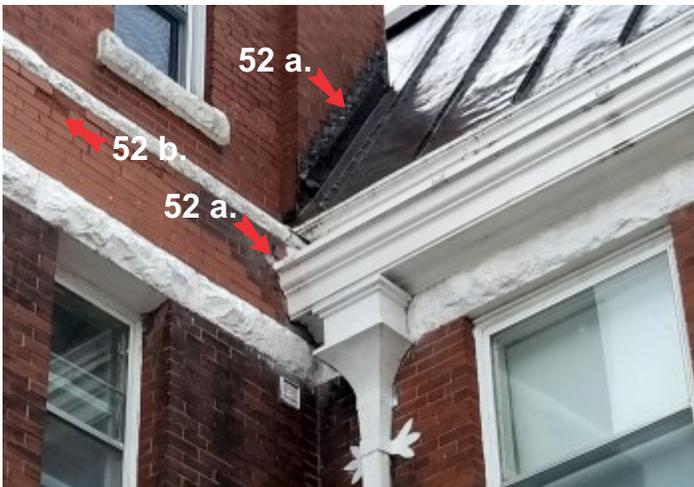
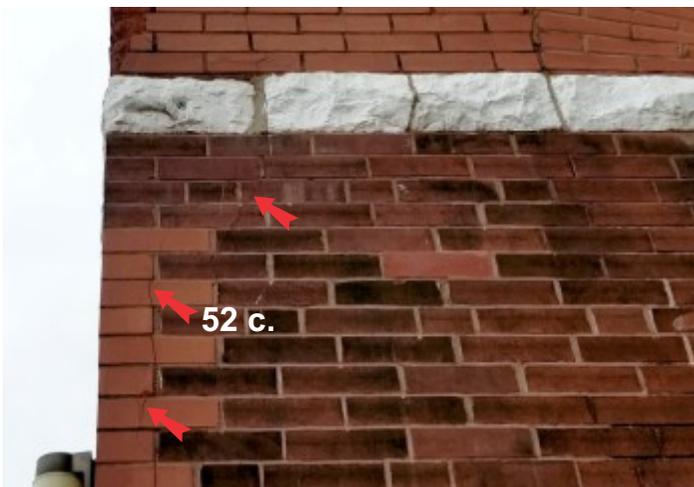
52 a. Much of the flashing on the building is well executed, however, in areas at the termination of the gutter against a perpendicular wall surface there needs to be a proper flashing let into the brick works or an adequate splash guard installed. I noted some deterioration and water staining of the adjacent walls. Verify that the gutters are all flowing properly and are not leaking against the masonry units. Should down-spots be exiting overland rather than into a footing weep tile or storm sewer?

52 b. The masonry is in miserable condition with considerable spalling. The masonry in question is new brick units installed during a "renovation" the bricks do not match the existing historic fabric and may be spalling because of Portland cement mortar employed in the "new" brick areas. A further pathology inspection of this building is highly recommended to inspect for roof water and damp issues which may also be affecting these areas as well. The affected brick areas need to be replaced wholesale and a suitable matching or custom brick needs to be employed. Only an all lime-based mortar should be used. During any subsequent pathology inspection existing mortar and brick samples should be taken to create a conservation plan for replacement and remediation.

52 c. There are sizable stress cracks that have appeared in some areas, these may have appeared because of the use of Portland cement or it could indicate some other underlying structural condition. Portland cement damage seems more plausible.

52 d. The front steps indicate the use of salts used during winter months. These areas need to be kept well pointed with an all lime mortar and kept well maintained to arrest any further damage to the rusticated stone works.

52 e. I would discourage the use of paint on the rusticated stone works, it is unsympathetic to the heritage fabric of the building.

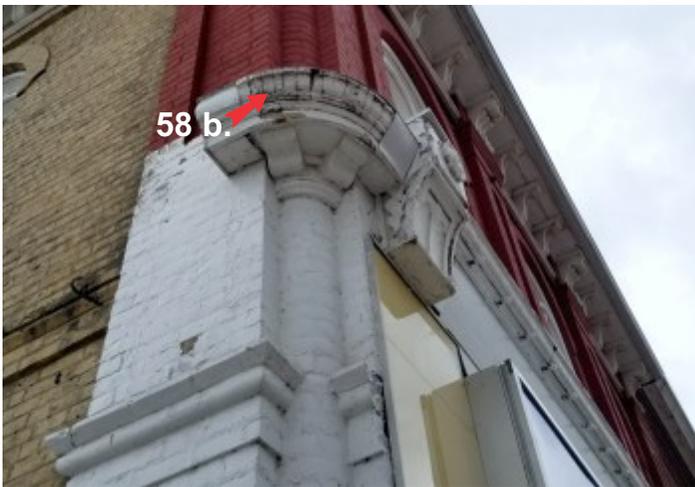
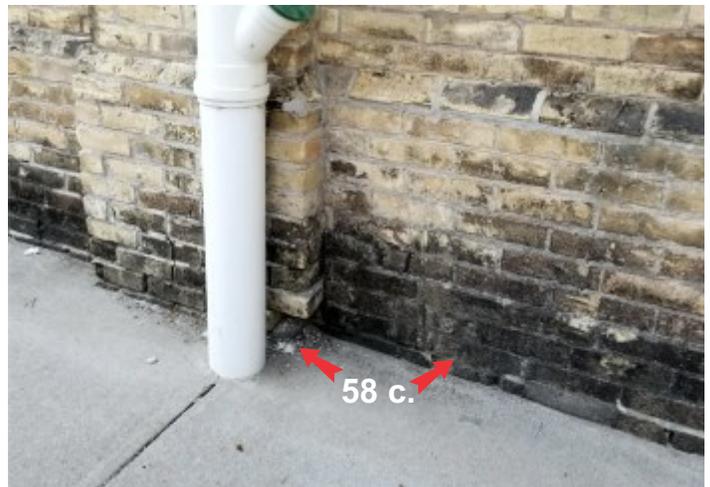
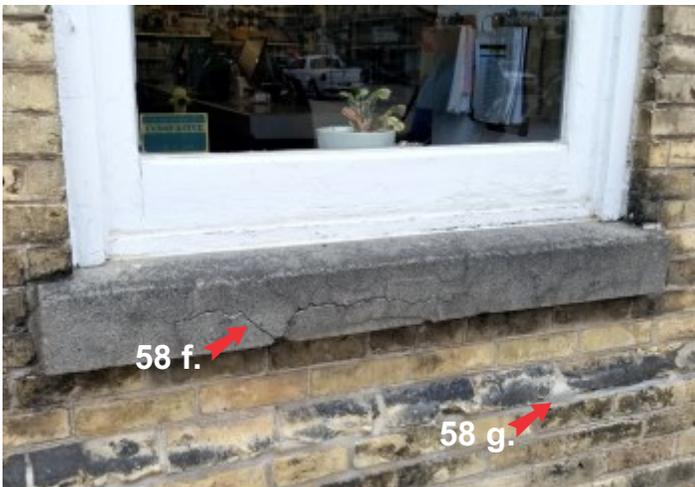
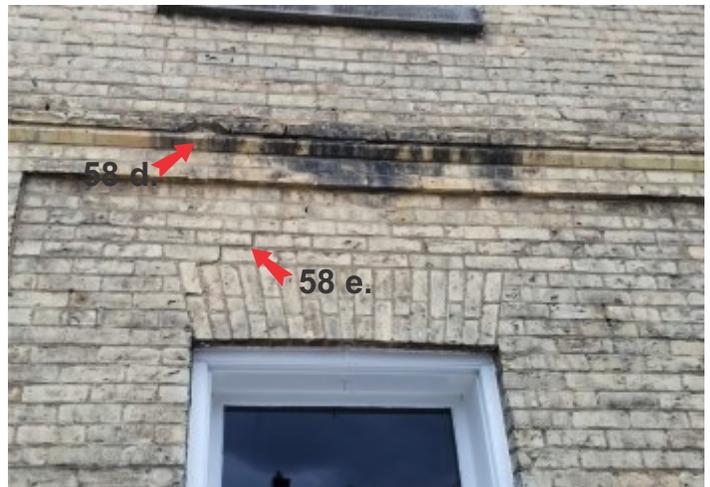
58 a. Regularly inspect eavestroughs for leaks and repair or replace as necessary.

58 b. This building has a beautiful cornice with outstanding console brackets and corbels. Several areas of the cornice is in poor condition with aluminium installed (which should be removed and the cornice restored). The flashing at the rear of this console is not adequate allowing water to enter from the rear creating a cuboidal rot situation. The lower flashing located at the fascia board on the first level should be inspected for integrity and repaired or replaced as necessary. All areas of painted timber (i.e. fascia board, corbels, cornice and original window trim) should be scraped and repainted as required with regular maintenance. If there are any areas of cuboidal wet rot, those areas that are simple flat sections of timber should be replaced wholesale with like material. Any areas with remarkable architectural moulding and detail should have any areas of cuboidal wet rot repaired with a two-part epoxy system.

58 c. Sections of the masonry have deterioration at its base where it comes in contact with the sidewalk. This problem is due to freeze and thaw cycles and soluble salts (winter road salt) destroying the masonry units. Water and soluble salts which destroy lime mortar must be kept in check therefore keeping these joints properly pointed is very important to the health of the exterior brick cladding. Repointing of the brick works should be done utilizing only lime-based mortar devoid of any cement. And, a regular yearly maintenance routine will need to be employed to keep the mortar in check and repair as necessary.

58 d. The main above-grade masonry exterior cladding is in fair condition with several areas of deterioration due to miss-managed roof water, however, (see 58 g.) cement has been used to fill voids in the original all lime-based mortar which is very damaging. Water and soluble salts which destroy lime mortar must be kept in check therefore keeping these joints properly pointed is very important to the health of the exterior brick cladding. Repointing of the brick works should be done utilizing only lime-based mortar devoid of any cement. Any spalled (broken-off) brick or washed out mortar should first be investigated to the reason why they have spalled or washed out i.e. broken or cracked

caulking around windows, Portland cement, landscape material too close to masonry, bad eavestroughs and downspouts or flashing, generally spalled masonry, and washed out mortar are a symptom of a moisture problem and should be repaired (water issues) as a priority.

58 e. The exterior brick work has a few areas with pronounced pyramidal cracks. Many of these types of cracks may have appeared in the first decade after original construction due in part to excessive shrinkage of wooden window frames and lintels. However, it can also indicate a problem with rot and the masonry has shifted. Keep pyramidal cracks well pointed with an all lime based mortar, consult a structural engineer if the crack widens or becomes unstable.

58 f. A cut stone (or pre-cast) sill is in poor condition. A detailed inspection must be made to investigate why this sill has cracked and deteriorated, most likely water damage. Repointing of the stonework should be done utilizing only lime-based mortar devoid of any cement. There are many conservation products with a long history of success available to completely restore this sill back to its original condition.

58 g. Portland cement has been used to fill voids in the original all lime-based mortar which is very damaging. Repointing of the brick works should be done utilizing only lime-based mortar devoid of any cement.

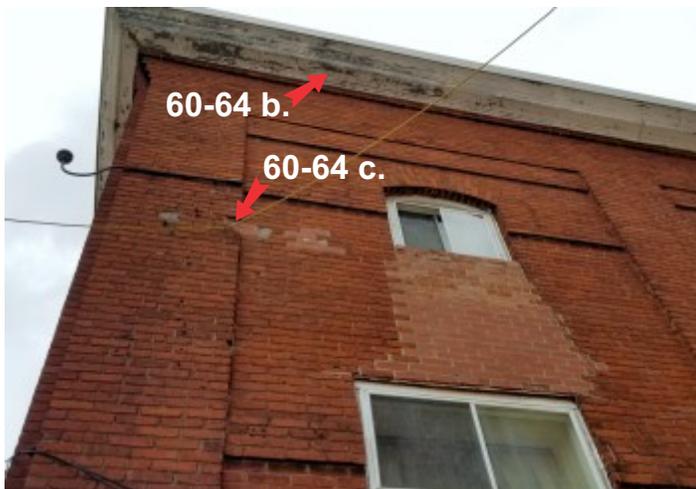
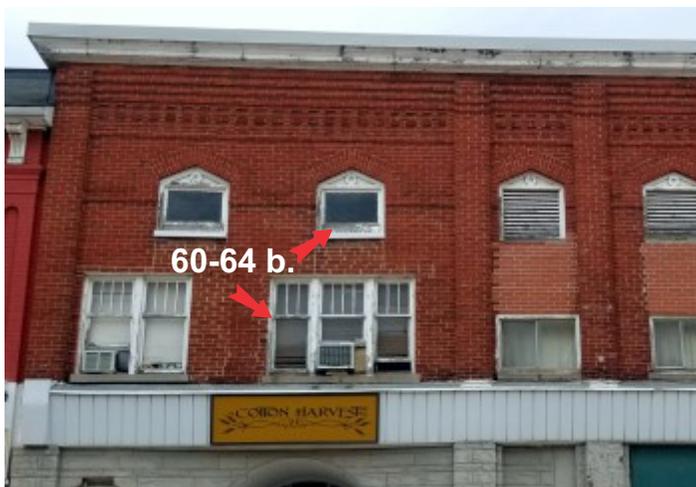
60-64 a. The upper parapet flashing appears to be in good condition. The lower fascia board flashing is deteriorating and should be inspected that it is adequately caulked or let into the masonry with an all lime-based mortar.

60-64 b. The existing cornice is very handsome and should be retained at all costs. After repair, make certain that the flashing is adequately protecting timber elements. All areas of painted timber should be scraped and repainted as required with regular maintenance. If there are any areas of cuboidal wet rot, those areas that are simple flat sections of timber should be replaced wholesale with like material. Any areas with remarkable architectural moulding and detail should have any areas of cuboidal wet rot repaired with a two-part epoxy system.

60-64 c. The main above-grade masonry exterior cladding is in poor condition with several areas of deterioration due to miss-managed roof water, however, Portland cement has been used to fill voids in the original all lime-based mortar which is very damaging. Water and soluble salts which destroy lime mortar must be kept in check therefore keeping these joints properly pointed is very important to the health of the exterior brick cladding. Repointing of the brick works should be done utilizing only lime-based mortar devoid of any cement. Any spalled (broken-off) brick or washed out mortar should first be investigated to the reason why they have spalled or washed out i.e. broken

or cracked caulking around windows, Portland cement, landscape material too close to masonry, bad eavestroughs and downspouts or flashing, generally spalled masonry, and washed out mortar are a symptom of a moisture problem and should be repaired (water issues) as a priority.

60-64 d. Sections of the masonry have deterioration at its base where it comes in contact with the sidewalk. This problem is due to freeze and thaw cycles and soluble salts (winter road salt) destroying the masonry units. Water and soluble salts which destroy lime mortar must be kept in check therefore keeping these joints properly pointed is very important to the health of the exterior brick cladding. Repointing of the brick works should be done utilizing only lime-based mortar devoid of any cement. And, a regular yearly maintenance routine will need to be employed to keep the mortar in check and repair as necessary.

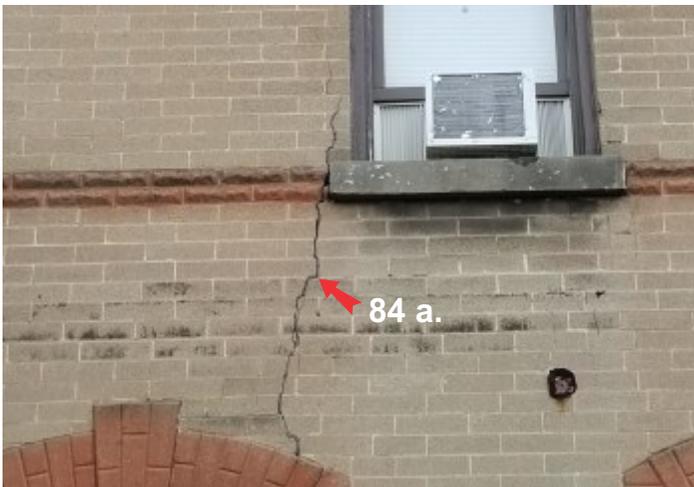
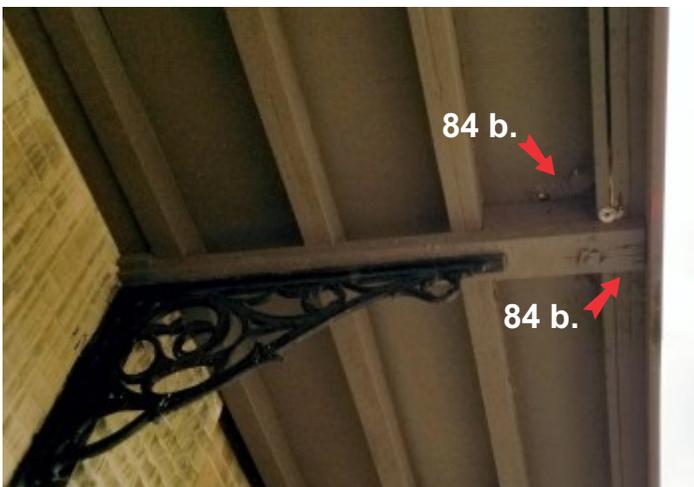
84 a. The exterior brick work has a few areas with pronounced pyramidal cracks. Many of these types of cracks may have appeared in the first decade after original construction due in part to excessive shrinkage of wooden window frames and lintels. However, it can also indicate a problem with rot and the masonry has shifted. Keep pyramidal cracks well pointed with an all lime-based mortar, consult a structural engineer if the crack widens or becomes unstable.

84 b. A detailed inspection of the balcony for rot should be made and repaired immediately. I detected a few areas that showed signs of cuboidal wet rot. Inspection of the water drainage of the deck should be made as well as any flashing along the edge. Repair and replace as necessary.

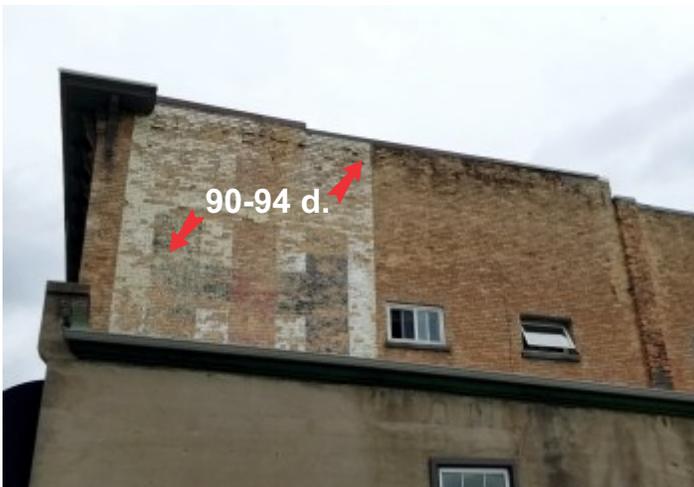
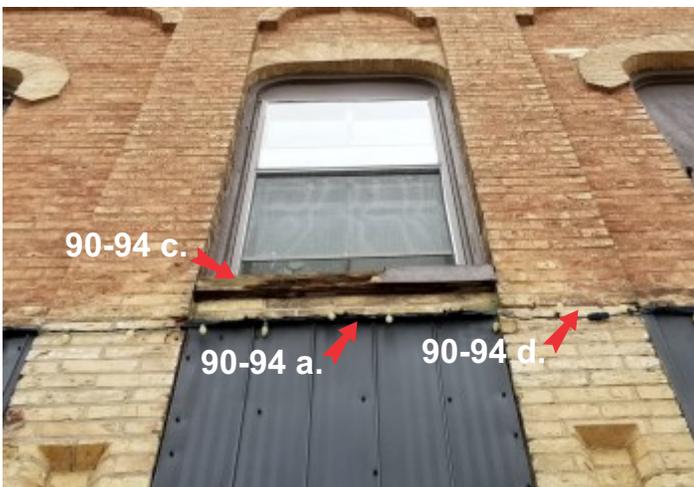
90-94 a. The upper parapet flashing appears to be in good condition. The lower fascia board flashing is in poor condition and should be inspected that it is adequately caulked or let into the masonry with an all lime-based mortar.

90-94 b. This building has a beautiful cornice with outstanding console brackets. Several areas of the cornice is in poor condition with aluminium installed (which should be removed and the cornice restored). The flashing at the rear of this console is not adequate allowing water to enter from the rear creating a cuboidal rot situation. The lower flashing located at the fascia board on the first level should be inspected for integrity and repaired or replaced as necessary. All areas of painted timber (i.e. fascia board, corbels, cornice and original window trim) should be scraped and repainted as required with regular maintenance. If there are any areas of cuboidal wet rot, those areas that are simple flat sections of timber should be replaced wholesale with like material. Any areas with remarkable architectural moulding and detail should have any areas of cuboidal wet rot repaired with a two-part epoxy system.

90-94 c. The building has timber sub-sills under the majority of the existing windows. There is severe deterioration and loss of the paint surface. These sub-sills should be scraped, and any areas of rot repaired with a two-part epoxy system and repainted. Sills and sub-sills should never be caulked on the bottom as this can create issues with the passage of moisture which can rot out the sill and the sub-sill.

90-94 d. Sections of the masonry have deterioration at its base where it comes in contact with the sidewalk as well as the side of the building and in many areas on the front facade. Water and soluble salts which destroy lime mortar must be kept in check

therefore keeping these joints properly pointed is very important to the health of the exterior brick cladding. Repointing of the brick works should be done utilizing only lime-based mortar devoid of any cement. And, a regular yearly maintenance routine will need to be employed to keep the mortar in check and repair as necessary.

90-94 e. Many areas on this building are using plywood as cladding notably windows, with many areas of rot. Interior or construction grade plywood is not a satisfactory material unless it is rated for exterior uses such as MDO (medium density overlaid plywood). All areas of painted timber (i.e. console brackets) should be scraped, repaired and repainted.

90-94 f. This building has wooden elements in direct contact with masonry and concrete. Timber elements and masonry with the potential of sustained damp (e.g., sidewalks) will prematurely rot the timber. All timber should be terminated at least 1" above ground surface masonry.

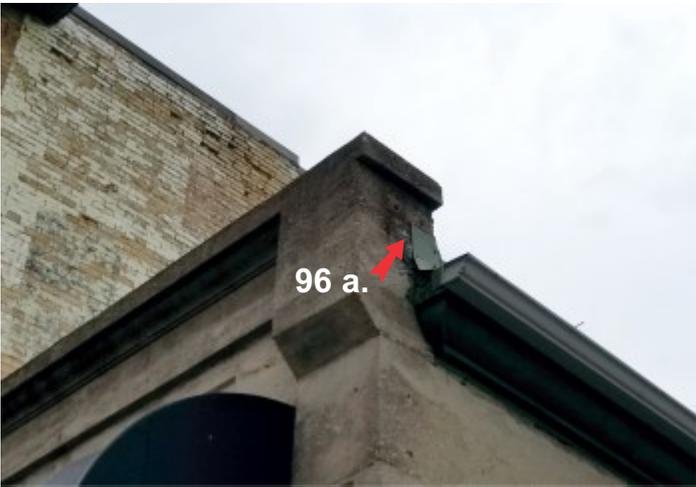
96 a. This building is very interesting as it is built in pre-cast concrete. The upper concrete parapet wall should be inspected periodically for cracks and fishers that may allow water to enter the wall which could cause considerable damage in a freeze and thaw cycle. Keep any flashing in good order and well caulked or let into the masonry.

96 b. Soluble salts can be very damaging to any masonry including pre-cast concrete. Remove any areas of salt efflorescence and keep the lower sections where it comes in contact with the sidewalk well pargetted with similar materials.

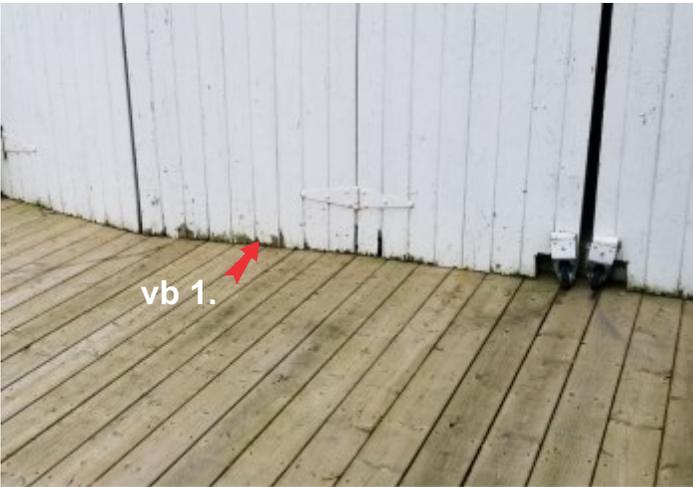
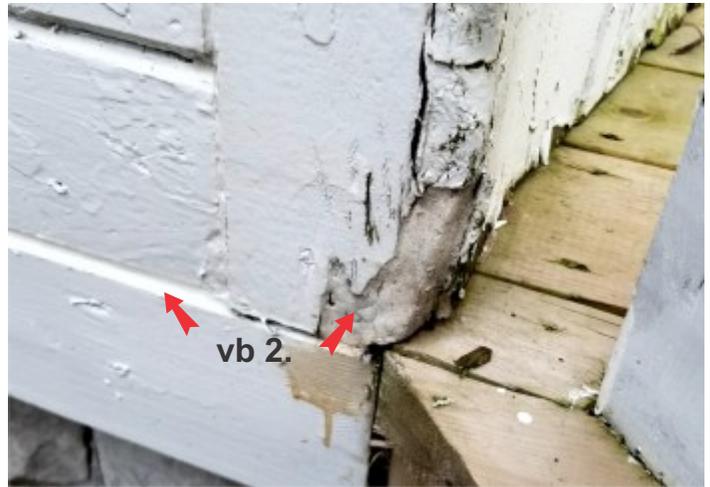
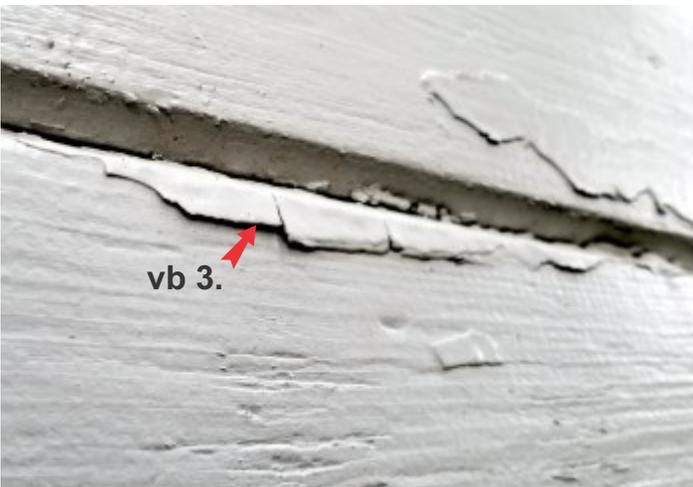
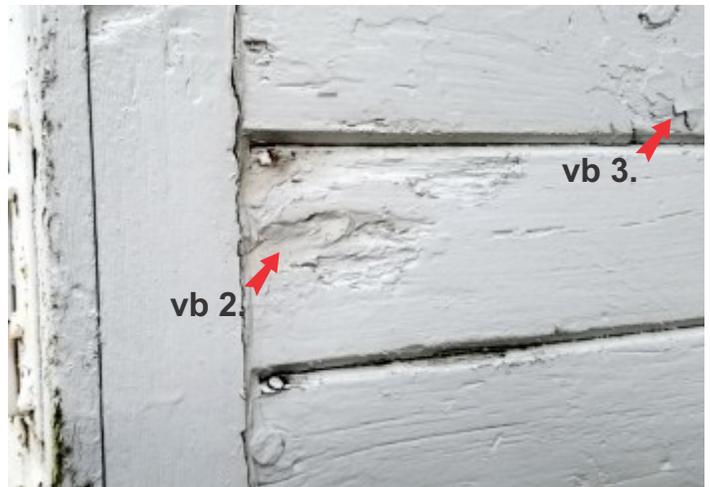
vb 1. The bottom of the bi-fold doors should be trimmed back 2" to remove rot and to keep the wood from contacting the wood deck which will prematurely rot the bottom of the doors. Provide a proper door sweep to the bottoms of the doors to stop accumulation of debris and snow from entering the interior of the building.

vb 2. Caulking has been used to repair rotted wood. Caulking cannot be used for this type of repair ever! I also noted several horizontal joints caulked along the lower watertable board which will prevent the passage of water and create a rot situation! If there are any areas of cuboidal wet rot, those areas that are simple flat sections of timber should be replaced wholesale with like material. Any areas with remarkable architectural moulding and detail should have any areas of cuboidal wet rot repaired with a two-part epoxy system.

executed poorly, leaving unstable existing paint surfaces in-situ causing peeling and failure in the paint film. All areas of painted timber (i.e. siding, watertable boards etc.) should be scraped to native wood utilizing an infrared paint stripper and repainted as required with regular maintenance. If there are any areas of cuboidal wet rot, those areas that are simple flat sections of timber should be replaced wholesale with like material. Any areas with remarkable architectural moulding and detail should have any areas of cuboidal wet rot repaired with a two-part epoxy system.

This building is of great historic significance and is a very rare building type. This building has significant issues with rot and water damage. This building requires a complete and separate Pathology report to build a conservation plan for future works.
